LICENSEE EVENT REPORT (LER)																
Facility Name (1) SAN ONOFRE NUCLEAR GENERATING STATION (SONGS), Unit 2										Docket Number (2) 0 5 0 0 0 3 6 1			Page (3) 1 of 0 4			
Title (4) Missed Technical Specification Surveillance Due to Lack of an Alarm																
EVENT DATE (5)			LER NUMBER (6)				REPORT DATE (7)			OTHER FACILITIES INVOLVED (8)						
Month	Day	Year	Year	///	Sequential Number	///	Revision Number	Month	Day	Year	Facility Names		Docket Number(s)			
0 8	1 3	9 5	9 5	---	0 1 4	---	0 0	0 9	1 5	9 5	SONGS Unit 3		0 5 0 0 0 3 6 2			
OPERATING MODE (9)			THIS REPORT IS SUBMITTED PURSUANT TO THE REQUIREMENTS OF 10CFR (Check one or more of the following) (11)													
POWER LEVEL (10) 0 9 9 //////////////////// //////////////////// //////////////////// //////////////////// ////////////////////			20.402(b)				20.405(c)				50.73(a)(2)(iv)				73.71(b)

SAN ONOFRE NUCLEAR GENERATION STATION	DOCKET NUMBER	LER NUMBER	PAGE
UNIT 2	05000361	95-014-00	2 of 4

DESCRIPTION OF THE EVENT

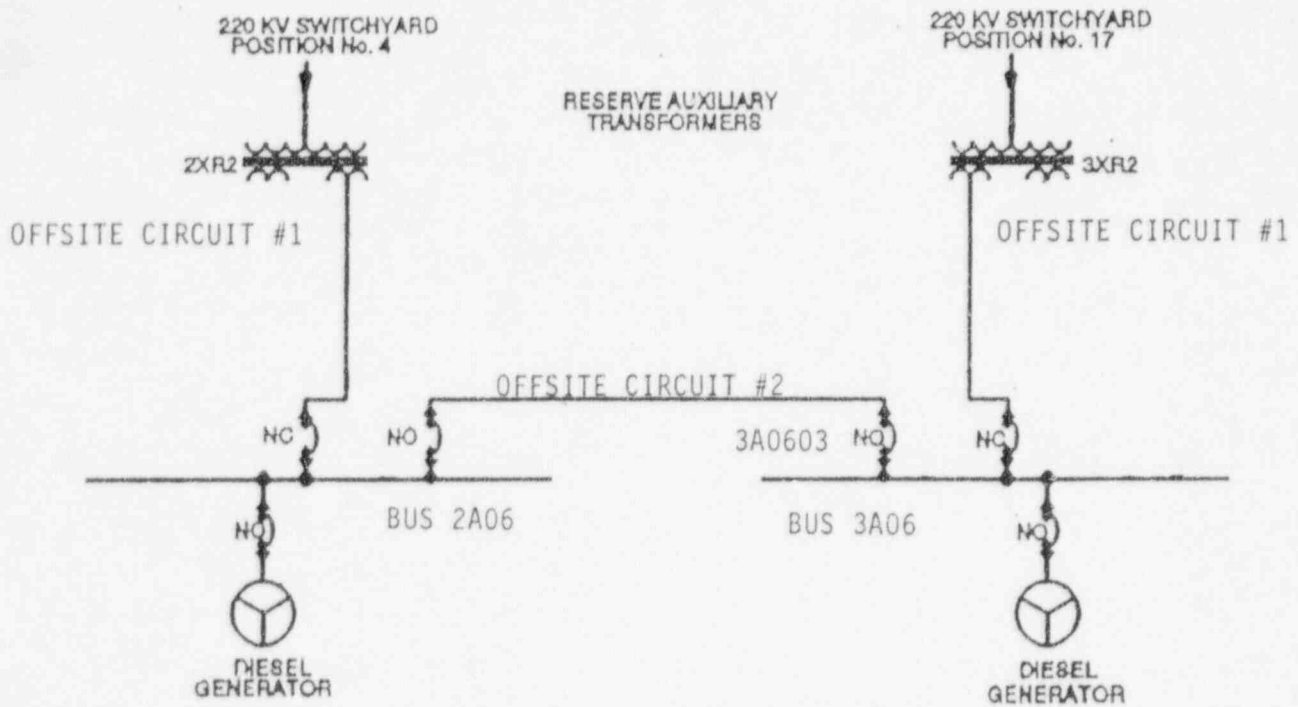
Figure 1

At 0450 on 8/13/95, operators started pump 3P114 by the preferred method - actuating SIAS subgroup relay K-103B - silently transferring crosstie breaker 3A0603 to MANUAL. At 0930, the Shutdown Nuclear Safety Coordinator (utility, non-licensed) observed the breaker in MANUAL during a routine control board walkdown. The CRS (utility, licensed) was informed but did not recognize that Unit 2 was in a one hour TS action statement. At 1410, the Shift Superintendent (utility, licensed) was informed, immediately recognized that the Unit was in an action statement, and directed the CRS to place the breaker in AUTOMATIC. The response to this event was delayed because the CRS did not recognize the second source of offsite power was inoperable (cognitive error). This event was reviewed with licensed plant operators. The CRS involved was appropriately disciplined.
