AFFIDAVIT

I, Charles C. Stokes, am providing this statement of my own volition in response to various Pacific Gas and Electric (PG&E) submittals to the NRC. This is intended to follow up on issues which I have raised in prior statements to the Commission and which I feel must still be addressed in detail by PG&E Diablo Project management before Unit 1 is allowed to go beyond 5% power. In some cases my comments suggest necessary methodological steps to obtain adequate correction action on my allegations, largely confirmed by Mr. Yin. In other cases, my comments expose false or misleading statements by PG&E in their response to Mr. Yin's inspection report.

In response to PG&E letters on the subject of **Tube Steel Radius** and **Flare-Bevel Welds** as addressed in the April 7, 1984 and April 11, 1984 to the members of the Appeal Board, and PG&E letter No.: DCL-84-083, DCL-84-164, DCL-84-166, and DCL-84-190.

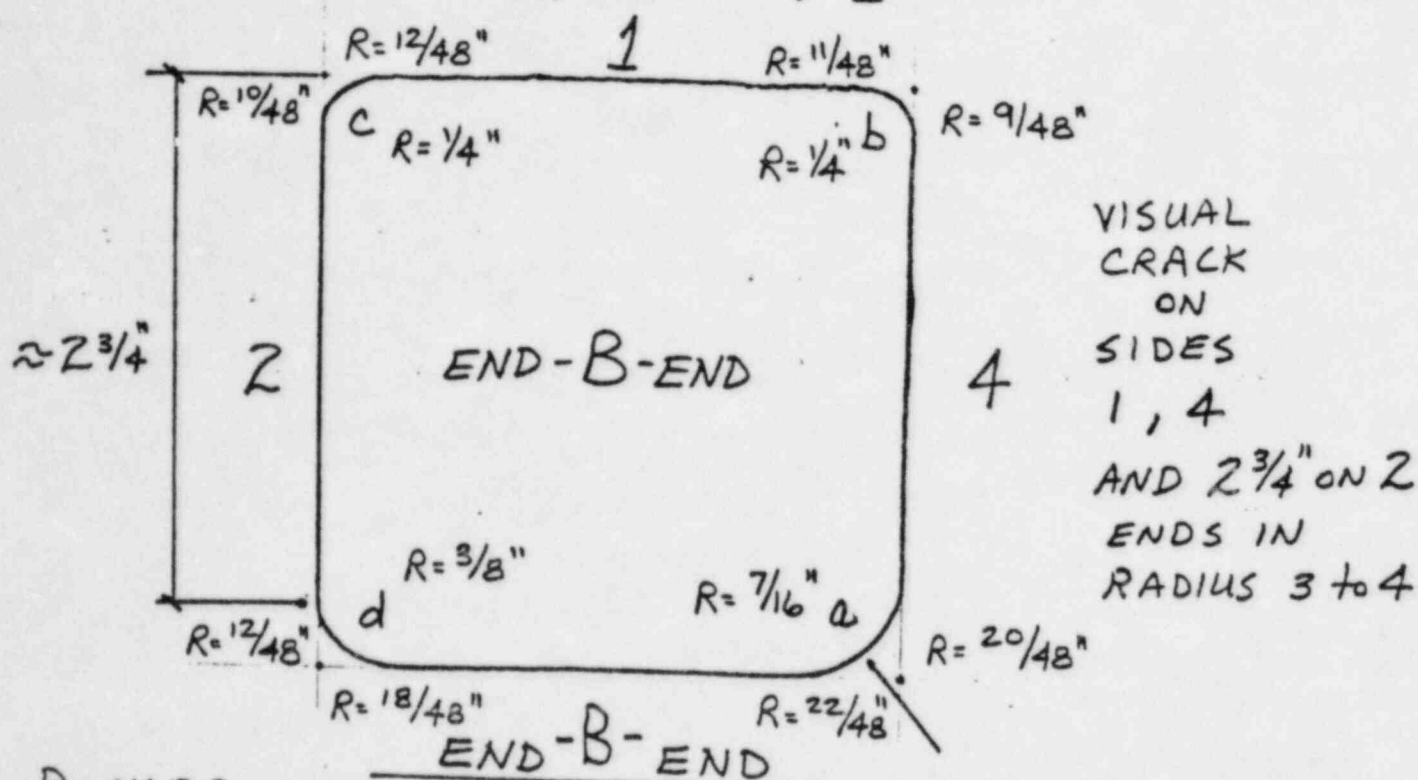
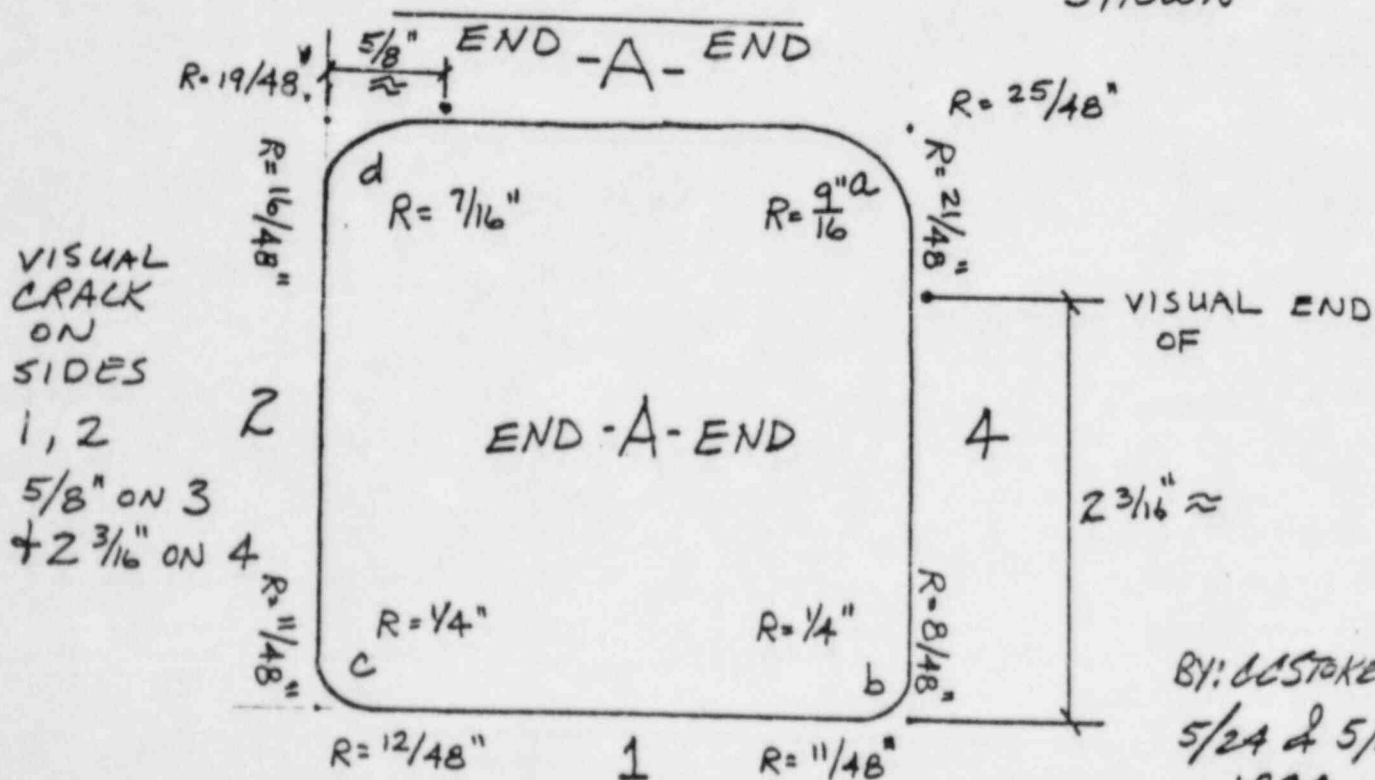
ATTACHMENT 1

This tubing (Attachment 1 sketches) not only has a corner radius less than 2t but has only one (1) corner which is 2t. Three corners are less than 2t, of which two (2) are only 1t as I and others have confirmed. It measures 1t using the Straight Ruler Method (per PG&E) and using the Concave Radius Gage Method. An additional flaw exists, which before seeing this piece, not even I was aware of. The tube wall has what appears to me to be a lamination crack running all the way around its' perimeter. This lamination crack is almost exactly at the center line of the tube wall.

R - INSIDE MEASURED
W/ FILLET GAUGES

$$\text{IF } R = 2t = 2\left(\frac{1}{4}\right) = \frac{1}{2}" = \frac{24}{48}"$$
