**GULF STATES UTILITIES COMPANY**

River Bend Station - Unit 1  
Docket No. 50-458

Please find enclosed an Informational Report concerning cracks discovered in welds in the hydraulic control unit piping at River Bend Station - Unit 1. This report is submitted to inform the NRC of these conditions and document GSU's investigation and corrective actions.

## INTRODUCTION

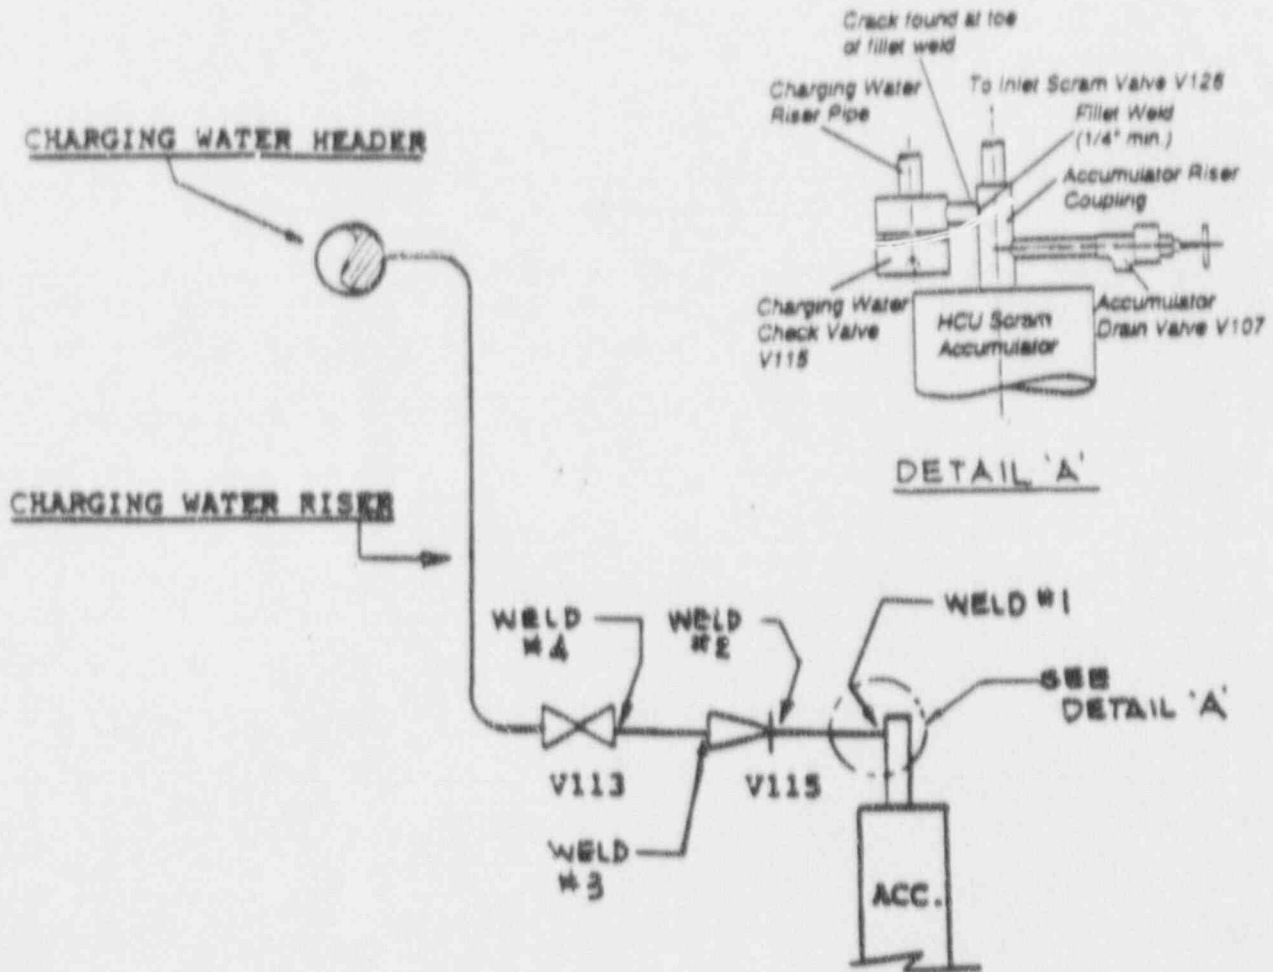
FIGURE 1

On February 28, 1991 hydraulic control unit No.36-21 was found leaking. After closer examination of the HCU, it was noted that the water was spraying out from a circumferential crack in a short, horizontal segment of charging water piping between the accumulator pipe coupling and the charging water check valve, near the toe of the weld (see Figure 1, weld #1). This was documented on condition report (CR) 91-0074. The plant was not operating at the time of discovery.

The leaking pipe was replaced and liquid penetrant test (PT) examinations were performed on the remainder of the HCUs (144 units) at the location of the leak (weld #1, Figure #1). Sixteen additional linear indications were discovered and reworked; none were leaking (See Table #1).

2. As described below, PT examinations were conducted on the next three welds upstream of weld #1 prior to restart from the MDCY4 outage (see Figure 1). Note that these welds were determined to be susceptible to cracking from review of available pipe stress analyses. All (100%) of the weld #2 and #3 locations were inspected and a selected sample of the weld #4 locations were inspected (only when an indication was found in either of the corresponding weld #2 or #3 locations). All indications were reworked accordingly and no indications were found in any of the inspected welds at location #4. Table 2 summarizes the results of these inspections.

Cracking of the HCUs at RBS is determined to be caused from low cycle fatigue due to a fluid transient of unknown origin which occurs during full core reactor scrams from power. Cracking typically occurs in the first two or three welds on the charging water line off the accumulators on the HCU skid. This is not a safety issue because automatic or manual scram can be achieved during normal operation without accumulator pressure by using reactor pressure. Moreover, during startup, the ability to scram is assured by the commitment at RBS to rework or replace all known indications in charging water pipe welds prior to plant startups.

Typical HCU Charging Water Piping Arrangement

1. PT examinations of the welds at location #1 have been and will continue to be performed following every full core plant scram from power for 100% of the HCUs. All indications documented during these inspections shall be reworked/replaced prior to restart of the plant from each scram.
