UNITED STATES OF AMERICA
NUCLEAR REGULATORY COMMISSION

In the Matter of)	Docket Nos. STN 50-454 OL
)	STN 50-455 OL
COMMONWEALTH EDISON COMPANY)	
)	
(Byron Nuclear Power Station,)	
Units 1 and 2))

DIRECT TESTIMONY OF
BOBBY G. TREECE
ON ISSUES 5 AND 6
(CABLE OVERTENSIONING),
AS LIMITED BY THE LICENSING BOARD'S
ORDER OF JUNE 8, 1984

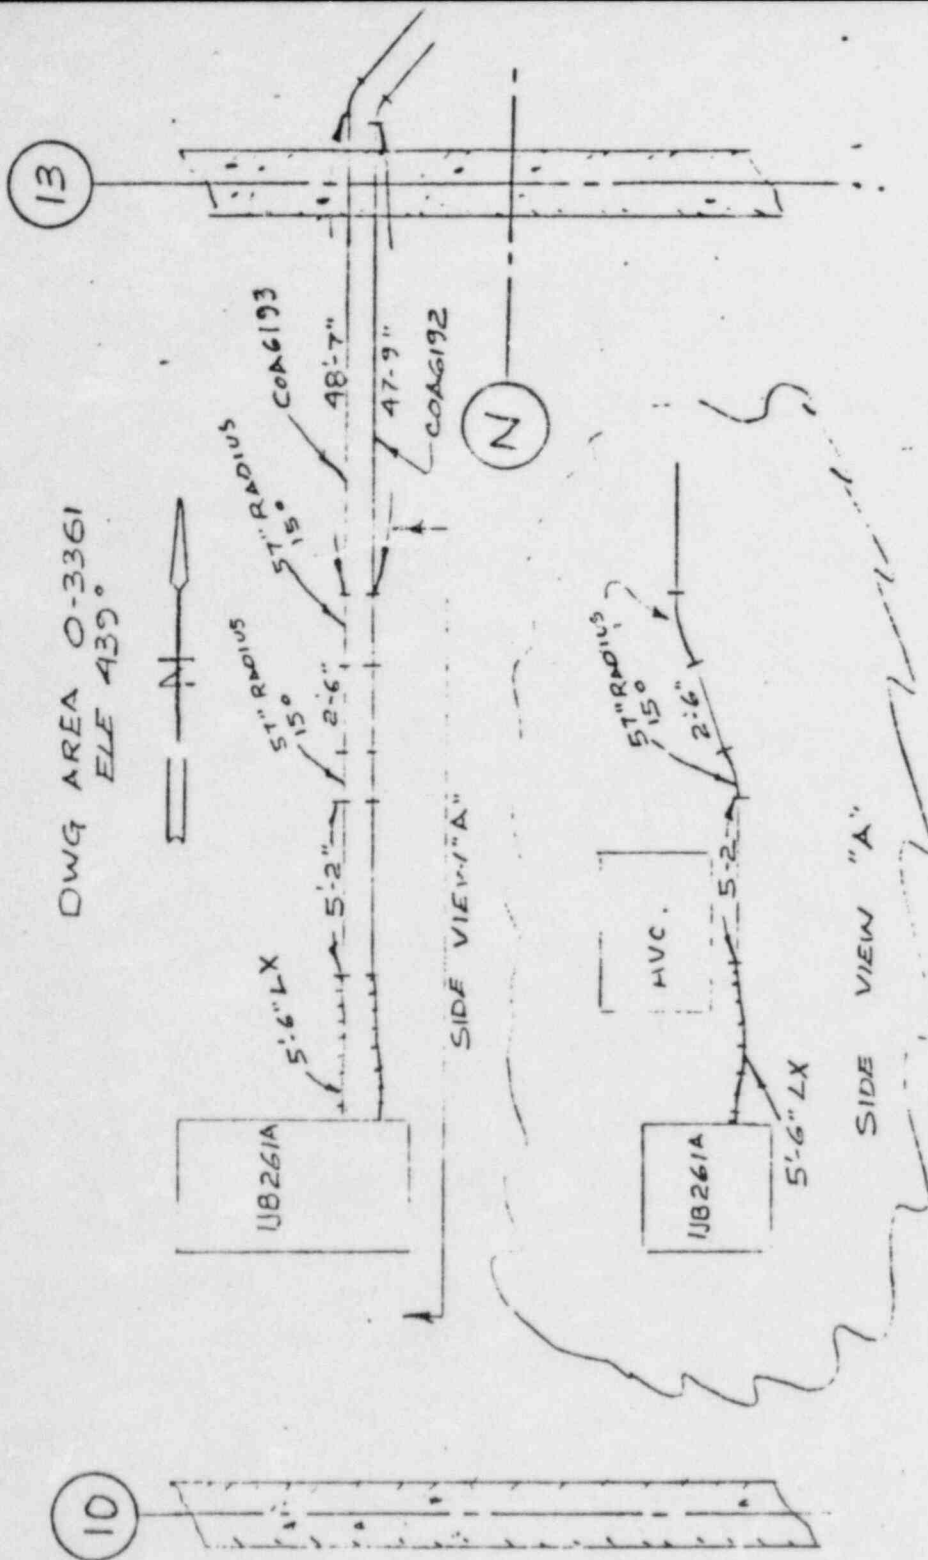
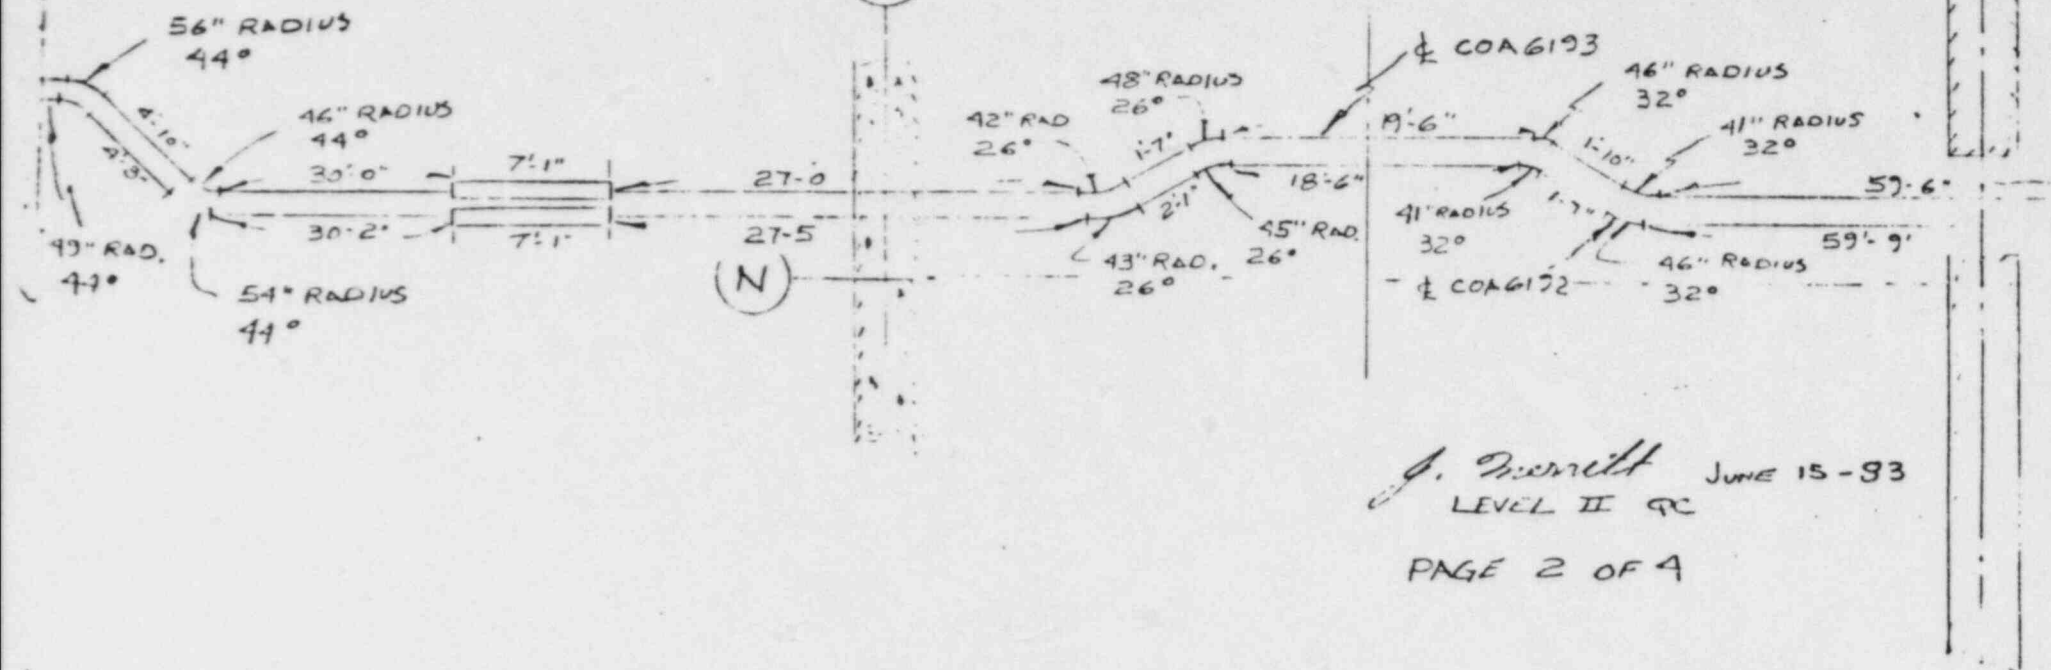
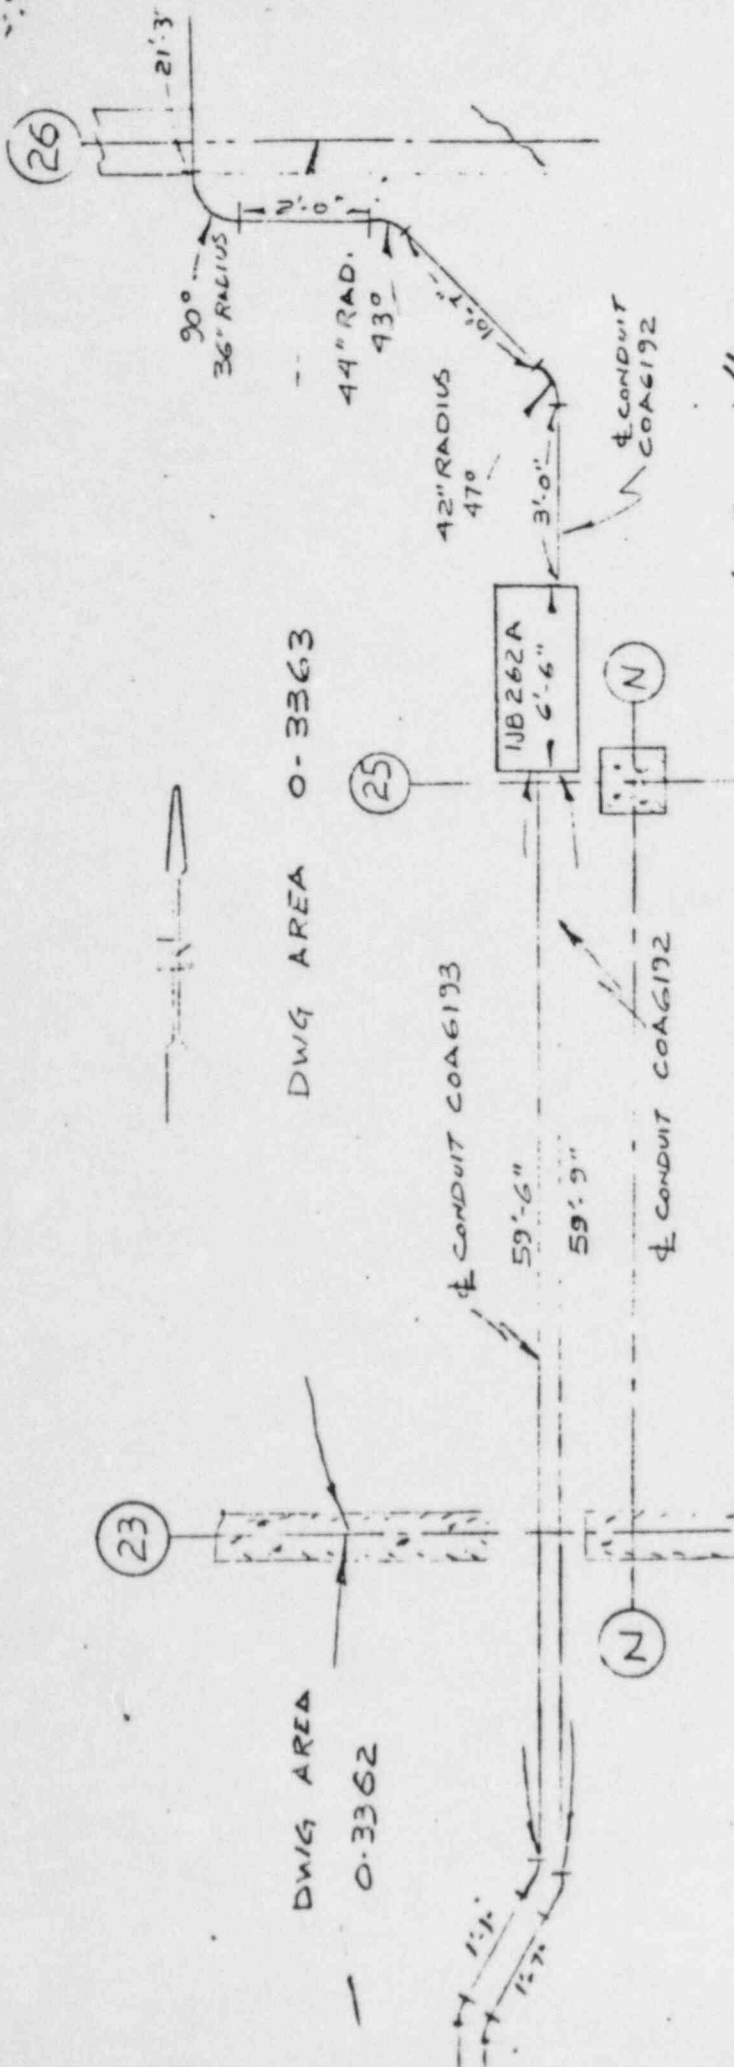
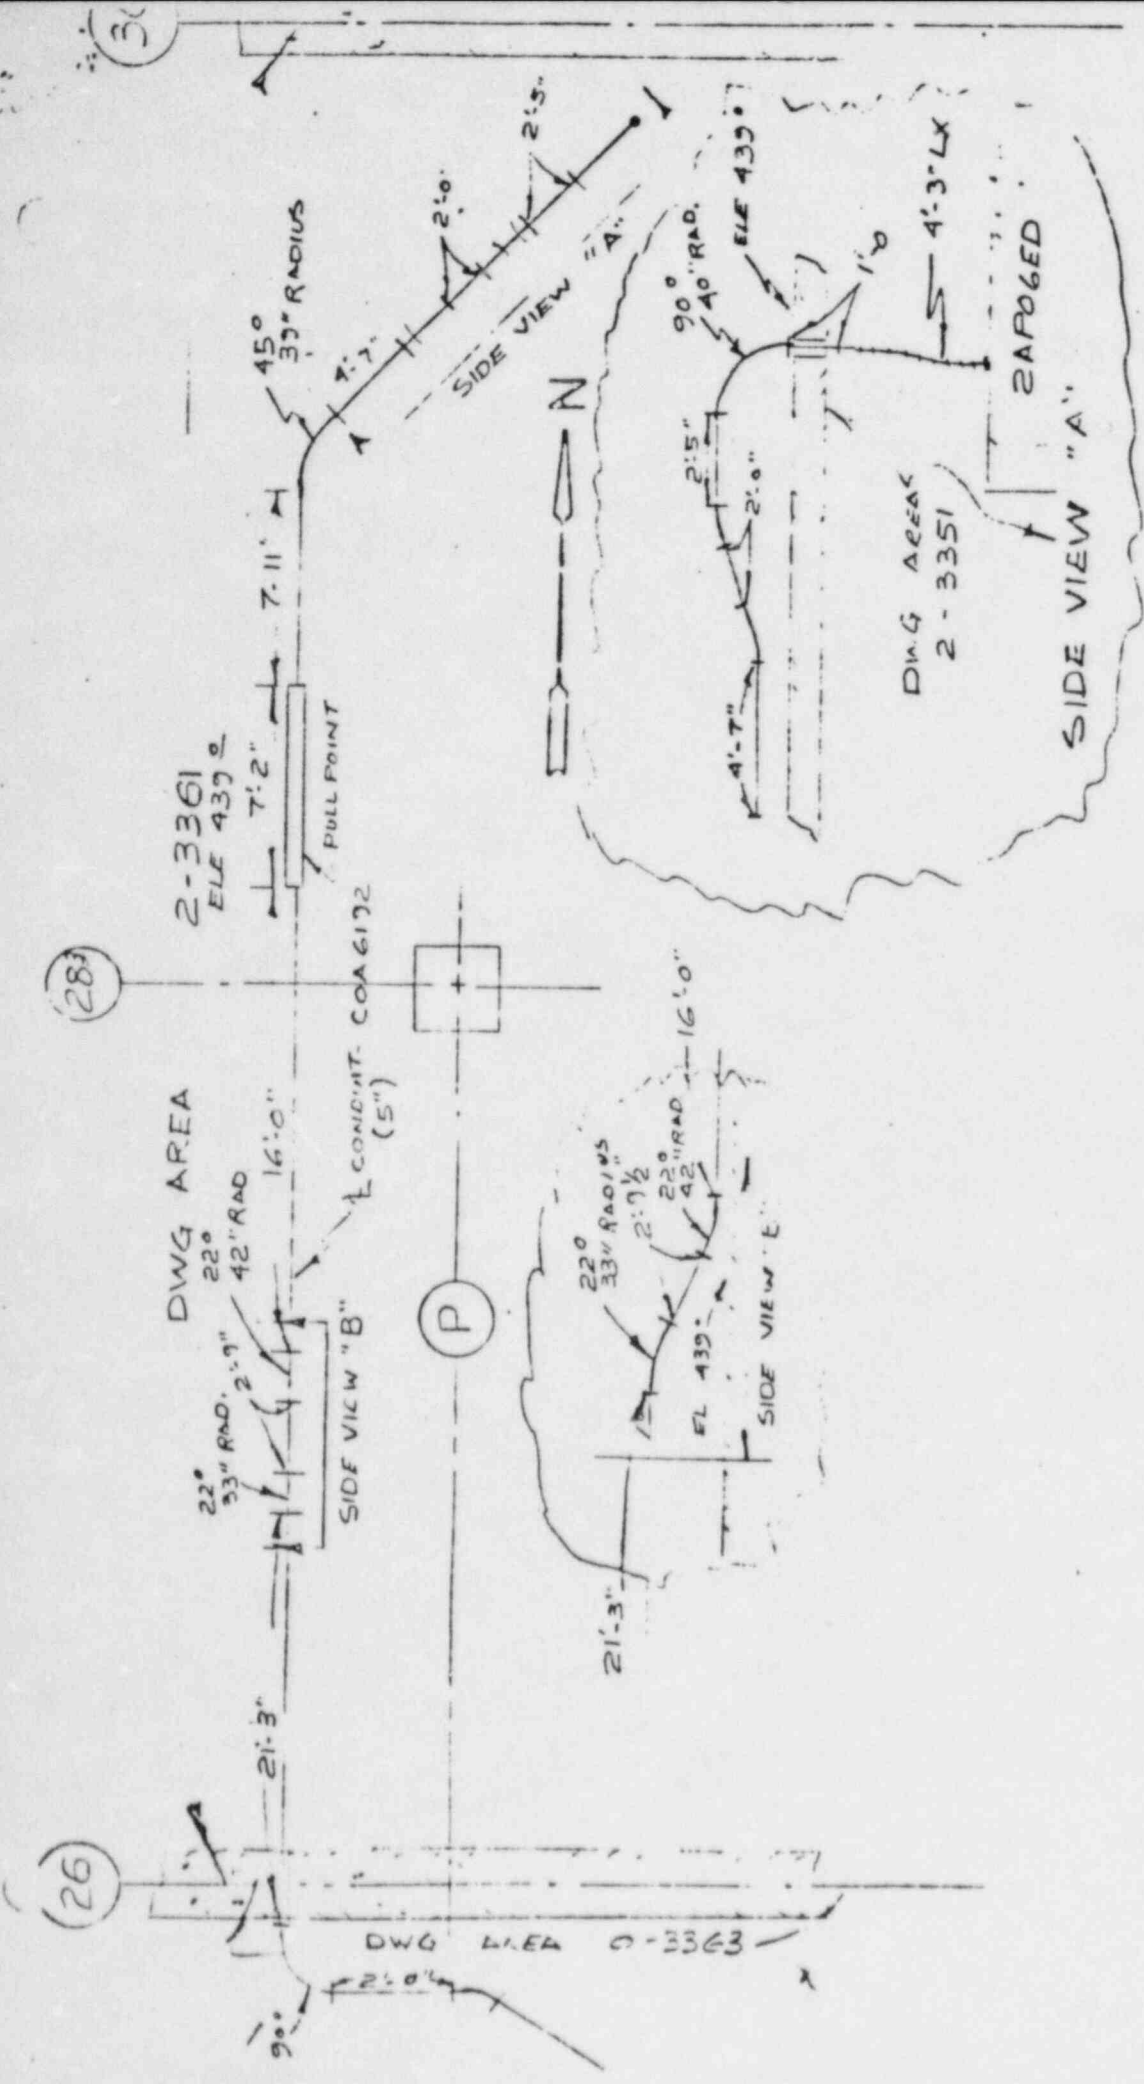
DWG AREA O-3361
ELE 439°

Attached are calculations for the cable pulls for the drawings submitted by you. Pulling from LJB261A to Gear in one continuous length provides excessively high pulling tension and sidewall pressures. This is caused by the excessive number of offsets located in this run. The total tension calculates out to 52,000 lbs. in this direction. The coefficient of friction actual was probably lower than 0.35 but in any case the allowable tension and sidewall pressures were exceeded by the wide margin. These calculations appear on pages 1 and 2 of the attached sheets.

If the cable was pulled from LJB261A to gear it should be replaced because of the very high pulling tension and sidewall pressure that would have been experienced.
