CATAWBA NUCLEAR STATION
DIESEL ENGINE 1A COMPONENT REVALIDATION INSPECTION
FINAL REPORT

PREPARED BY
DUKE POWER COMPANY

June 29, 1984

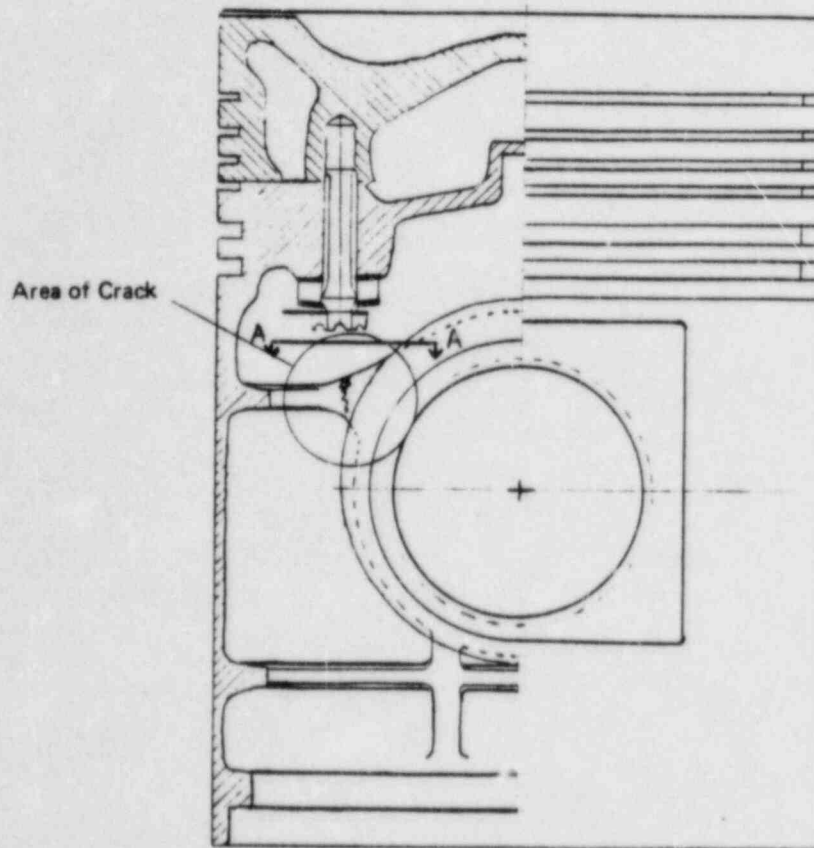
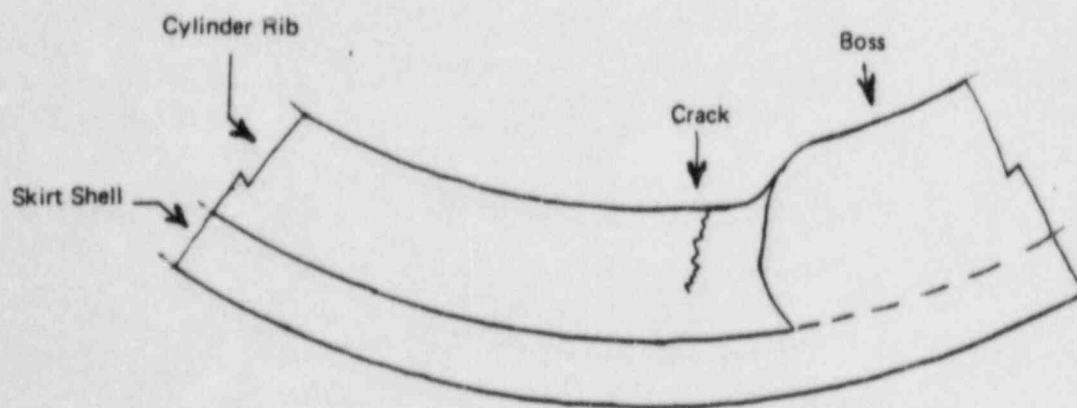
FIGURE 2-1
CRACKED TYPE AN PISTON SKIRT

- One major problem was noted on the 1A diesel. Four of the type AN piston skirts used in the 1A diesel were found to have one or more cracks in the region where an internal circumferential reinforcing rib intersects the piston pin boss (Figure 2-1). This problem is discussed further in Section 2.2.

Four type AN skirts were found to have cracks adjacent to piston pin bosses. (Figure 2-1) These cracks run approximately vertically, and appear to initiate on the inside of the skirt where a circumferential reinforcing rib intersects the piston pin boss. The largest crack, on skirt 3L, was through wall and was about 3 to 4 inches long on the outside.

The most significant condition noted was the presence of cracks in four piston skirts adjacent to piston pin bosses. The largest crack was 3 or 4 inches long and was through the wall. The cracks appear to originate at the skirt ID, on the fillets where a reinforcing rib intersects the piston pin bosses, and to run in an approximately axial direction. The cause of the cracking is unknown at this time but is believed to be due to cyclic fatigue. Skirts have been sent to FaAA for failure analysis.

The cracked AN type piston skirts in the Catawba 1A diesel did not cause any operational problems, and 12 of the 16 skirts were free of cracks. Nevertheless, all the piston skirts will be replaced with improved design AE skirts. The AE skirts have been stress relieved and include improved design features such as a thicker reinforcing rib and better rib-piston boss intersection details. These improvements are expected to adequately reduce the stresses and propensity for cracking in the area which experienced cracking at Catawba. The FaAA/Owners Group program will quantify the benefits achieved by use of AE piston skirts. It is anticipated that this will show that no cracking is expected during the life of the Catawba diesels. The AE piston skirts also incorporate the latest improvements in the stud boss region, which has been a problem area in earlier piston designs at the skirt to head transition.

Cracks were found to be present in piston skirts near piston pin bosses. As a result, all of the piston skirts will be replaced with type AE pistons. In addition, a detailed failure analysis has been initiated, as part of the TDI Owners Group program.

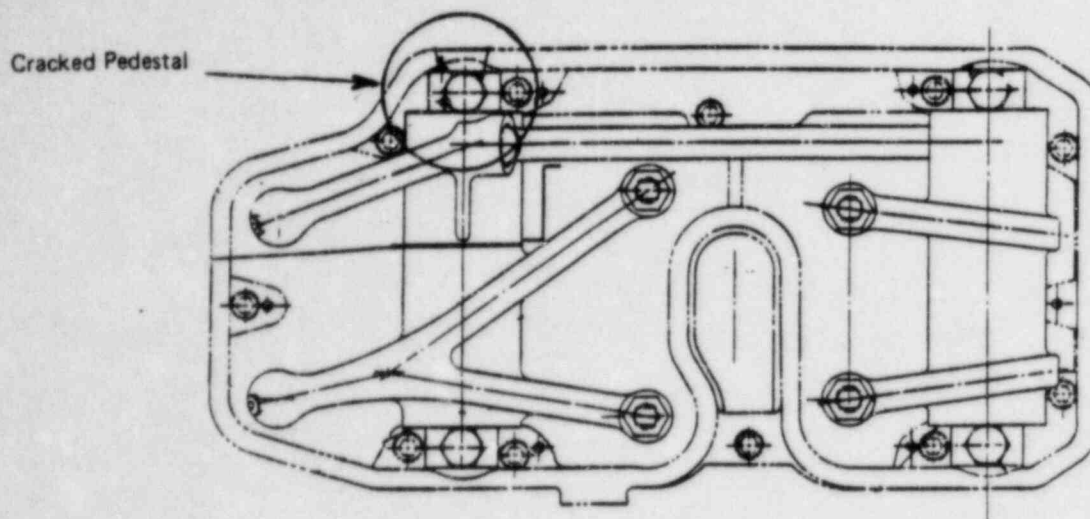
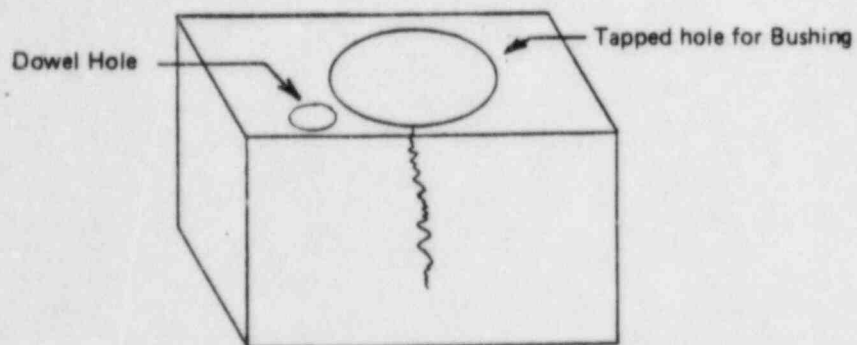
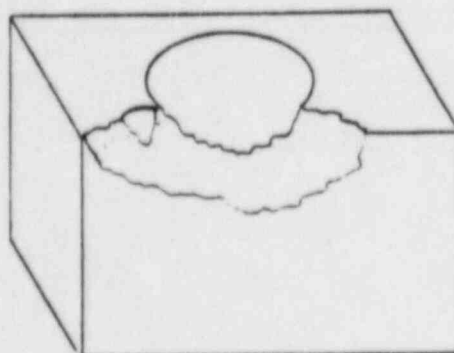
FIGURE 2-2
CRACKED SUBCOVER CASTINGS

- Two subcover castings were found to have cracks in an intake rocker arm pedestal (Figure 2-2). These cracks are discussed in Section 2.3.
- Two Catawba cylinder heads (one on diesel 1A and one on 1B) experienced small jacket water leaks into the fuel injector cavity. Metallographic examinations of the head removed from the 1A diesel indicates that the leak was due to a fatigue crack (Figure 2-3). This problem is discussed in Section 2.4.

Two cast iron subcovers were found to have cracks in a pedestal where the intake rocker arm shaft is bolted to the subcover (Figure 2-2B). Prior to the extended operation test, another subcover was found to have a piece of this pedestal missing (Figure 2-2C). None of these cracks have affected diesel operability. However, since similar problems have been reported with other diesels, FaAA has initiated a failure analysis of a Catawba subcover as part of the Owners Group program. Preliminary studies indicate that the cracks are due to installation tolerances between dowels, bushings and the pedestal leading to excessive interference and possibly fatigue cracking.

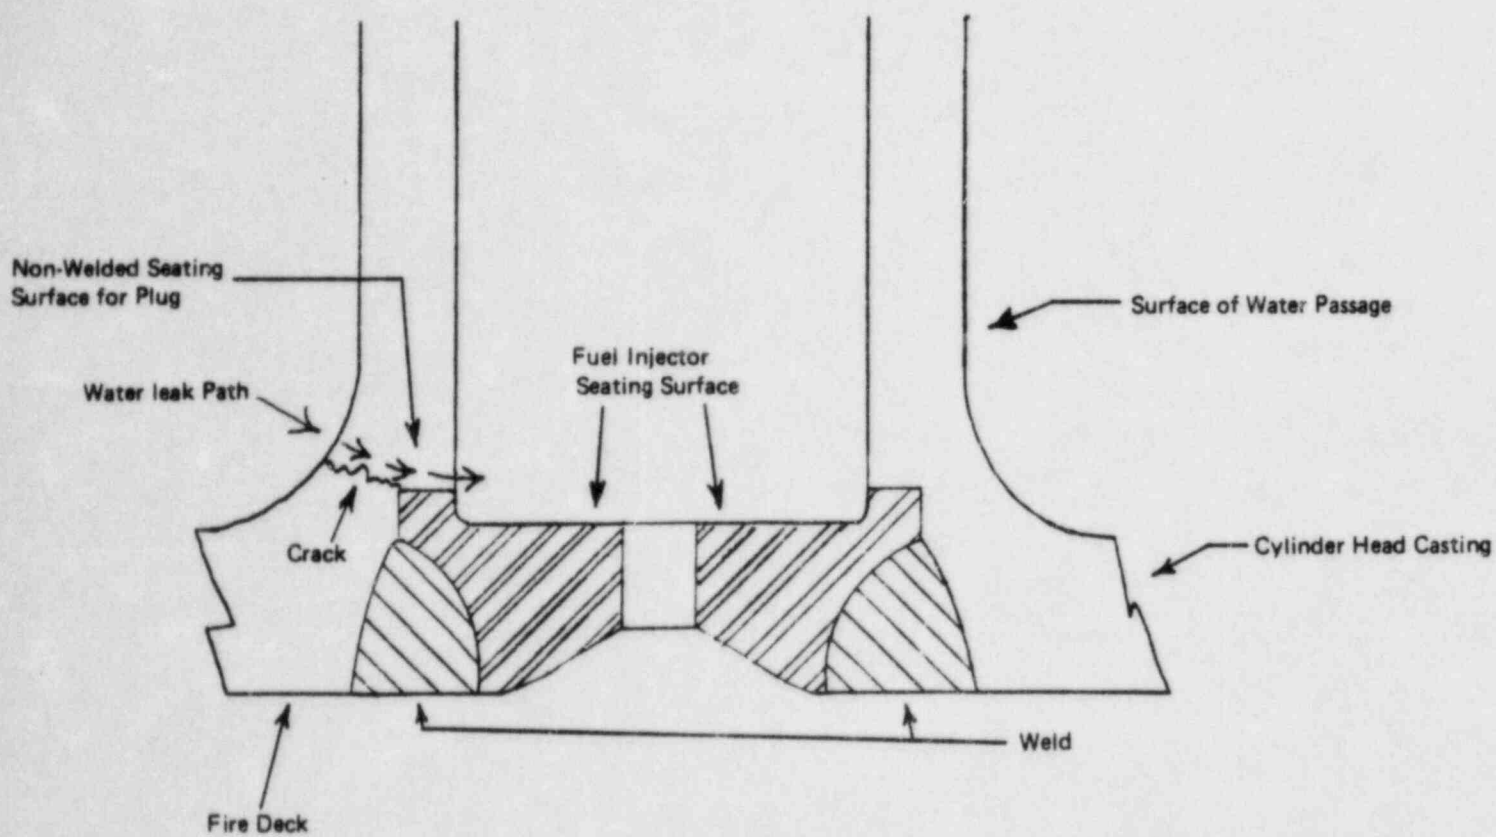
FIGURE 2-3
CRACK IN CYLINDER HEAD

engine was of similar magnitude to that of 1A. The 1A cylinder head has recently been examined by FaAA. This investigation (reference 20) revealed that the leak was caused by a crack initiating from the corner of a welded-in plug where it was seated in the cylinder head (Figure 2-3). This welded-in plug is reported by TDI to have been used to repair the casting around the fuel injector hole. Evaluation of all heads installed on Engine 1A (reference 22) indicates that one other head (6 left) has been repair welded with a plug.

Two small jacket water leaks have been experienced at Catawba resulting in water leaking into the fuel injector nozzle cavity. Failure analysis of one of the leaking heads has been completed (reference 20). The leak was due to cracks propagating from a corner where a welded plug was installed in the fuel injector nozzle seating area. This welded plug was used to repair the injector bore during manufacture. (Figure 2-3)

The leaks caused by the cracks have not affected diesel operability since they result in small amounts of water leaking into the fuel injector cavity and then off of the diesel. As all of the heads now on diesel 1A have experienced no cracking and were not leaking after the extended operation test, the heads are considered acceptable for continued operation. However, the repaired head (6 left) will be replaced as a matter of conservative judgement.

The currently installed heads in the 1A diesel engine are considered to be satisfactory since they were not leaking when last used and exhibit no cracks in inspectable areas. Further, the type of leaks caused by cracks due to plug welding do not affect diesel operation and are not significant. However, the repaired head (6 left) will be replaced.
