LICENSEE EVENT REPORT (LER)

FACILITY NAME (1) Fort St. Vrain, Unit No. 1										DOCKET NUMBER (2) 0 5 0 0 0 2 6 7 1					PAGE (3) 1 OF 015							
TITLE (4) Loss Of 480V Bus 1 - Loop 1 Shutdown																						
EVENT DATE (5)			LER NUMBER (6)				REPORT DATE (7)			OTHER FACILITIES INVOLVED (8)												
MONTH	DAY	YEAR	YEAR	SEQUENTIAL NUMBER	REVISION NUMBER	MONTH	DAY	YEAR	FACILITY NAME N/A				DOCKET NUMBER(S) 0 5 0 0 0									
0	5	2	9	8	4	8	4	0	0	7	0	0	0	6	2	8	4	0	5	0	0	0
OPERATING MODE (9) N		THIS REPORT IS SUBMITTED PURSUANT TO THE REQUIREMENTS OF 10 CFR 5: (Check one or more of the following) (11)																				
POWER LEVEL (10) 0 0 2		20.402(b)				20.408(a)				<input checked="" type="checkbox"/> 50.73(a)(2)(iv)				73.71(b)

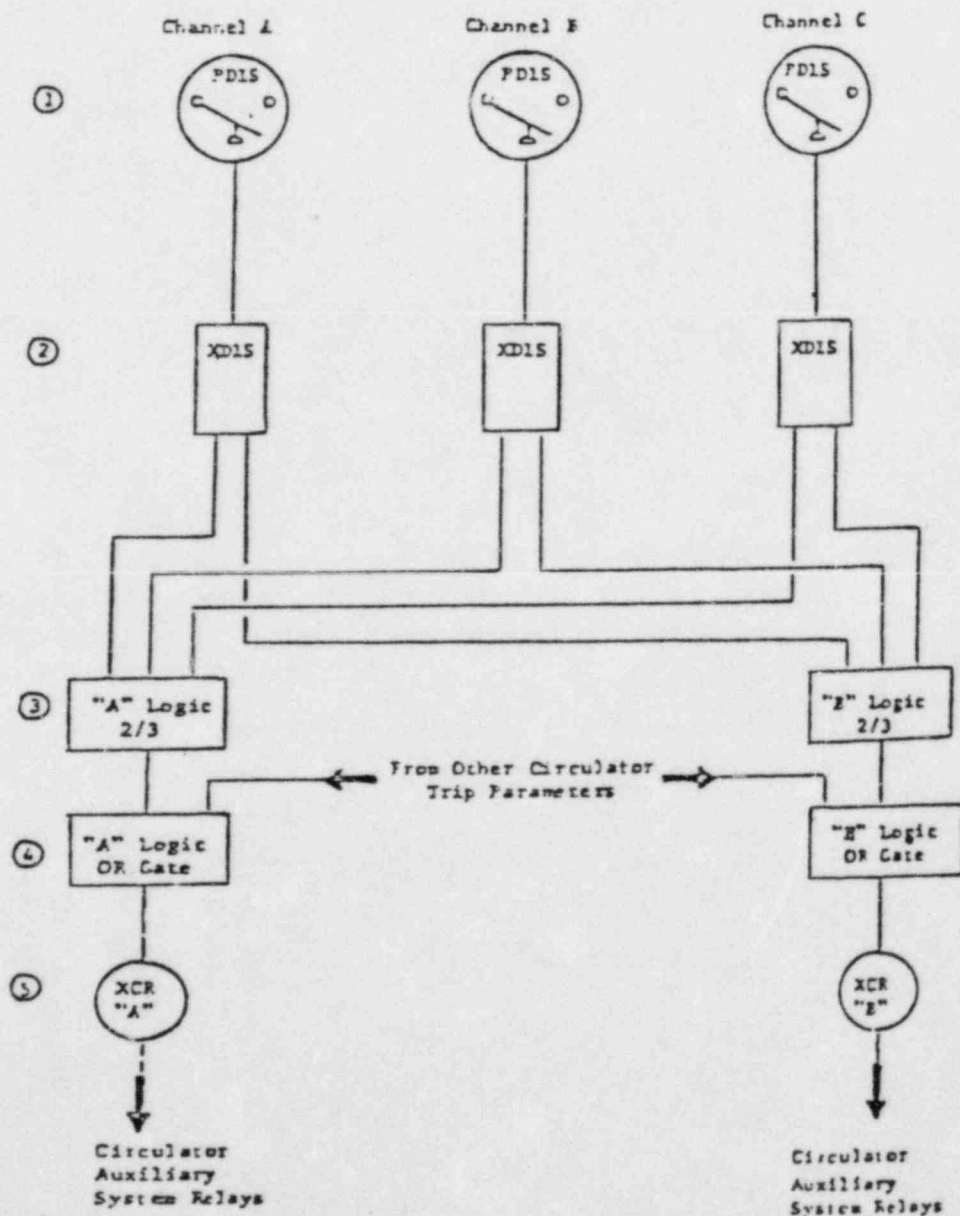
FIGURE 1

The momentary loss of electrical motive power to the in-service bearing water pumps initiated trip inputs to the Plant Protective System when a pressure differential of less than 475 PSID was detected by the helium circulators pressure differential indicating switches with the resultant Loop I shutdown.

Referring to Figure 1, as the pressure differential between the water supply cavity and the main drain decreases, the pressure differential switches (PDIS) [1] will individually close at their respective setpoints. This applies a voltage to the switch input modules (XDIS) [2], tripping them. Each tripped XDIS module transmits a signal to both "A" and "B" logic channels [3]. When either "A" or "B" logic receives inputs from any two of the three XDIS modules, they will transmit a signal to the "A" or "B" logic OR gate [4] respectively. The OR gates transmit any input signal to the respective special control relay (XCR) [5] to energize auxiliary relays which trip the helium circulator and initiate the following helium circulator protective actions:
