LICENSEE EVENT REPORT (LER)

FACILITY NAME (1) North Anna Unit 1										DOCKET NUMBER (2) 0 5 0 0 0 3 3 8				PAGE (3) 1 OF 0 4	
TITLE (4) Recirculation Spray Cooler Lap Ring Cracking															
EVENT DATE (5) MONTH DAY YEAR 0 9 0 1 8 4			LER NUMBER (6) YEAR SEQUENTIAL NUMBER REVISION NUMBER 8 4 - 0 0 8 - 0 0			REPORT DATE (7) MONTH DAY YEAR 0 9 2 7 8 4			OTHER FACILITIES INVOLVED (8) FACILITY NAMES DOCKET NUMBER(S) North Anna Unit 2 0 5 0 0 0 3 1 3 9						
OPERATING MODE (9) 5		THIS REPORT IS SUBMITTED PURSUANT TO THE REQUIREMENTS OF 10 CFR 5: (Check one or more of the following) (11)													
POWER LEVEL (10) 0 0 0 0		20.402(b)			20.406(a)			50.73(a)(2)(iv)			73.71(b)

North Anna Power Station

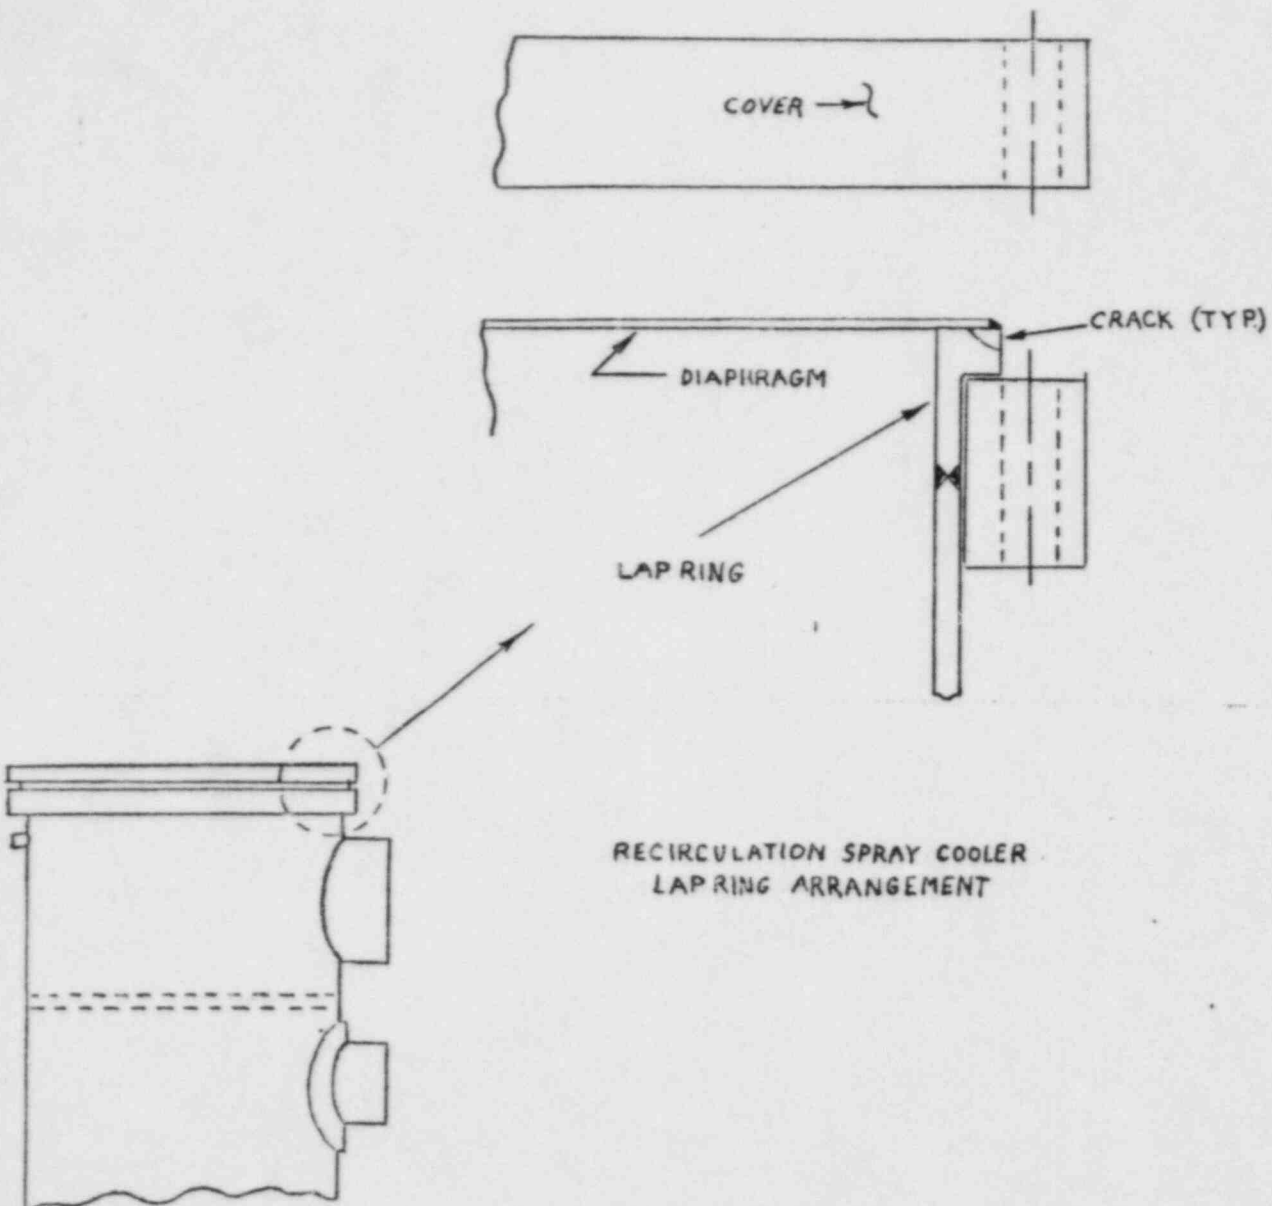
Figure 1

During the 1984 North Anna Unit 1 Type 'A' Containment Pressurization Test, the Recirculation Spray Coolers were suspected as a possible air leakage source. After removal of the 'D' Recirculation Spray Cooler diaphragm from the lower lap ring and subsequent examination of the lap ring by L.P. visual examination, surface flaws caused by crevice corrosion became evident. Subsequent excavation in the area of the flaws revealed radial cracking initiating from the point of crevice corrosion pitting to the outside diameter of the lap ring. The lap ring is a welded extension to the cooler shell. The bottom of the lap ring is a 1" thick by 5/8" high flange against which a diaphragm is welded along the outer edge as shown in the attached figure. A ring flange (free floating) rests on the outside edge of the lap ring and bolts to a bottom end plate or cover plate. The lap ring is employed as the pressure boundary wall and a bearing surface for compression of the diaphragm. The lap ring and diaphragm are made of stainless steel type 304L.

The crevice corrosion which existed on the lap ring was caused by contact with service water at a concentration of 12 to 50 ppm chloride, and subsequent concentrating of the chlorides in the crevice area between the diaphragm and the lap ring. (The service water is treated with Hypochlorite). The radial cracking, which extended from the crevice corrosion pitting to the lap ring outer diameter, was caused by chloride concentration in conjunction with a relatively high tensile stress region which was induced during lap ring manufacturing. At no point did cracking extend into the inner 3/8" thickness of the lap ring which is under compressive stresses induced by manufacturing, and the bolted joint design.

From information obtained from excavation of the 'D' Recirculation Spray Cooler, which had more severe crevice corrosion pitting than the other Recirculation Spray Coolers, a fracture mechanics analysis was performed using assumptions of failure due to unstable crack growth and net section collapse caused by flaw induced stress intensity and elastic-plastic failure flaw evaluation. These analysis were performed using the general approach of both ASME XI Appendix A and ASME Section XI IWB 3640, 1983 Addendum.

Both analysis, indicated that existing flaws are acceptable and do not degrade the vessel below design. The fracture mechanics analyses performed were extremely conservative; stresses in the lap ring were assumed to be material yield stress when in actuality the stresses thought to exist in the lap ring are significantly below yield.

In order to preclude further lap ring degradation a cladding of stainless steel Type 316L was applied to the lap ring surface in contact with the diaphragm. The diaphragms were also replaced with 316L. This was done to all four heat exchanger lower lap rings. Inspection will be made of the Unit 2 Recirculation Spray Coolers during the current Unit 2 refueling outage.
