Subject: Final Report - DER 84-46
A 50.55(e) Reportable Condition Relating to Refueling Water
Tank Penetration Sleeves.
File: 84-019-026; D.4.33.2

FINAL REPORT - DER 84-46
DEFICIENCY EVALUATION 50.55(e)
ARIZONA PUBLIC SERVICE COMPANY (APS)
PVNGS UNITS 1, 2, 3

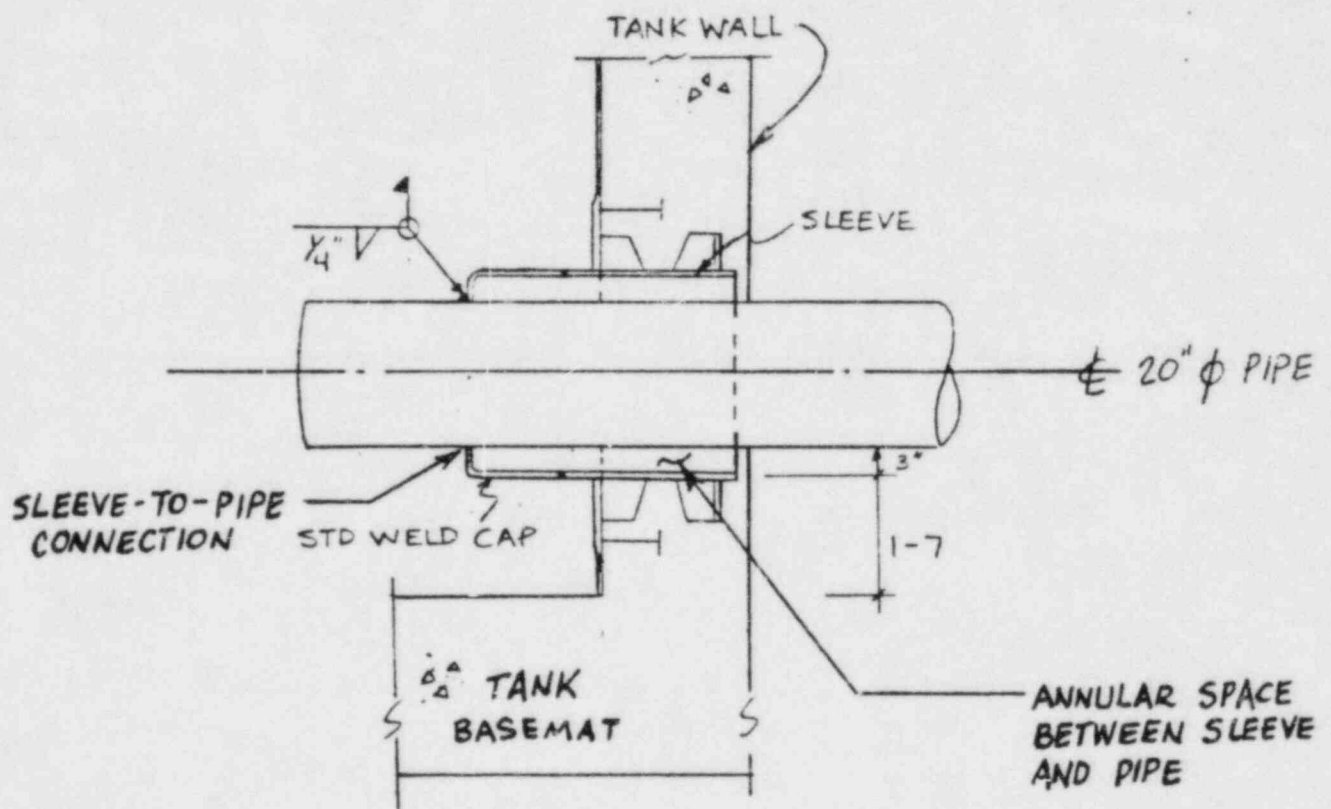
FIGURE 1

Following completion of the final stress calculation for the Chemical and Volume Control system (CH), it was determined that no design calculation had been performed for the sleeve-to-pipe cap plate connection for two 20-inch diameter pipes penetrating the Refueling Water Tank (See Figure 1). Calculations were performed and revealed that the connection would be overstressed during a seismic event due to loads resulting from seismic anchor movement.

In the original configuration, relative movement between the Refueling Water Tank and the Essential Pipe Tunnel during a seismic event would cause a relative transverse movement between the sleeve and the pipe. This movement created the overstress condition in the sleeve-to-pipe connection. To prevent this movement, the annular space between the sleeve and the pipe shall be filled with non-shrink grout. Calculation No. 13-CC-CT-015 has been performed to verify that this modification will prevent the overstress condition. This action will ensure that the system will not fail in the event of an SSE and that the leak-tight integrity of the Refueling Water Tank will be maintained.

The root cause is an oversight on the part of design engineering to perform a required evaluation. The final stress calculations provide a check on this type of oversight, and the lack of this calculation was discovered during final stress analysis.

Design Change Packages (DCPs) 1SC, 2CC, and 3CC-ZY-134 have been prepared and will be issued to perform and document the required grouting work for all 3 Units.
