Commonwealth Edison
Braidwood Nuclear Power Station
Route #1, Box 84
Braceville, Illinois 60407
Telephone 815/458-2801

Subject: Teleconference between Commonwealth Edison Company and the
Nuclear Regulatory Commission dated October 3 and 4, 1995,
Regarding the Increase in the Interim Plugging Criteria for Byron
Unit 1 and Braidwood Unit 1
NRC Docket Numbers: 50-454 and 50-456

Inspection in the Area of Anti-Rotation Devices

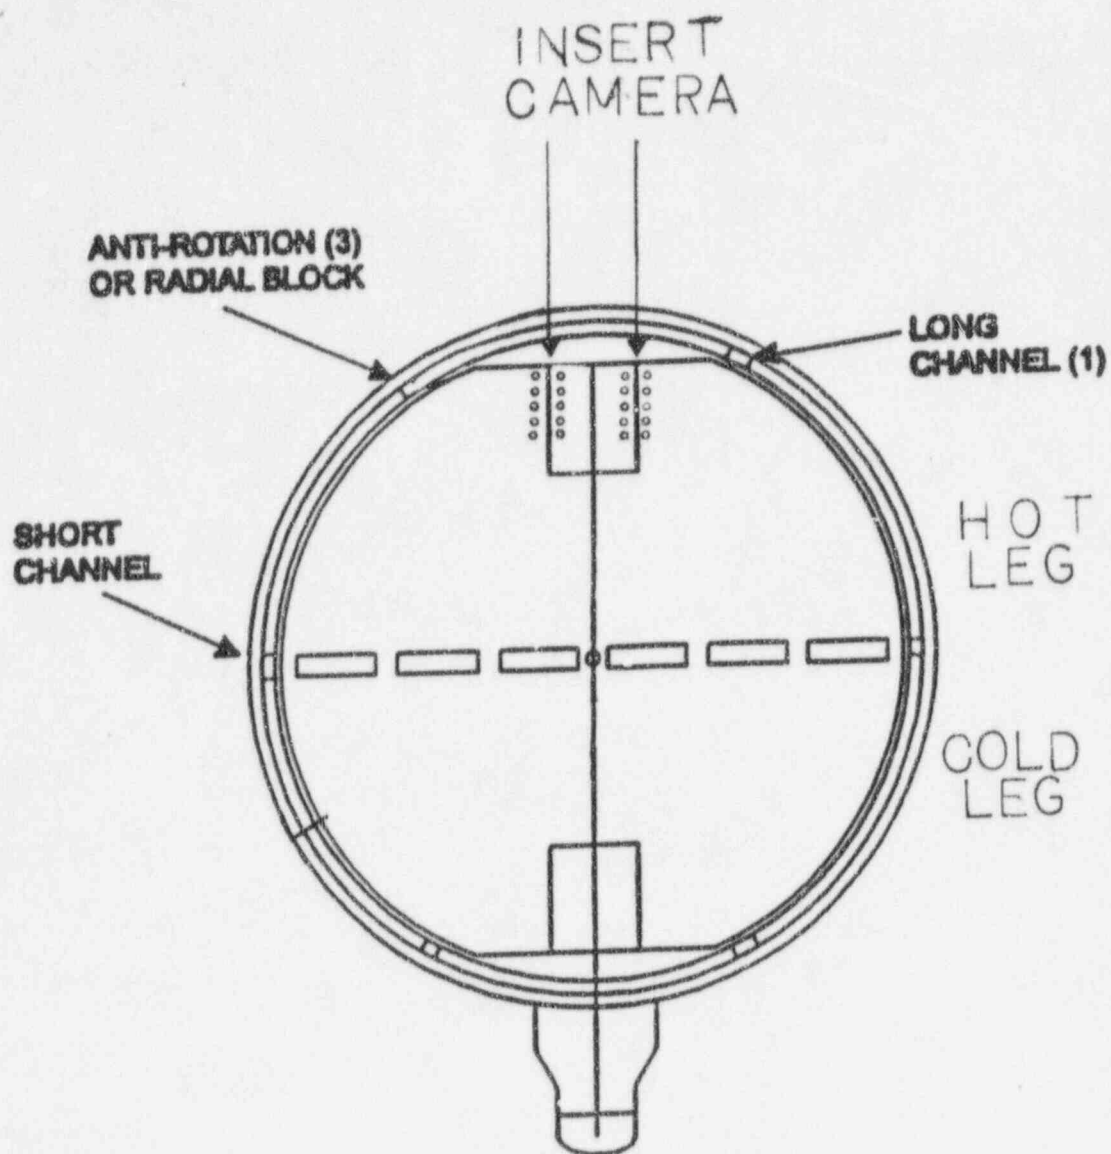
**MODEL D4
TOP PLATE**

During the Braidwood Unit 1 refueling outage a visual inspection of the "A" SG top TSP patch plate area will be performed. The inspection will consist of inserting a camera along the 2 accessible patch plate seams to a distance of 5 tube rows (see attached sketch). This visual inspection is intended to determine if TSP degradation is present in this area. Those TSP intersections that have received visual inspection (20 tubes), will also be eddy current inspected and data analyzed using techniques and analysis guidelines developed through the EPRI program to detect TSP degradation. The eddy current responses seen in the SG will be compared to those obtained in the EPRI mockup and any ambiguous signals will be investigated and reported to the Staff.
