October 9, 1995  
C311-95-2413

Subject: Three Mile Island Nuclear Station, Unit 1 (TMI-1)  
Operating License No. DPR-50  
Docket No. 50-289  
LER 95-003-00

REACTOR COOLANT LEAK DUE TO A CRACKED WELD IN A COLD LEG DRAIN LINE

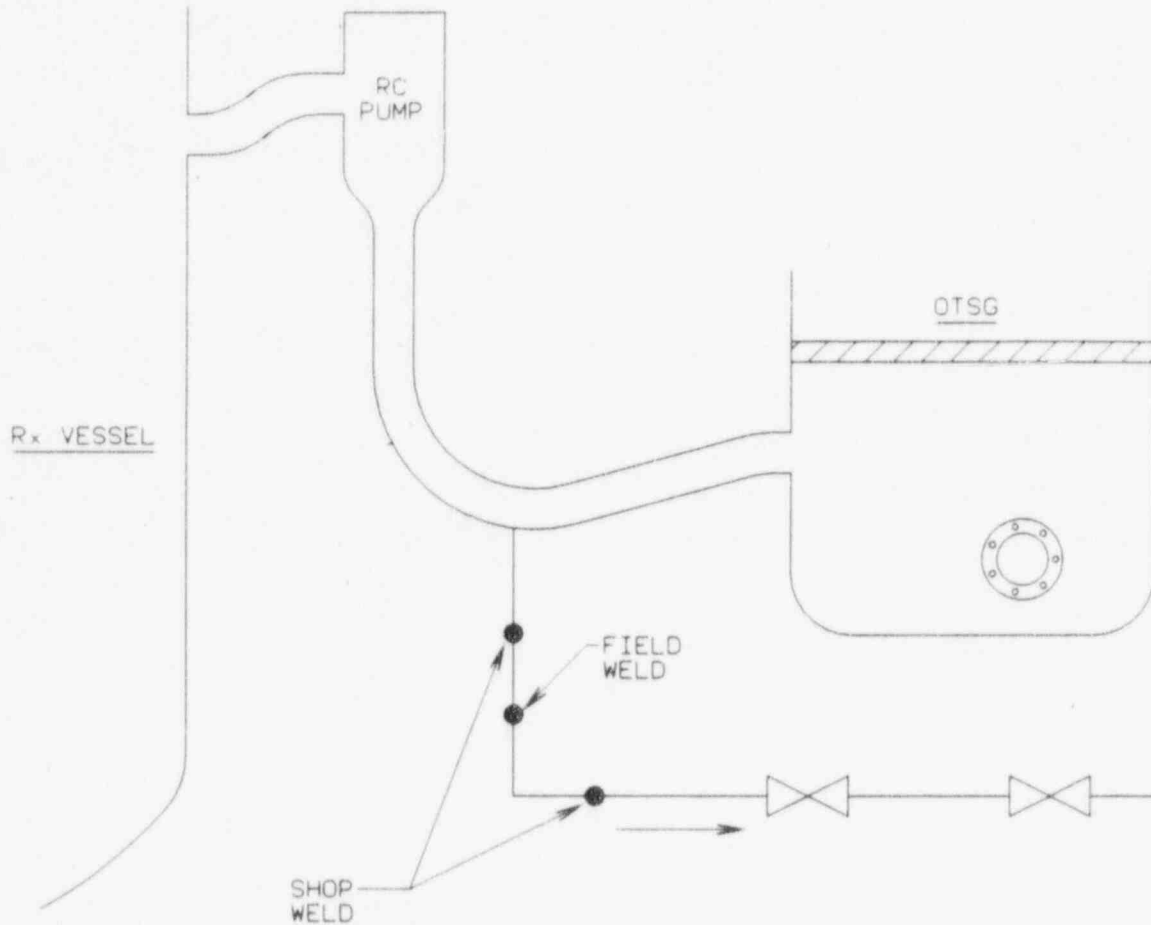
FIGURE 1

The leak is located at ISI Weld No. RC-187, which is the weld between the 1.5 inch x 2 inch, 90 degree reducing elbow and the 2 inch diameter horizontal pipe. The reducing elbow is the first elbow in the drain line off the RCS Loop "A" suction line to the "B" RCP. The elbow and horizontal pipe is type 316 stainless steel. The elbow is welded to the vertical 1.5 inch diameter Inconel safe end of the RCP suction drain nozzle. (See Figures 1 and 2).

Rx COOLANT DRAIN LINE  
(TYPICAL)

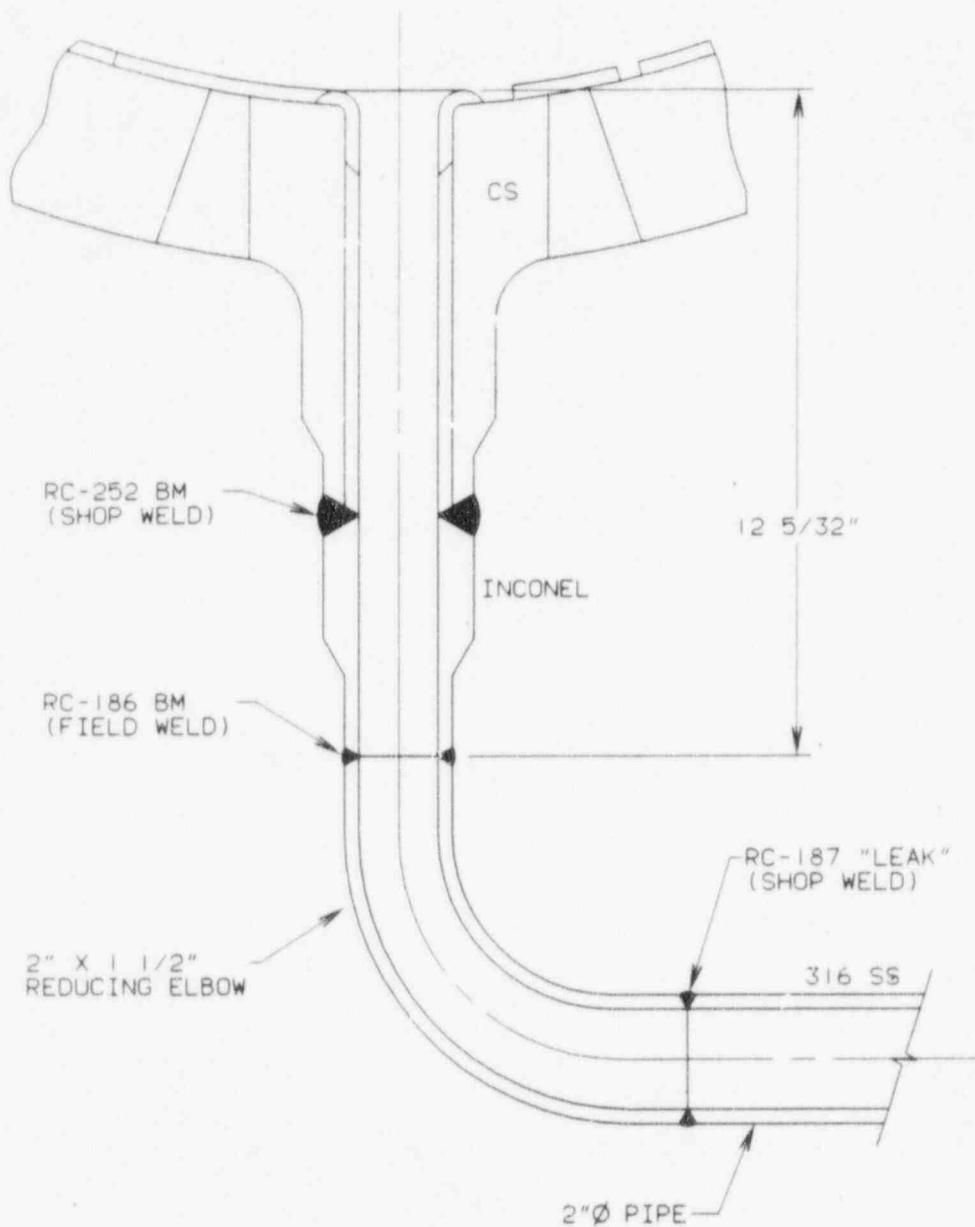
FIGURE 2

DRAIN LINE CONFIGURATION  
(TYPICAL) "B" SHOWN

3. The affected "B" RCP suction drain line was replaced from the nozzle safe end to approximately four feet along the horizontal section of pipe after the reducing elbow.

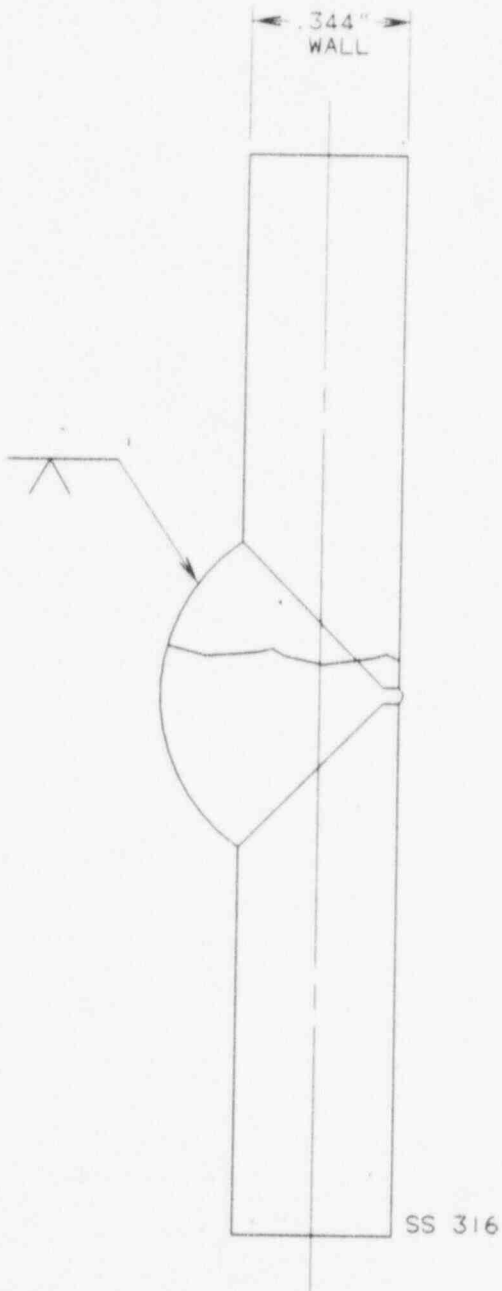
FIGURE 3

Visual and ultrasonic (UT) inspections were performed on the leaking weld (RC-187). Visually the indication is circumferential in the weld, two tenths (0.2) inches long starting 0.3 inches counter-clockwise (CCW) and stopping 0.5 inches CCW from top dead center looking in the direction of flow, from the nozzle and elbow to the first isolation valve, RC-V6B.

The UT examinations revealed that the indication is approximately 0.55 to 1.20 inches long on the outside diameter (OD) and approximately 2 to 3 inches long on the inside diameter (ID). Axially from the center of the weld, the indication favors the horizontal pipe side of the weld. The indication appeared to be located within the weld area including the weld root. Figures 3 and 4 illustrate the indication found in the affected pipe joint.

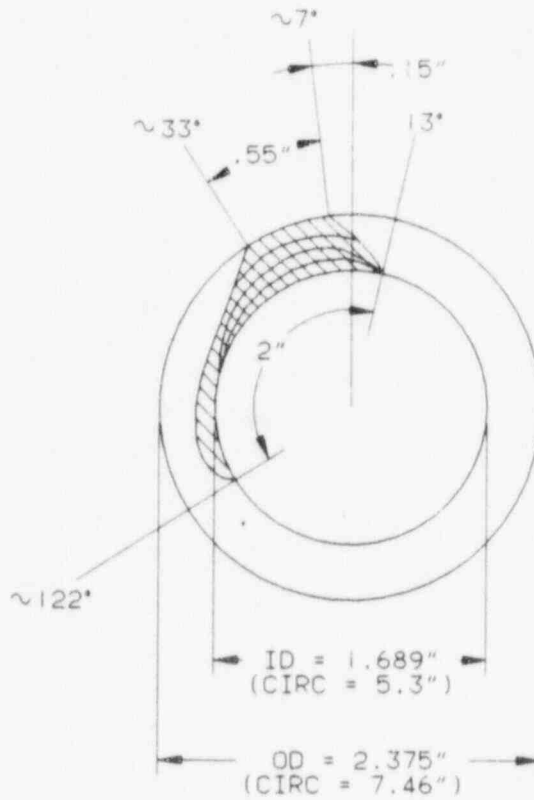
FIGURE 4

CRACKING CONFIGURATION FROM UT REPORT
