IEB 80-13

Subject: Peach Bottom Atomic Power Station, Unit 3  
Core Spray In-Vessel Piping

PEACH BOTTOM ATOMIC POWER STATION, UNIT 3  
CORE SPRAY DOWNCOMER

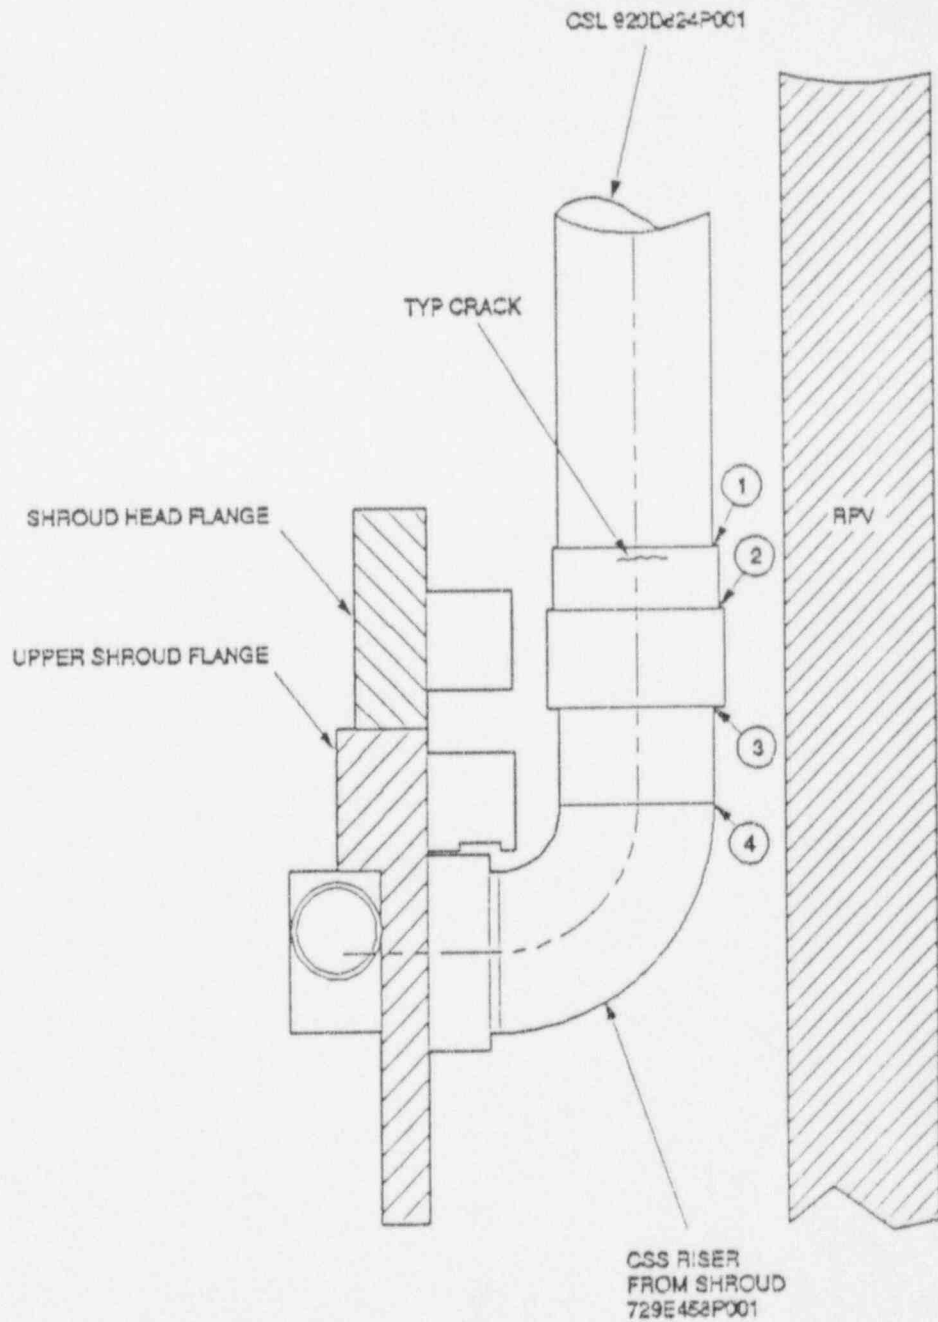
During the current refueling outage 3R10, visual examinations identified additional crack indications on the "A" and "C" downcomers. Subsequently, ultrasonic (UT) examinations were performed on all four CS downcomers. These examinations also identified cracking on the "B" downcomer. The cracks on all four downcomers are located on the outer sleeve of a sleeved-pipe connection. Specific details of the UT examinations were discussed with the NRC during an October 6, 1995 telephone call, and are included in the Attachment to this letter.

DOWNCOMER	CORE SPRAY LOOP	CRACK LENGTH (APPROX. DEG.)*
A (AZ 352.5°)	A	180
B (AZ 7.5°)	B	128
C (AZ 187.5°)	A	280
D (AZ 172.5°)	B	250

\* Not continuous, summation of total crack lengths.

PECO Energy will be installing a repair clamp on each of the four CS downcomers. This repair modification was reviewed in accordance with 10 CFR 50.59. A previous revision of the modification package was reviewed by the NRC and documented in Inspection Report 50-277/95-18 and 50-278/95-18.
