MISSISSIPPI POWER & LIGHT COMPANY

July 20, 1984

SUBJECT: Grand Gulf Nuclear Station
Units 1 and 2
Docket Nos. 50-416 and 50-417
License No. NPF-13
File: 0260/L-860.0
Additional Information - TDI Engine
Inspection
AECM-84/0373

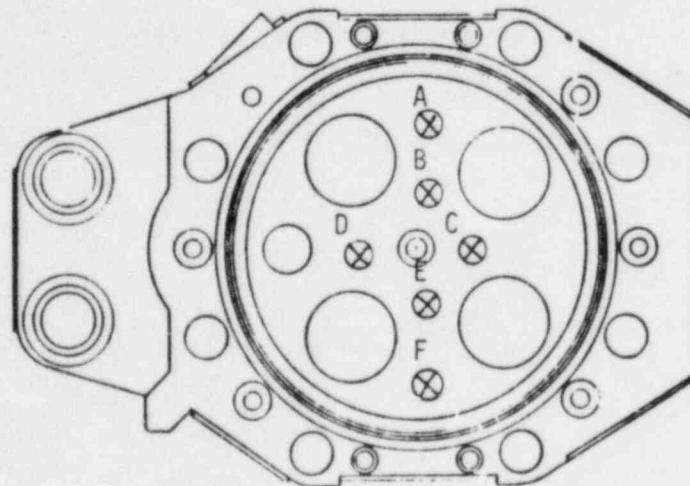
TABLE 1
Cylinder Head Baseline
Data for Flatness

A straight edge and micrometer were utilized to obtain baseline information for the cylinder head fire deck profiles. Measurements were taken at six different locations on the fire deck. Readings varied from head to head as to the depth of the fire deck depression. Results of the measurements are shown in TABLE 1.

Changes in readings taken across the fire deck were due to the curvature of the fire deck and were consistent for all heads and did not indicate a problem with head warpage. These readings were taken for baseline data to be used in the future to determine if warpage of the heads may have occurred.
