METALLURGICAL EVALUATION
OF
DIESEL GENERATOR TURBOCHARGER
GUIDE VANE HOLD DOWN BOLTS
AT
GRAND GULF NUCLEAR STATION - UNIT 1

PREPARED FOR: NUCLEAR PLANT ENGINEERING
MISSISSIPPI POWER & LIGHT COMPANY
PORT GIBSON, MISSISSIPPI 39150

PREPARED BY: J. S. BRIHMADESAM
NUCLEAR ENGINEERING DEPARTMENT
MIDDLE SOUTH SERVICE, INC.
NEW ORLEANS, LOUISIANA 70112

JULY, 1984

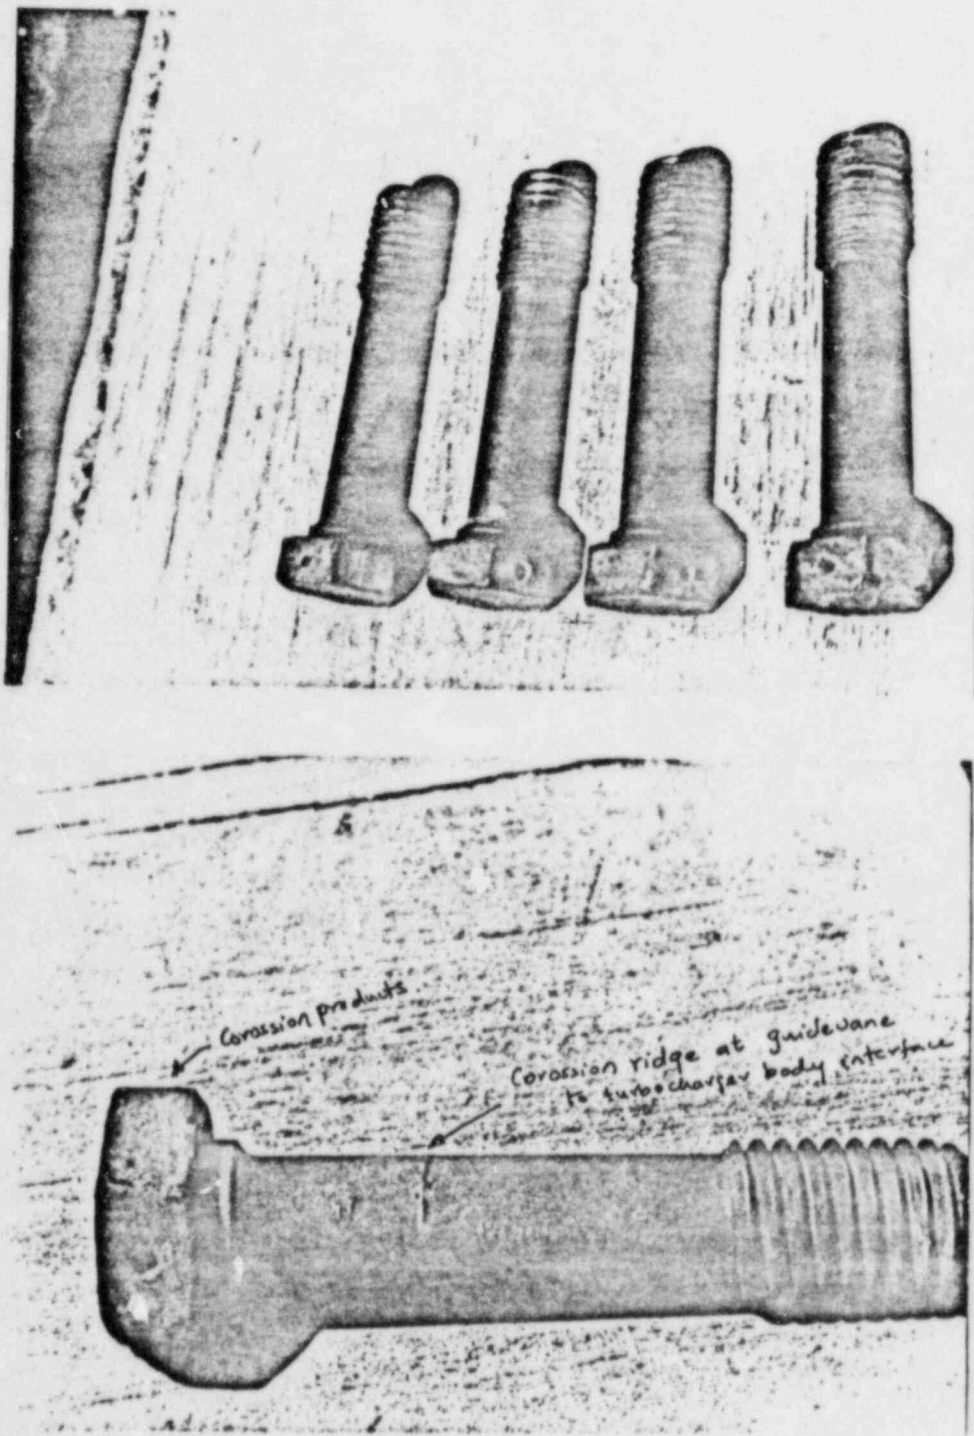
Figure 1 As-received Turbocharger Bolts From Division I

exhaust gases. On some bolts there was a whitish salt-like deposit at the head to shank radius. Some bolts also had a small ridge of reddish brown oxide at the interface between nozzle ring and turbocharger body. These observed features are shown in Figure 1. The fracture surface of the broken bolt showed a smooth half moon surface and a grainy morphology elsewhere. A macrograph of the fracture surface is shown in Figure 2. Lower power microscopic evaluation of the bolts did not reveal the presence of cracks in any of the other bolts and the fracture surface of the broken bolt showed evidence of secondary cracking in the grainy region.

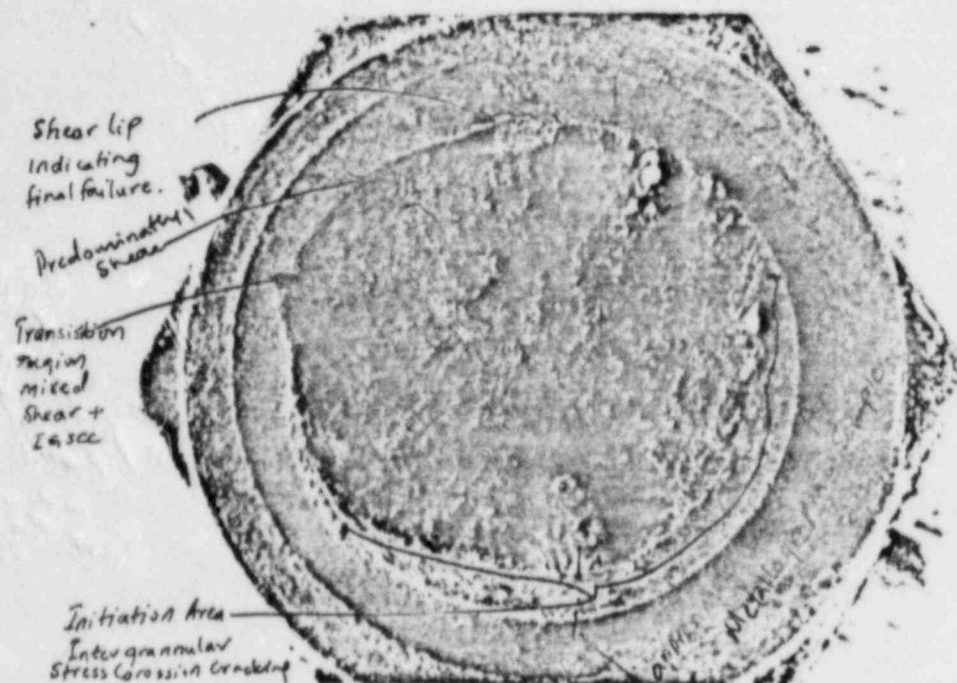
Figure 2 As-received Fracture Surface of Broken Bolt From Division I

Figure 29 and Figure 24 it is clear that this region is better revealed after cleaning. Based on the fractographic observations it is evident that the crack initiated and propagated by IGSCC over a majority of the fracture area, converted to a mixed mode (IGSCC plus shear) when overload conditions were approached, to an overload ductile tearing mode and finally to a shear lip failure. This progression is approximately mapped in Figure 2.

Shows where specimen for metallography was obtained. The areas of fracture initiation and propagation were marked based on fractographic evaluation presented in Section 4.0.

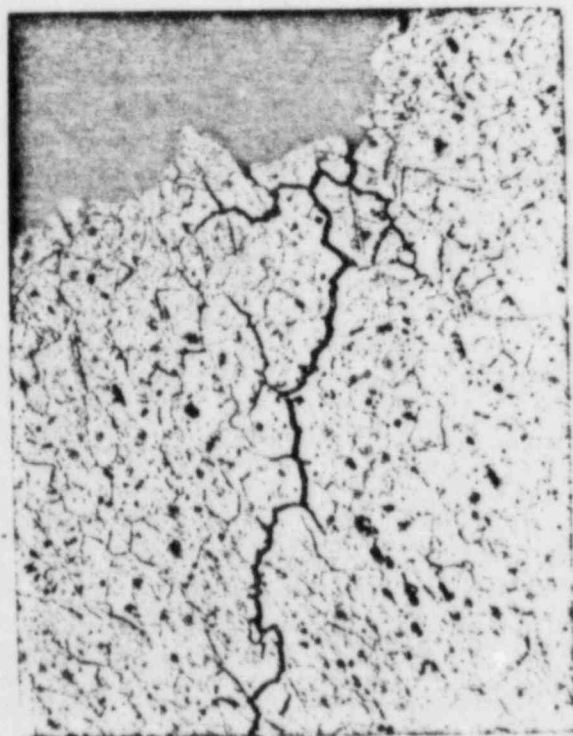
Figure 3 Intergranular Crack at Fracture Surface

A cross-section, as shown in Figure 2, was obtained, polished and etched. The crack profile is shown in Figure 3. The crack is intergranular and appears to be filled with corrosion products. In order to determine the morphology and identify the corrosion products, this cross-section was further analyzed using a Scanning Electron Microscope (SEM). SEM metallographs are presented in Figures 4 through 8. Figure 4 is taken at the fracture surface showing the individual grains, secondary cracking and a profile of secondary cracks on the polished face. Figure 5 shows the existence of the branched intergranular cracks which connect to other cracks that

Crack follows grain boundaries showing a typical IGSCC appearance. Inclusion like islands in the matrix are Intermetallic Compound precipitates.

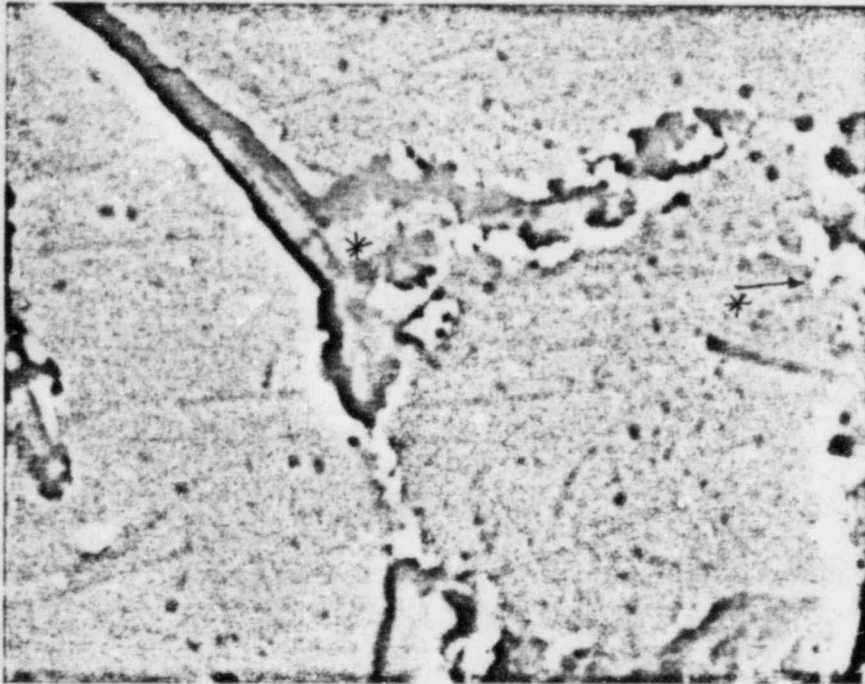
Figure 6 SEM Metallograph

emanate from the fracture surface. Intermetallic precipitates, primarily titanium and molybdenum, are also evident. At a higher magnification, Figure 6, the corrosion product within the grain boundaries is clearly visible. The corrosion product was identified to be predominantly iron with no evidence of sulphur. Thus, the product being iron oxide. This aspect is further discussed in Section 5, Chemical Analysis. Figure 7 shows the attack at the grain boundary and the remanant of a precipitate. The precipitate was found to be mostly titanium. Figure 8 shows a grain boundary corrosion product deposit with evidence of a whitish phase along the grain boundary. This whitish phase was found to be a nickel rich phase. The chemical identification of the corrosion products and phases identified here are presented in Section 5.

Corrosion Product (Iron Oxide) in Grain Boundaries (Division I)

Corrosion product within grain boundary crack clearly visible.
Also visible is a white phase segregation along grain boundary.

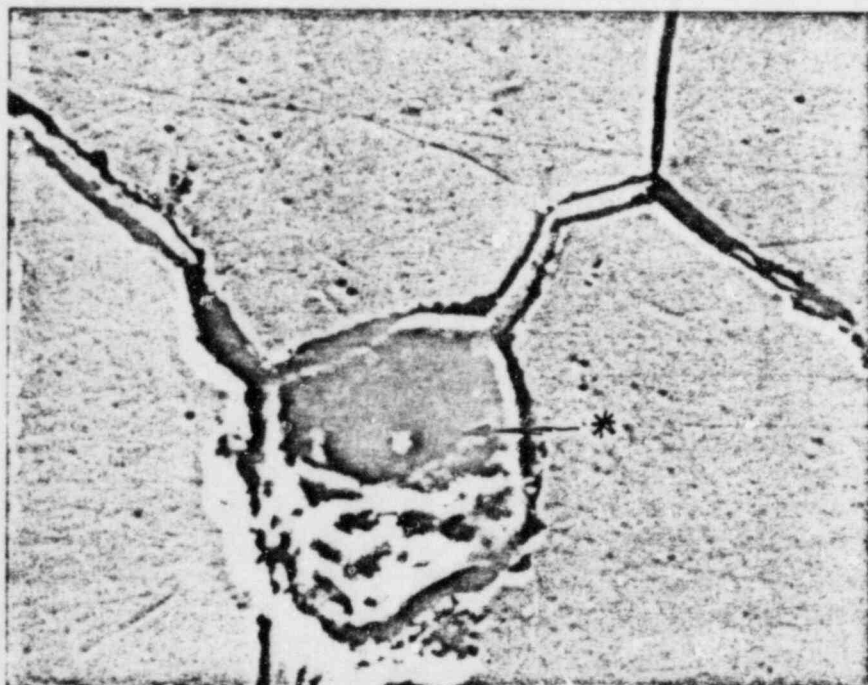
Figure 7 SEM Metallograph of Inclusion

Inclusion was found to be an intermetallic compound precipitate formed during aging treatment. Precipitate was a Titanium-Molybdenum Intermetallic Compound.

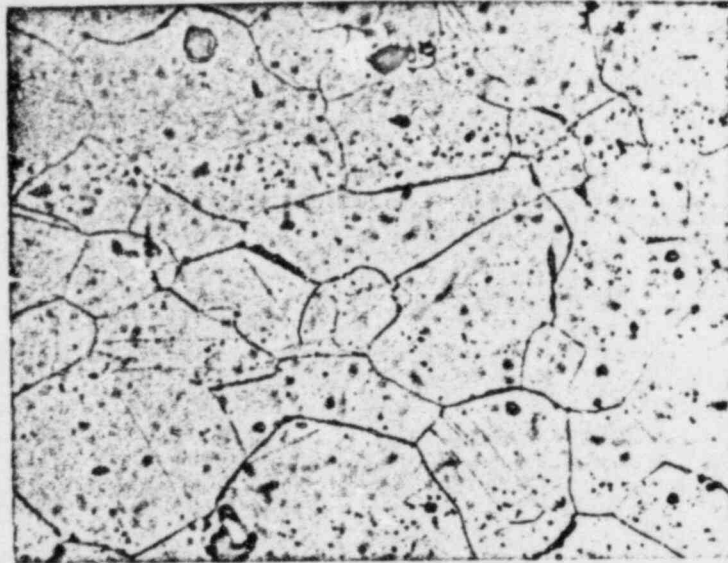
Figure 9 Photomicrograph of Broken Turbocharger Bolt (Division I)

Note large grains and intermetallic precipitates. There is some evidence of grain boundary precipitation.

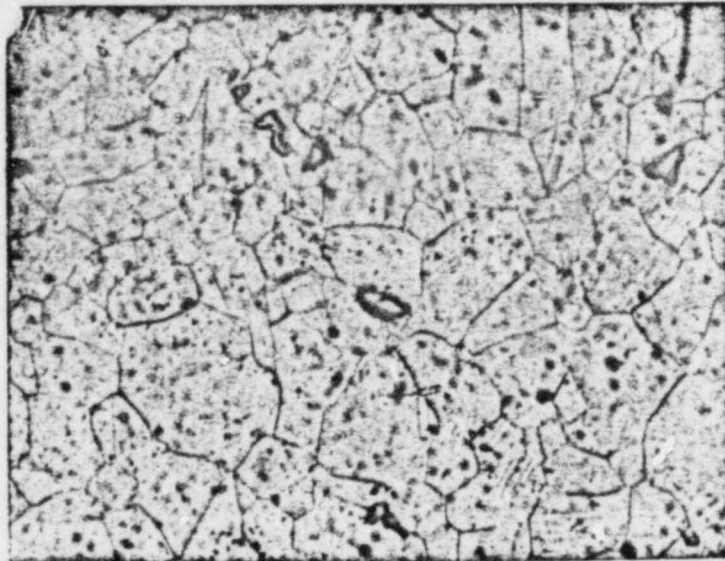
Figure 14 Photomicrograph of Turbocharger Bolt From Division II
L-1 Bolt

Note smaller grain size than the Division I bolts. Micro-structure shows some evidence of stepping, indicating absence of sensitization.

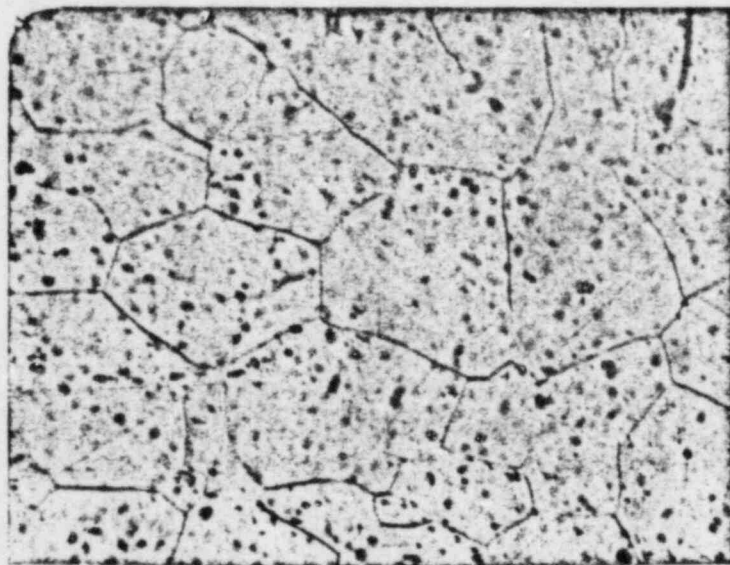
Figure 18 Photomicrograph of Turbocharger Bolt From Division II
L-3 Bolt

Note absence of grain boundary precipitation. Material
was not sensitized.

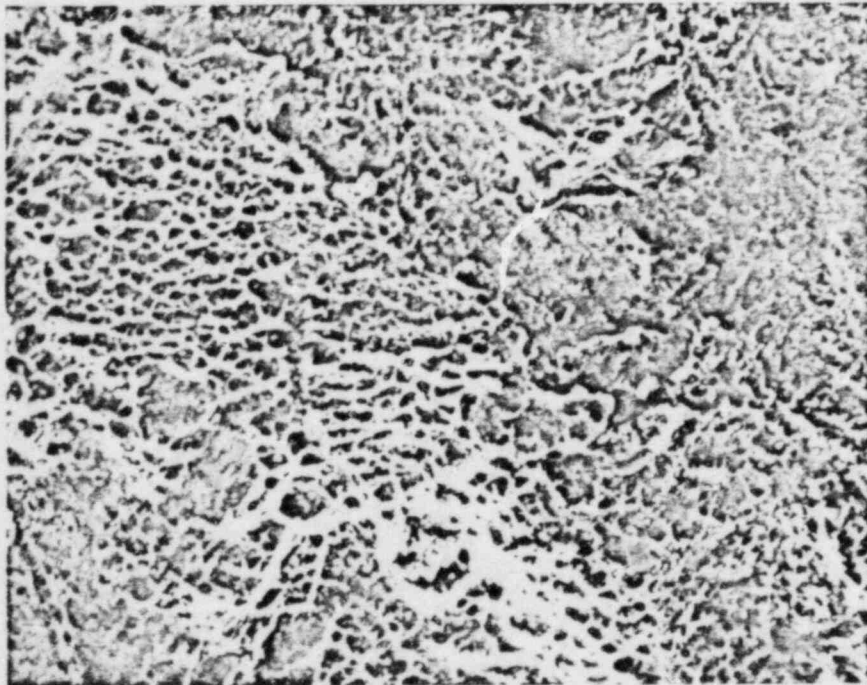
Figure 23 SEM Fractograph - Division I Broken Bolt Head

Taken near the smooth appearing region in Figure 2.
Appearance of ductile tearing due to mechanical overload is
blurred by oxide film.

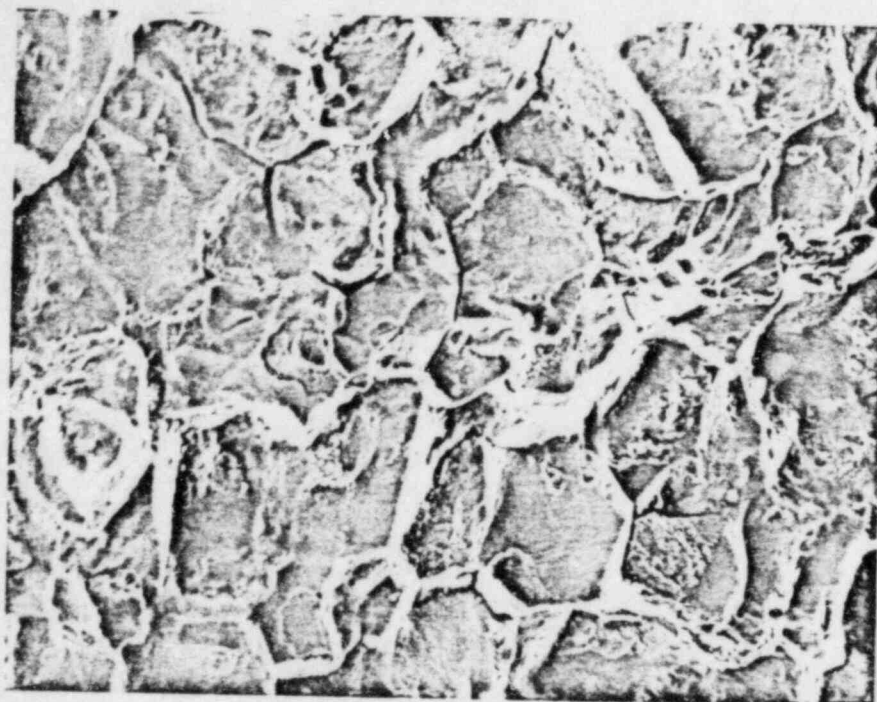
Figure 26 SEM Fractograph - Division I Broken Bolt Head
(After cleaning)

Fractograph taken in the mid-region of grainy surface. Evidence of IGSCC is clear.

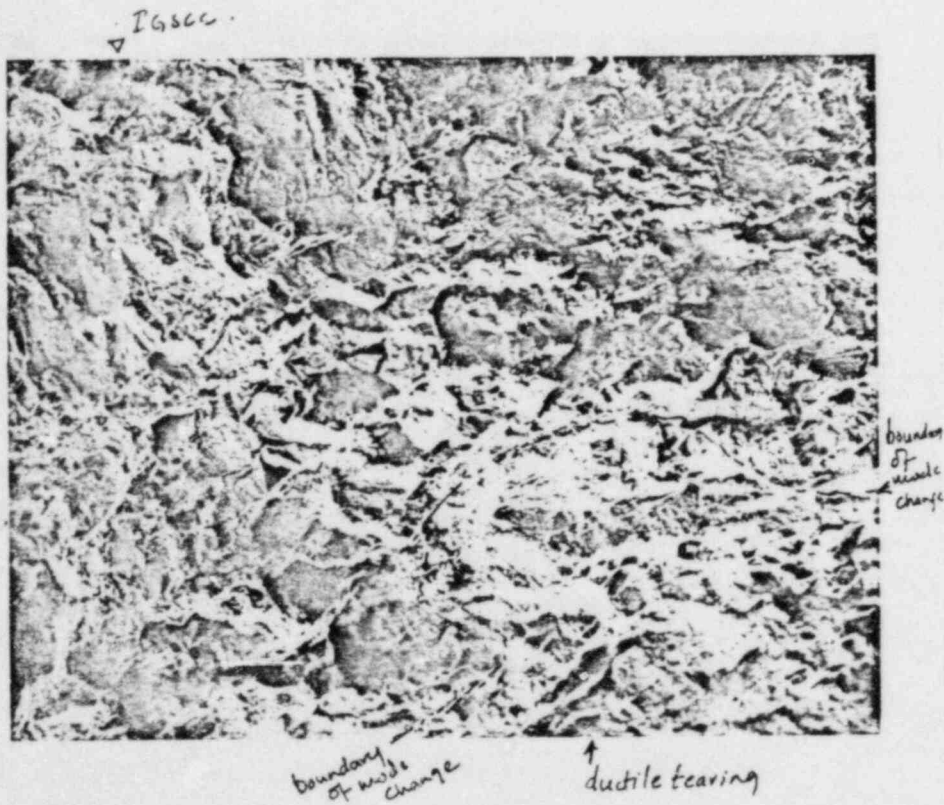
Figure 27 SEM Fractograph - Division I Broken Bolt Head
(After cleaning)

Fractograph taken at transition region between grainy surface and smooth surface. Evidence of IGSCC (grains and secondary cracks) at upper half and ductile tearing at lower right.

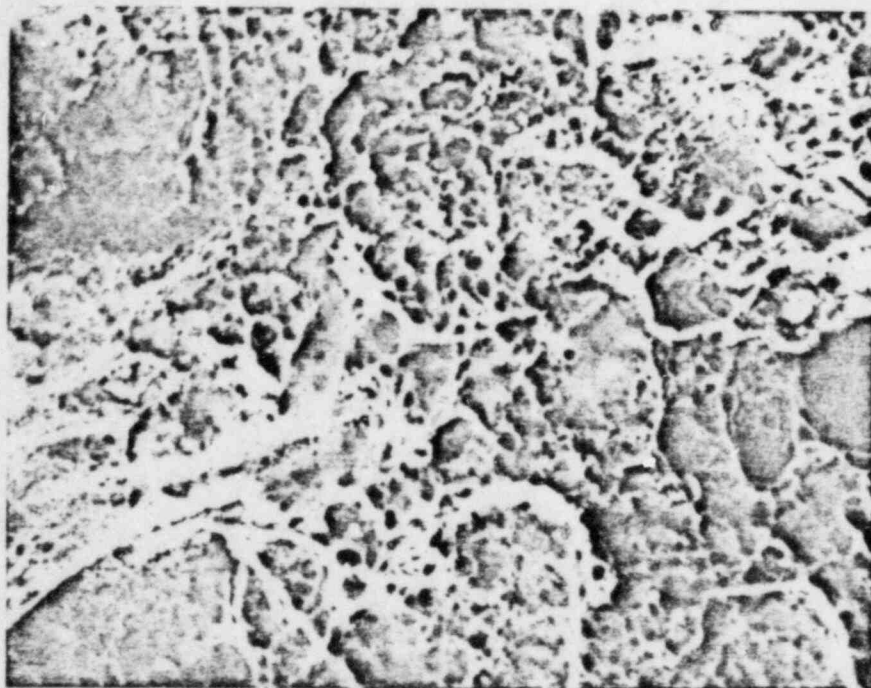
Figure 28 SEM Fractograph - Division I Broken Bolt Head
(After cleaning)

Taken in the smooth region in Figure 2. Dimpled morphology typical of ductile tearing due to mechanical overload.
(Preload supported by a small ligament area)

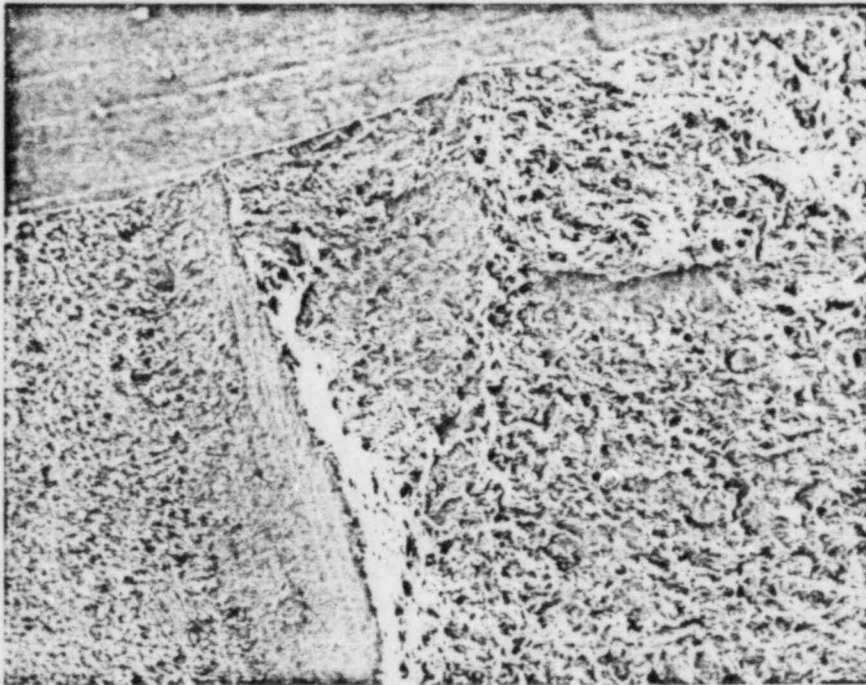
Figure 29 SEM Fractograph - Division I Broken Bolt Head
(After cleaning)

Shear lip formation is evident. Indicates the last step of fracture.

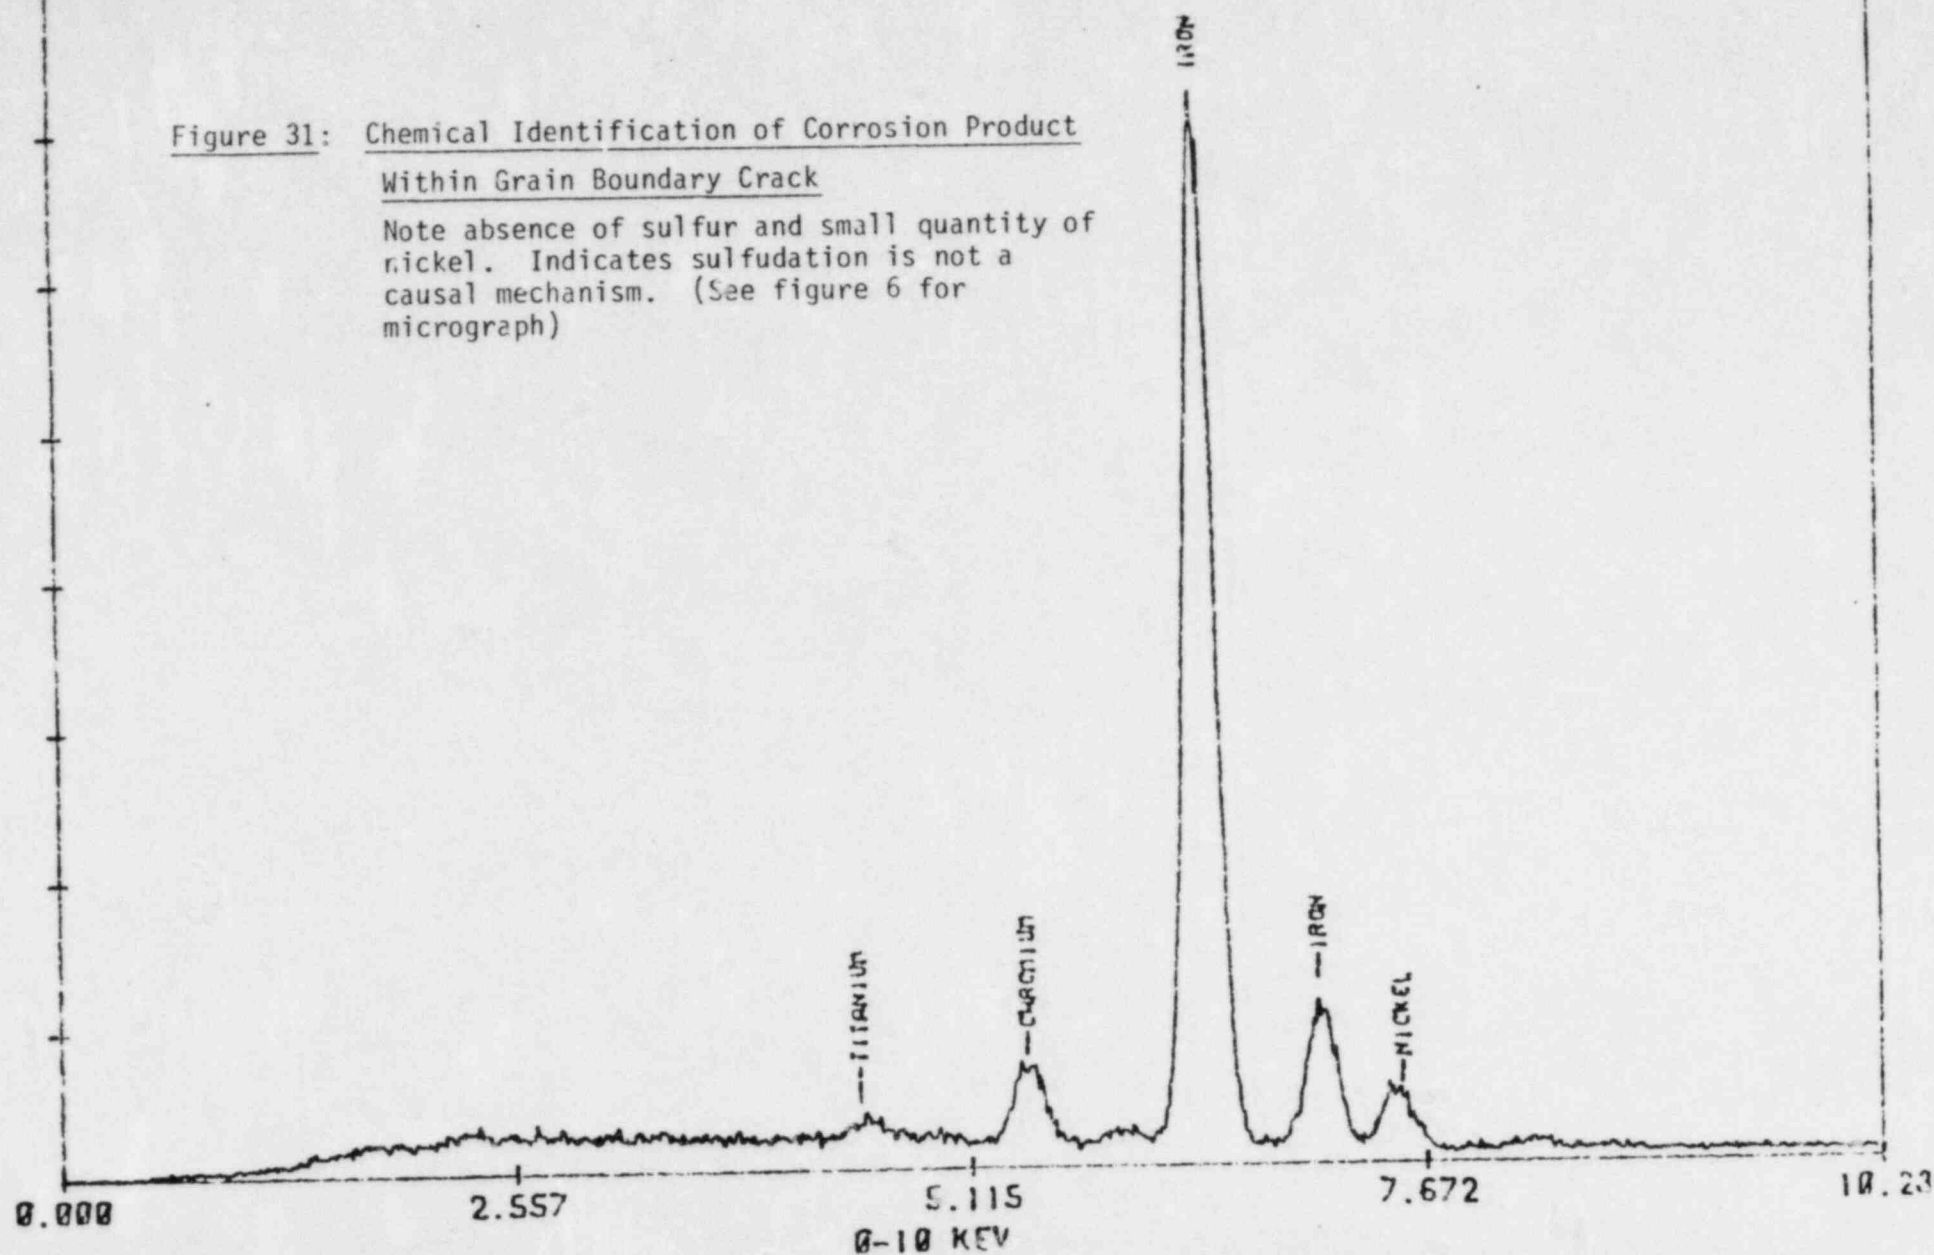
Figure 31: Chemical Identification of Corrosion Product

Note absence of sulfur and small quantity of nickel. Indicates sulfuration is not a causal mechanism. (See figure 6 for micrograph)

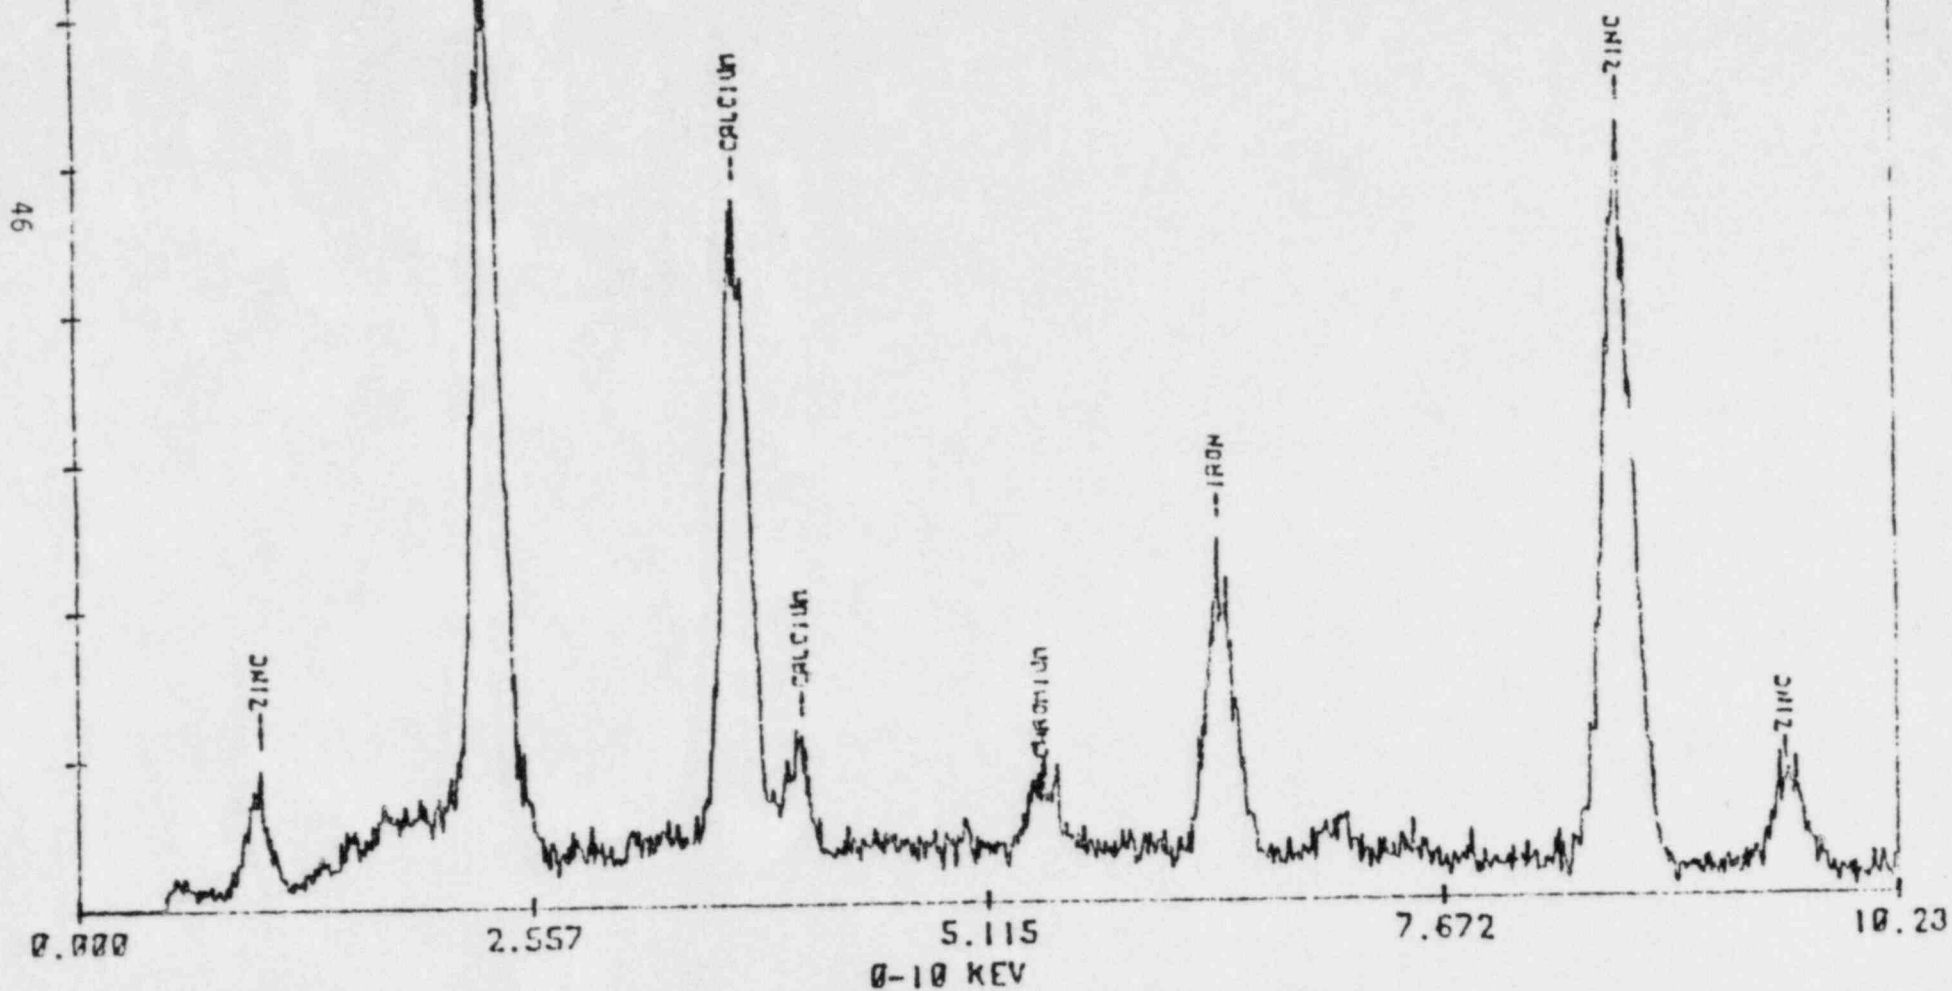
Figure 35: Chemical Identification of Corrosion Product Deposit

Spectrum shows predominance of combustion product species.
Note the small amount of base metal elements and the reversal
of trend from figure 30.

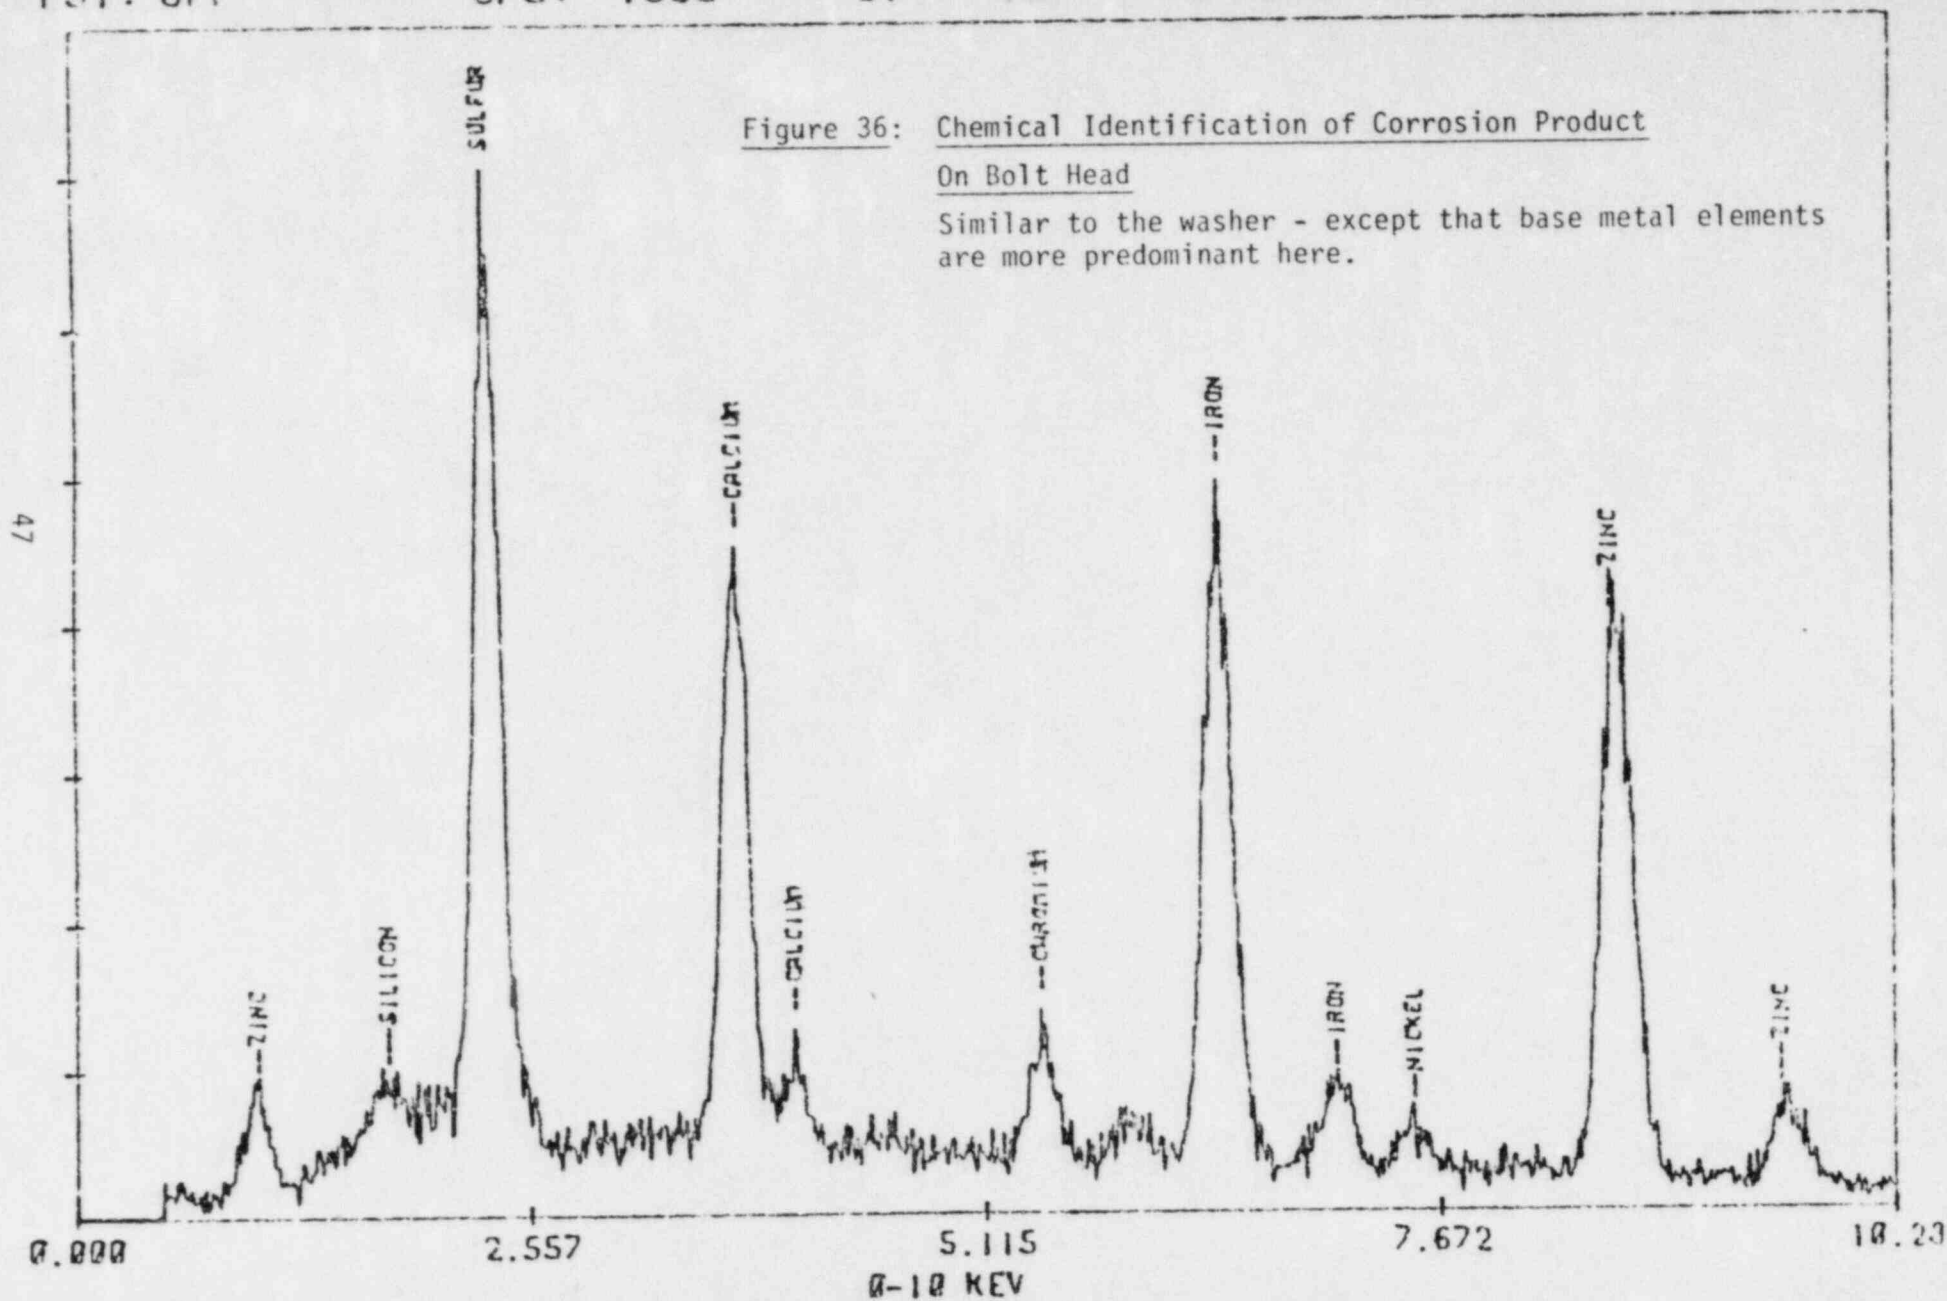
Figure 36: Chemical Identification of Corrosion Product
On Bolt Head

Similar to the washer - except that base metal elements
are more predominant here.

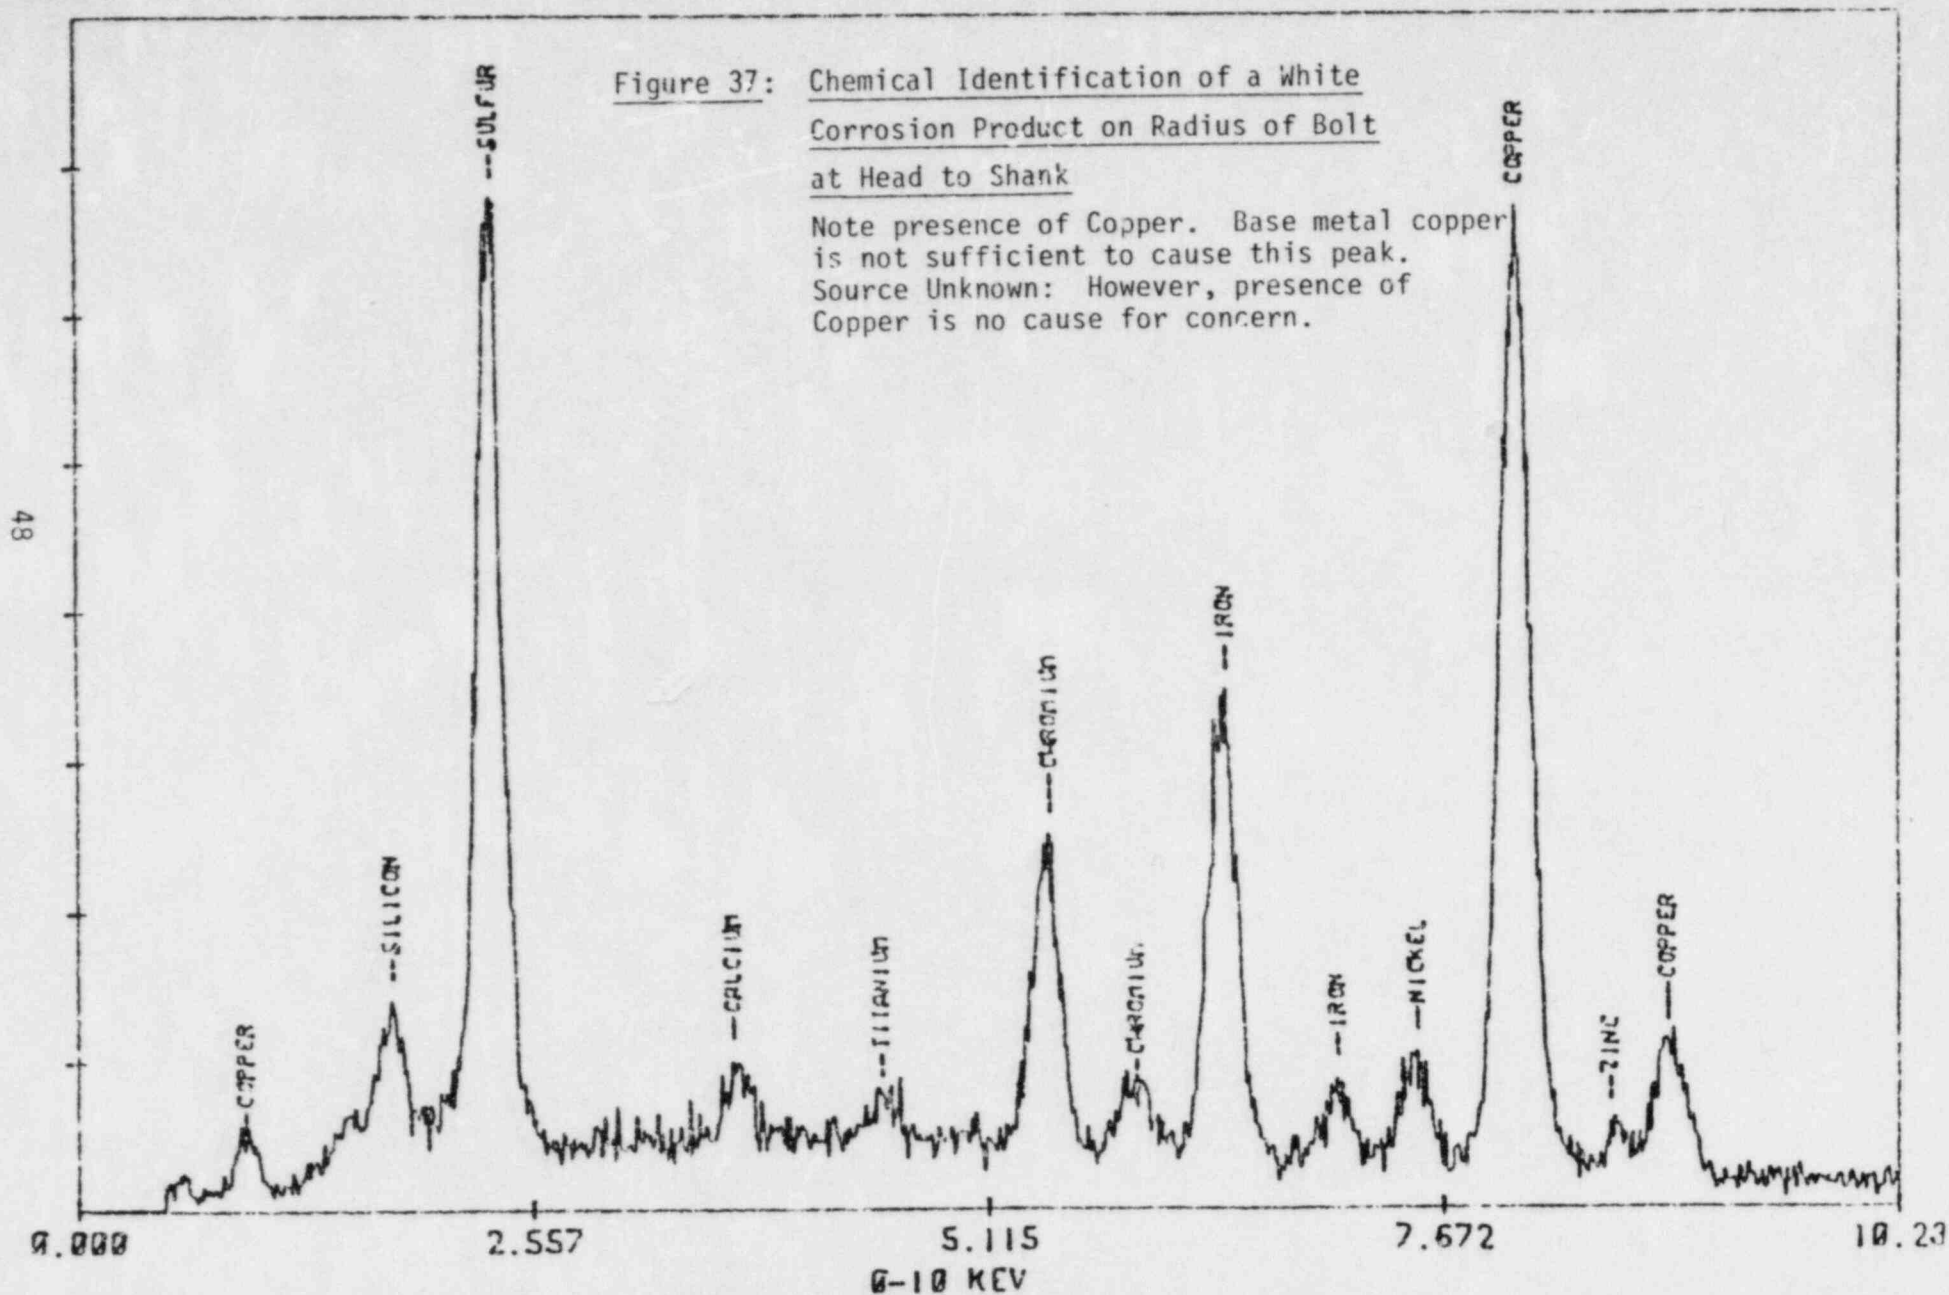
Figure 37: Chemical Identification of a White Corrosion Product on Radius of Bolt at Head to Shank

Note presence of Copper. Base metal copper is not sufficient to cause this peak. Source Unknown: However, presence of Copper is no cause for concern.
