METALLURGICAL EVALUATION
OF
DIESEL GENERATOR CYLINDER HEAD
VALVE SEAT CRACKS
AT
GRAND GULF NUCLEAR STATION - UNIT 1

PREPARED FOR: NUCLEAR PLANT ENGINEERING
MISSISSIPPI POWER & LIGHT COMPANY
PORT GIBSON, MISSISSIPPI 39150

PREPARED BY: J. S. BRIHMADESAM
NUCLEAR ENGINEERING DEPARTMENT
MIDDLE SOUTH SERVICE, INC.
NEW ORLEANS, LOUISIANA 70112

JUNE, 1984

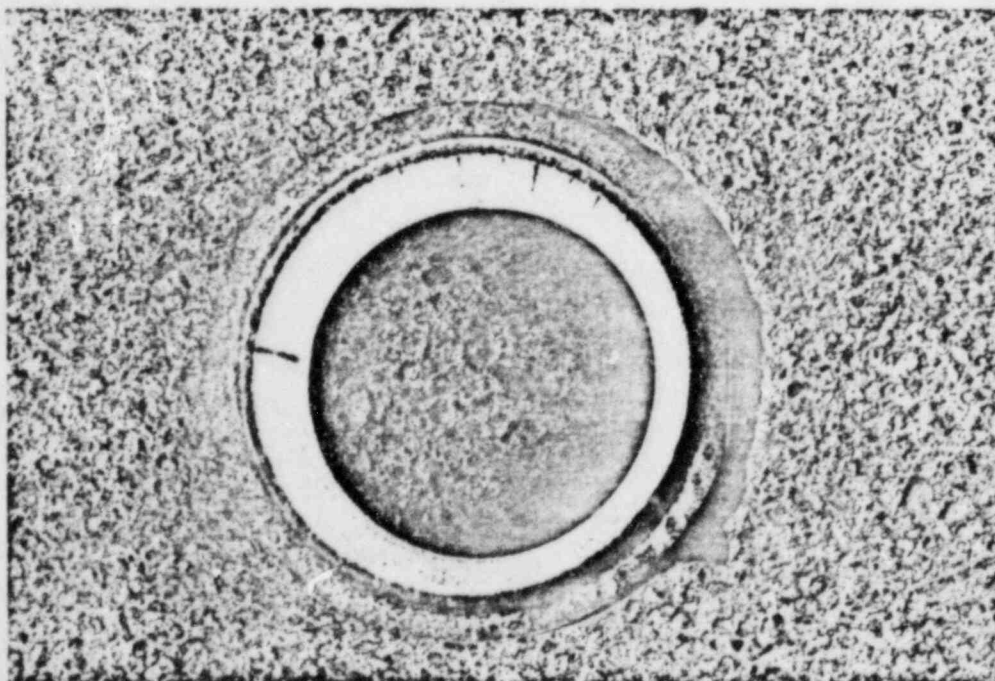
FIGURE 1: Liquid Penetrant Indications on Valve Seat

The specimen was examined using LP. The indications revealed are shown in Figure 1. A close up of the suspected leaker is shown in Figure 2 and Figure 3 shows multiple radial cracks on the seating surface.

The LP indications shows that the larger crack was about 90° away from the multiple cracks. A visual examination of the back side of the ring specimen, which was machined out of the cylinder head, showed a casting defect to be located behind the single large crack. Thus, it was decided to perform the following investigations:

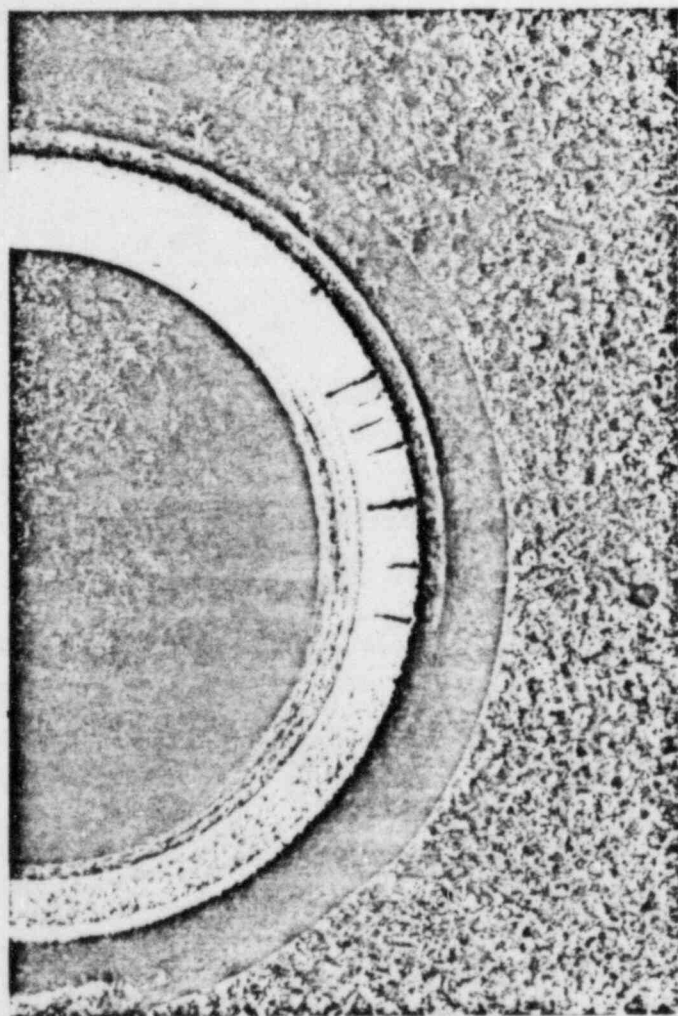
FIGURE 3: Liquid Penetrant Indications of Numerous Stellite Cracks

This data shows that the ratio between cast steel and stellite is 1:4. Therefore the stellite would expand considerably more than the cast steel during welding. Conversely during cooling the stellite would shrink 4 times faster causing large strains to be developed. These shrinkage strains are accommodated by cracking along grain boundaries. The cracks may or may not expose themselves to the surface. Therefore when the stellite seat is machined some cracks may be exposed to the free surface and some still be subsurface and not detectable by LP techniques. However, it is not probable that these cracks are numerous such that a large area of grain boundary would be expected to be cracked. This is a valid supposition and is borne out by metallography which showed that a majority of the grain boundaries were not cracked.

The subsurface shrinkage cracks can open to the surface during service only during cooling. This implies, a logical extension considering the differential thermal contraction, that frequent starts and stop operation of the engine are more apt to open such cracks than is a continuous steady operation. Thus with the given mode of operation (i.e., Surveillance Testing), it is expected that pre-existing subsurface cracks would open to the seat surface and be detected in subsequent LP exams.

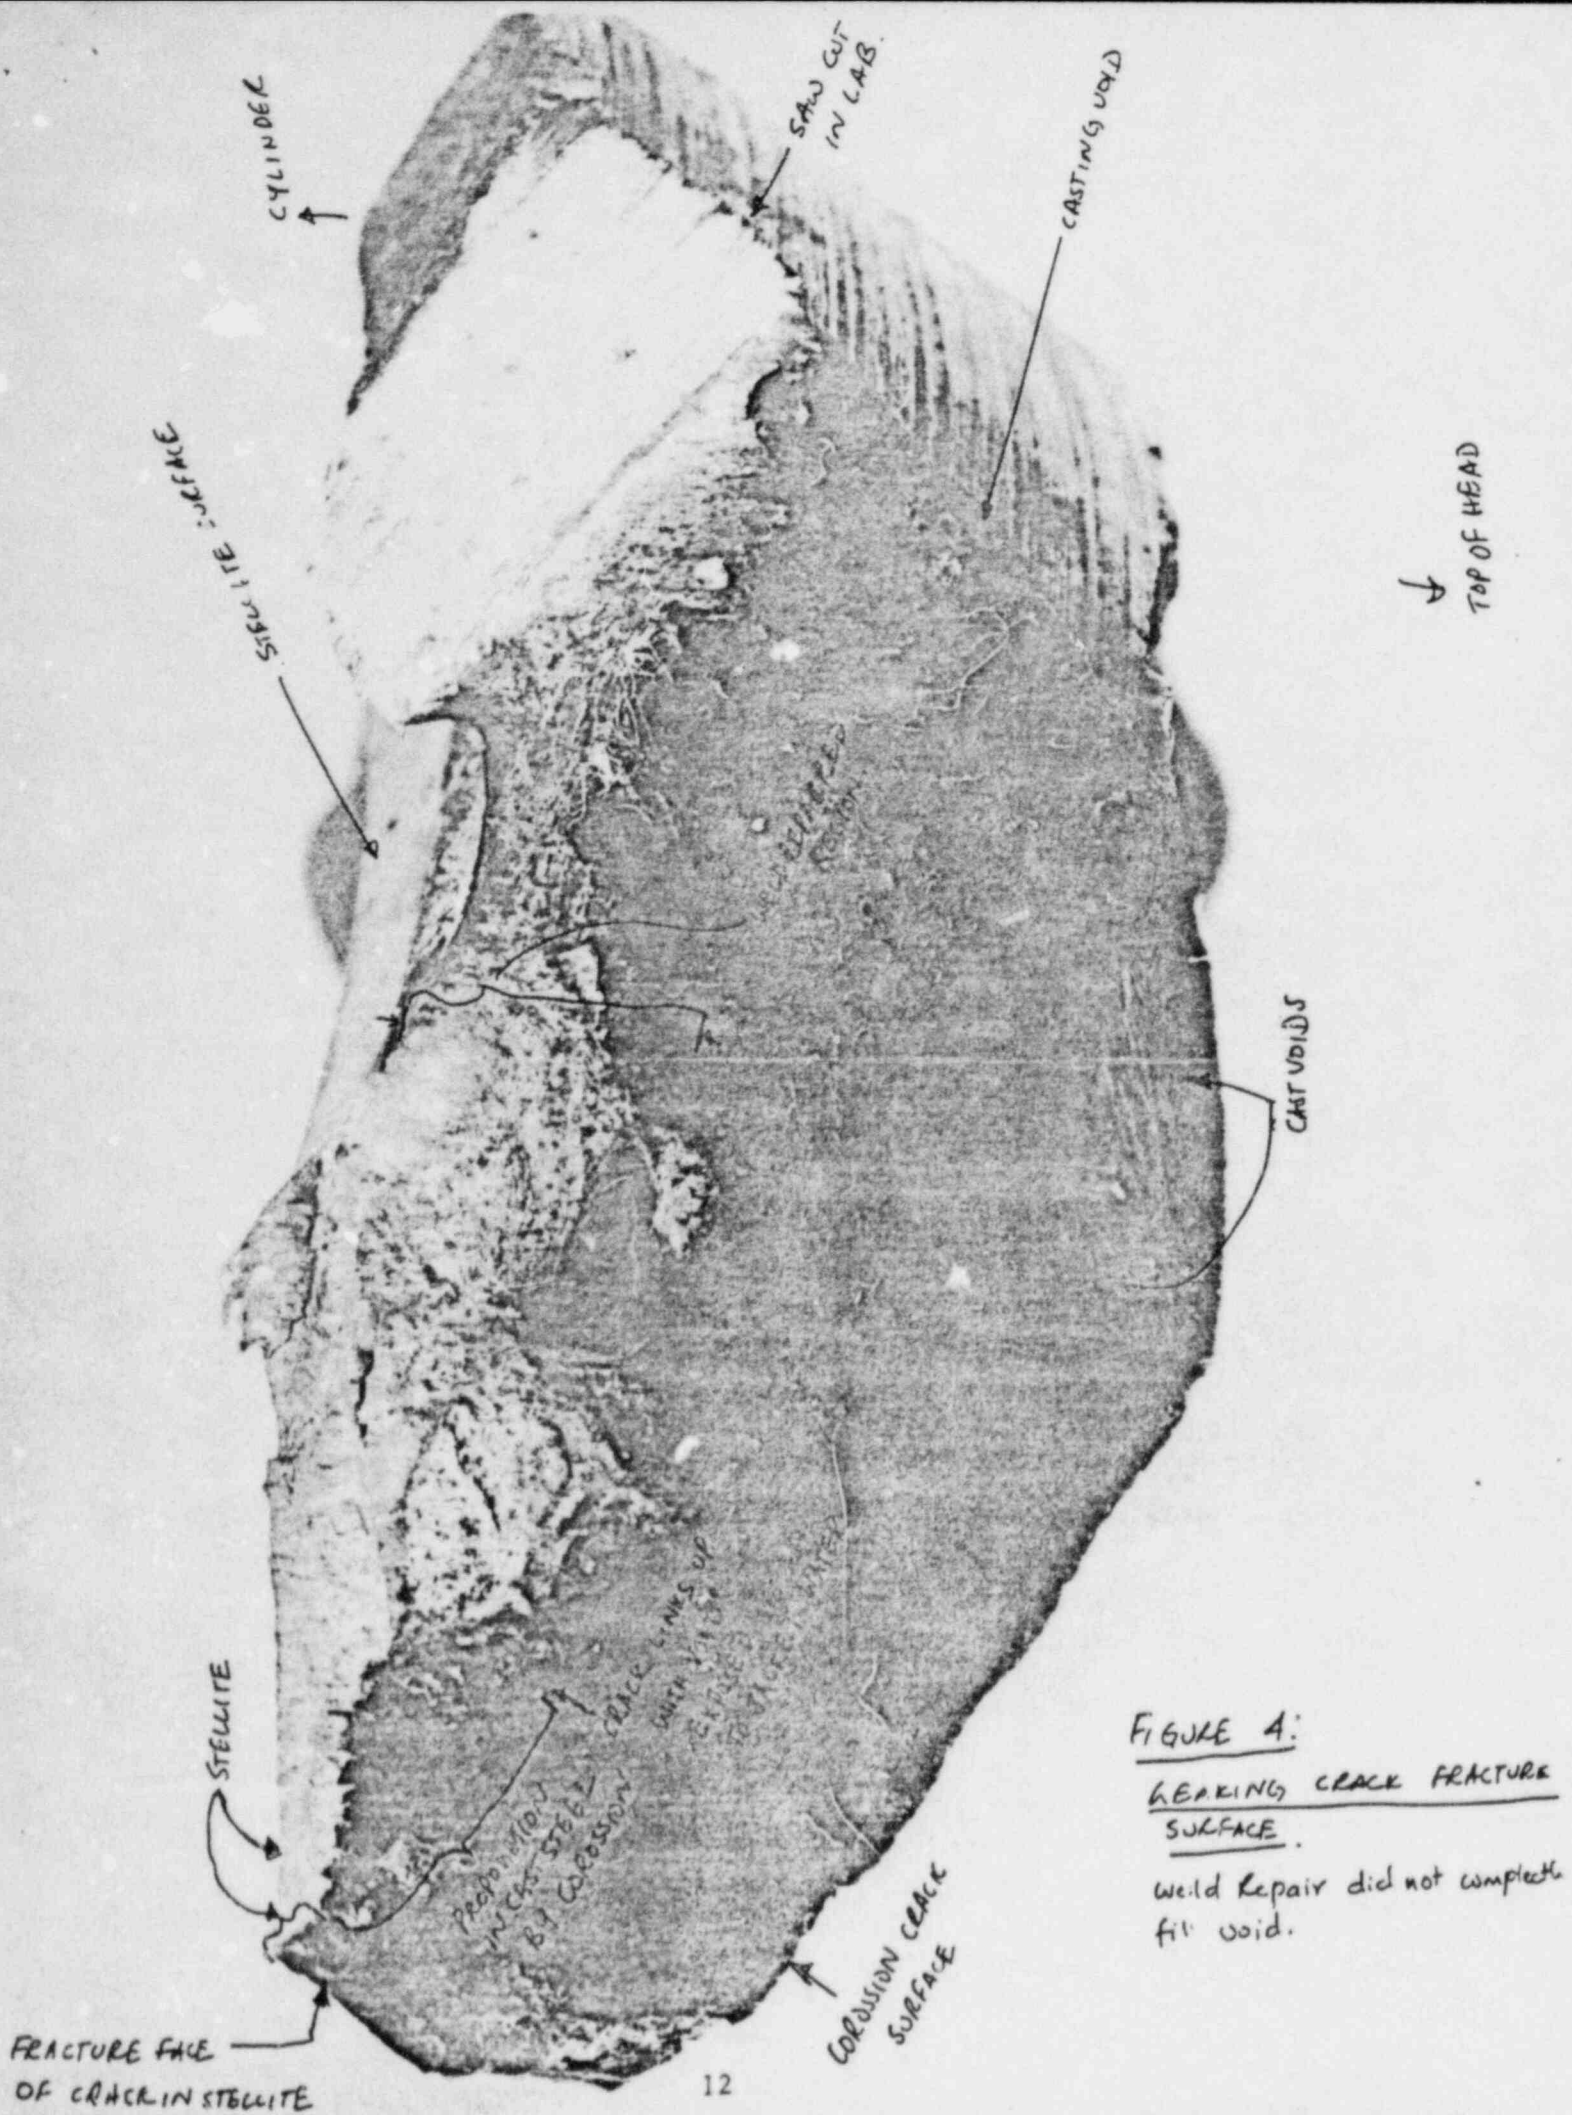
FIGURE 4:

The single crack face was opened in the laboratory by cutting the ligament from the back side of the ring specimen. The fracture surface is shown in Figure 4. The following features were revealed:

- o There were two casting defects (voids), one above the other on the back side of the seating surface.
- o The stellite fracture surface was covered with black adherent oxide film. Also portions of the casting fracture surface was covered with this oxide film.
- o There was a distinct difference in fracture surface appearance of the laboratory fracture surfaces at the bottom and top of the base material of the ring. The appearance at the top was indicative of a ductile weld material. This indicates that there was some weld repair performed in this region.
- o The crack appears to have propagated from the stellite casting interface to the casting void by corrosion. The cause for corrosion is the exhaust combustion gases.

As mentioned earlier, it appeared that the cylinder head, in one area of this exhaust valve seat was repaired by welding. The need for weld repair may have been to fill the casting void such that an even surface for weld deposition of stellite was obtained. Though the weld repair achieved the objective of providing an even surface, the weld metal did not appear to have filled the entire void (See Figure 4). Furthermore, the casting void below this repaired void was untouched since it did not penetrate the exposed surface of the seat area. A section of this region was obtained using a diamond impregnated metallurgical saw. The section was used to perform metallography so as to confirm the existence of weld metal (from repair welding). The metallographic section is shown in Figure 5. Areas where microstructural evaluations were performed are also shown on this figure. No evidence of a soft butter weld between the cast steel and the stellite was observable. Figure 6 is a micrograph obtained in a area that shows the microstructure of the cast steel. The microstructure consists of a ferrite matrix with pearlite grains. Figure 7 is a micrograph obtained

HEAVING CRACK FRACTURE SURFACE.

Weld Repair did not completely fill void.

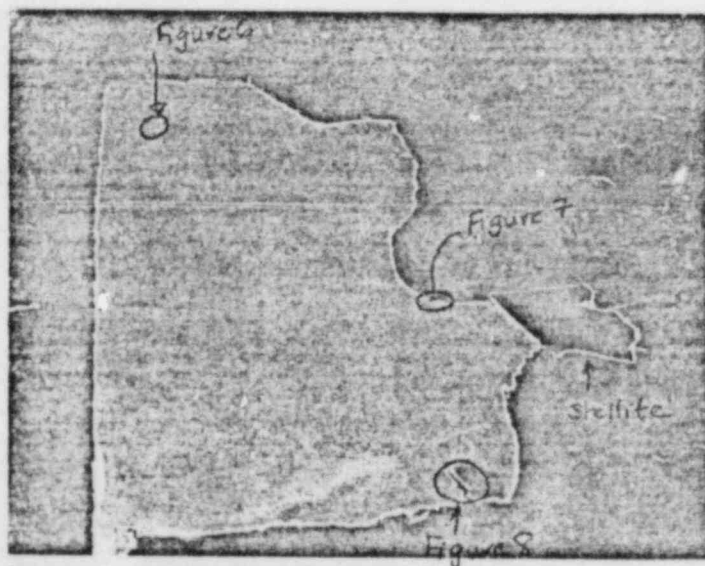
FIGURE 5: Cross Section of Valve Seat Surface

Section taken adjacent to the leaking crack.

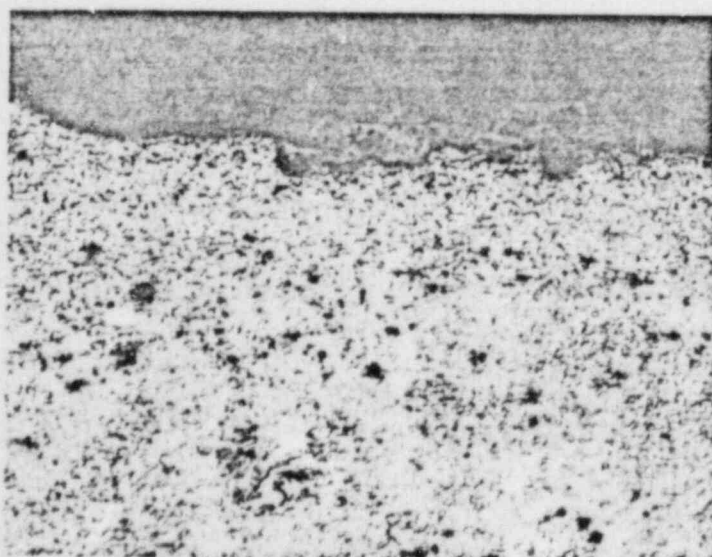
from an area on the top side of the stellite. The microstructure is acicular and representative of a weld material. Similarly, Figure 8, a micrograph obtained from an area below the stellite, shows a microstructure representative of a weld material. This finding confirms the existence of a weld repair, in the casting.

FIGURE 7: Microstructure Behind Stellite Top Surface
Microstructure typical of a weld.

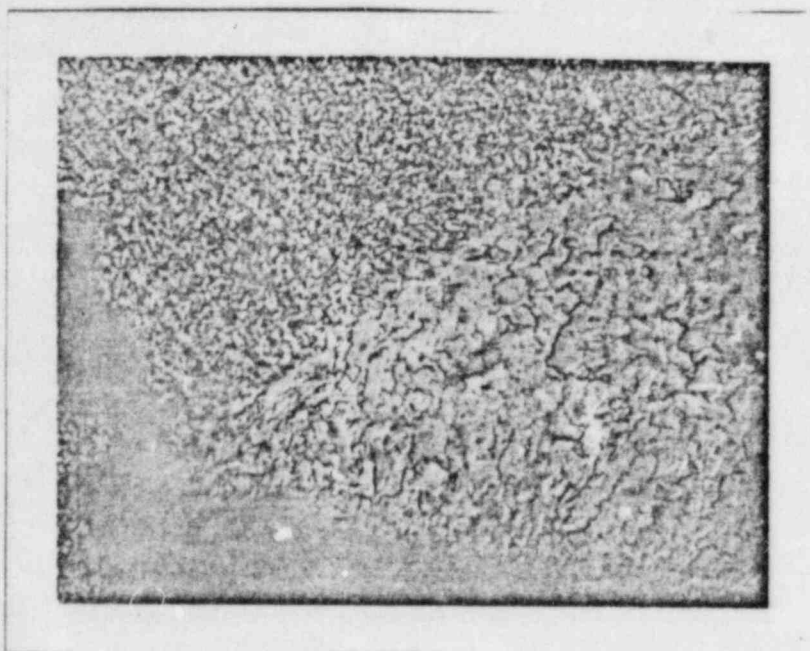
FIGURE 8: Microstructure Behind Stellite Bottom Surface
Microstructure typical of weld metal.

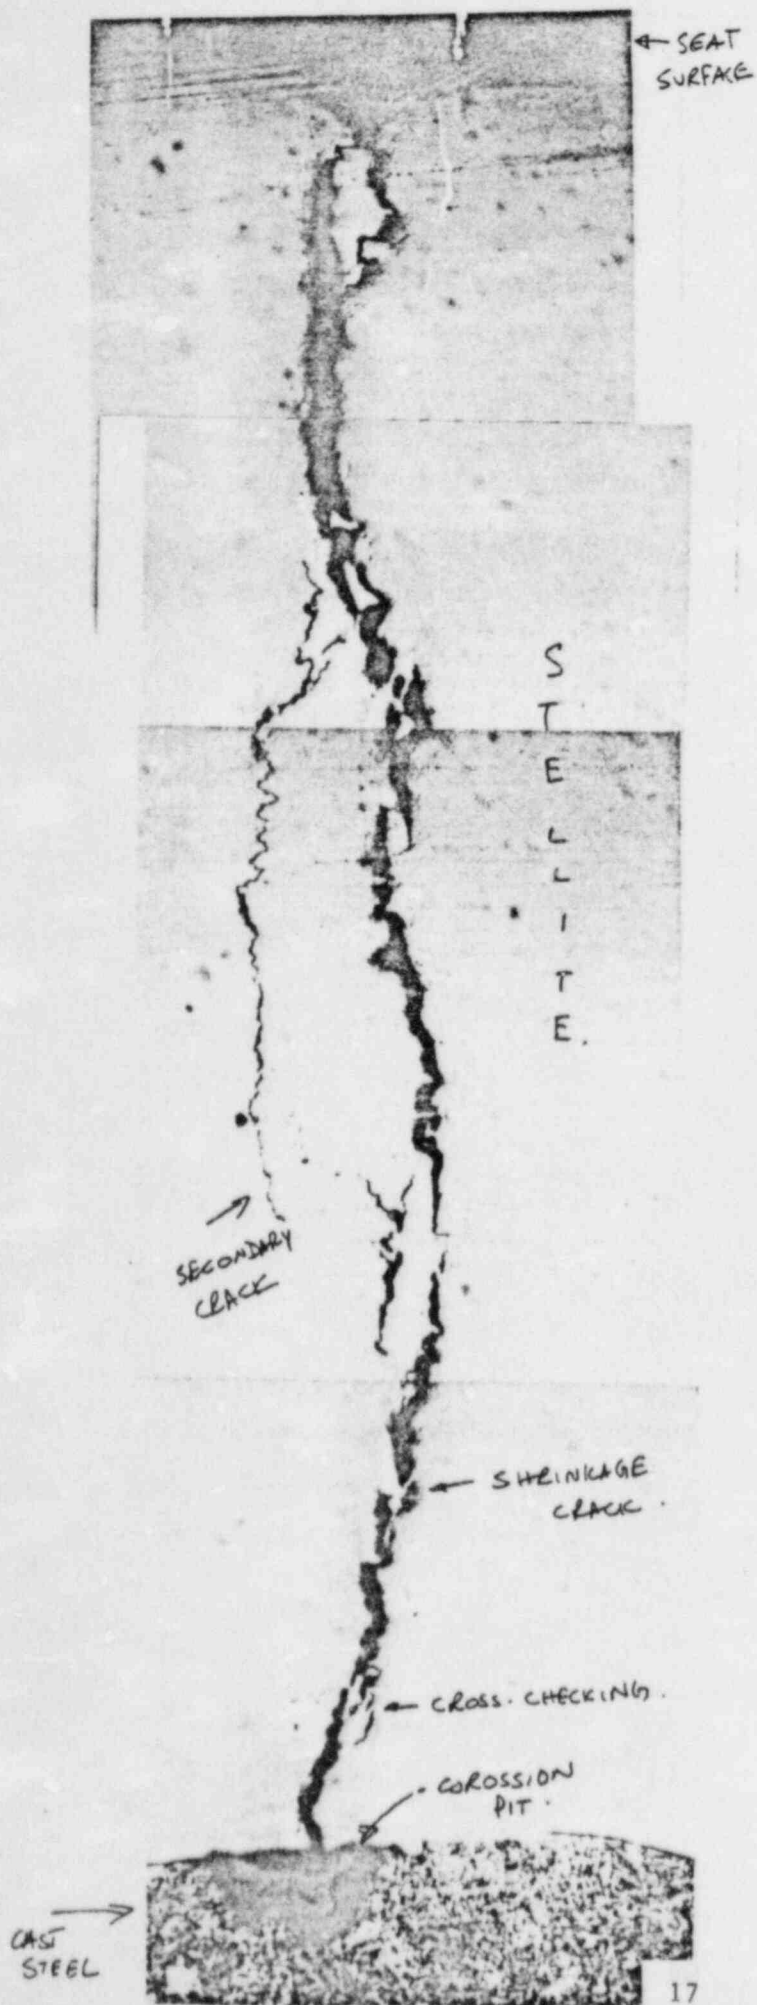
FIGURE 9: Montage - Shrinkage Crack in Stellite

A typical crack in stellite. Jagged path and secondary cracks.

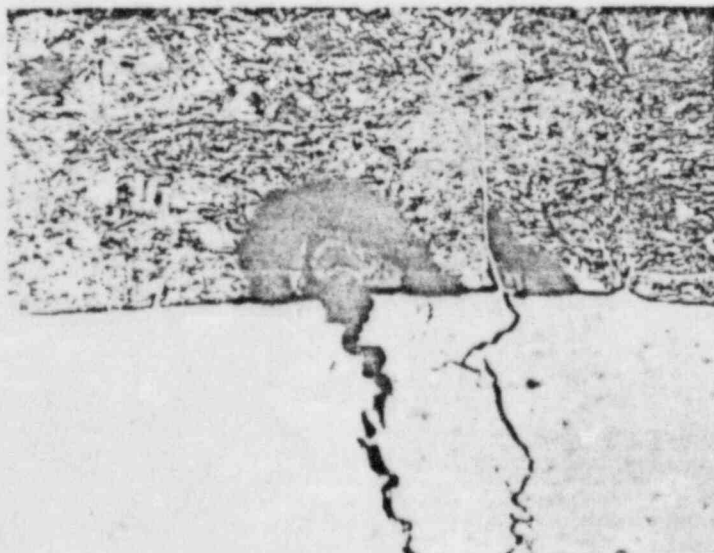
FIGURE 11: Micrograph Near Stellite Cast Steel Interface

However, it was also shown (Section 4.0) that corrosion pits existed at the tail end of the stellite cracks and that the fractography (Section 3.0) showed evidence of corrosion on the fracture surface of the cast steel on the leaking crack. Therefore, the mechanism that would lead to failure is by corrosion of the cast steel by the hot exhaust gases. Gases formed by combustion of the diesel fuel include; oxides of sulphur and nitrogen. These oxides and water vapor formed during combustion form respective acids which enter the stellite cracks and attack the underlying cast steel. Hence, the cracking mechanism that can cause failure is corrosion.

Corrosion pit at the end of shrinkage crack.
Evidence of stellite intrusion into cast steel.
Fusion line between stellite and cast steel
in regions other than cracks and pits is good.

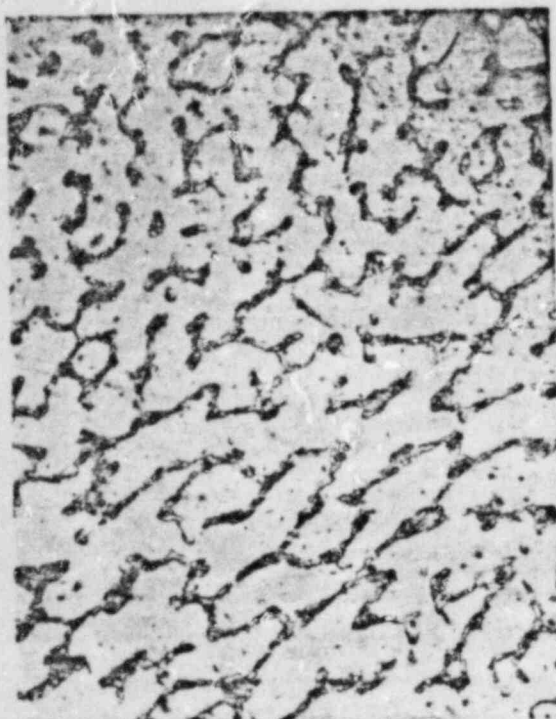
FIGURE 12: Microstructure of Stellite

Figure 12 shows the microstructure of the stellite. The microstructure shows that the material is a cobalt base, hard facing alloy deposited by a shielded arc process (SMAW).² The microstructure is austenitic with a carbide grain boundary network. Figure 13 is a micrograph showing both the crack and the microstructure. It can be seen from this micrograph that the crack runs along the grain boundary following the carbide network. From reference 2 it is observed that brittle hardfacing alloys when deposited by the SMAW process can crack and cross check during cooling to relieve the large strains in the stellite. This aspect is discussed in a later section. Thus, these cracks form in the regions where the material is still in the liquidus state. The carbide rich grain boundary is the last to solidify and hence these cracks form along the grain boundaries and are characterized as shrinkage cracks.

Shows carbide network at grain boundaries.

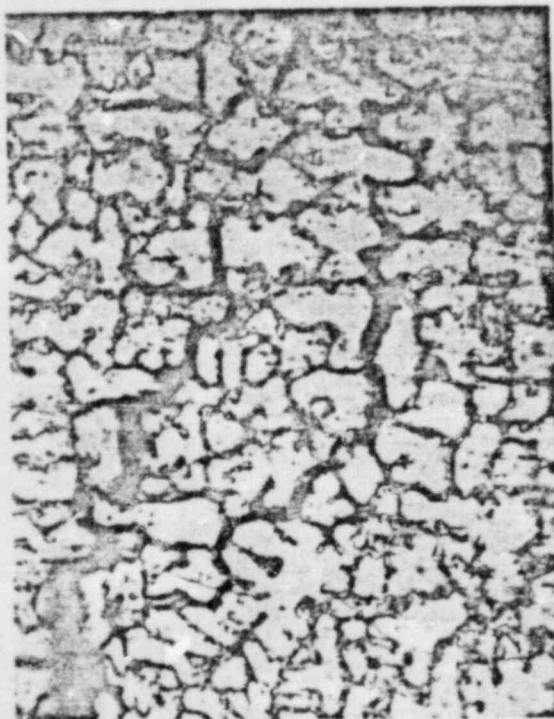
FIGURE 13: Crack in Stellite and Microstructure

Crack is clearly in carbide network
at Grain Boundaries.

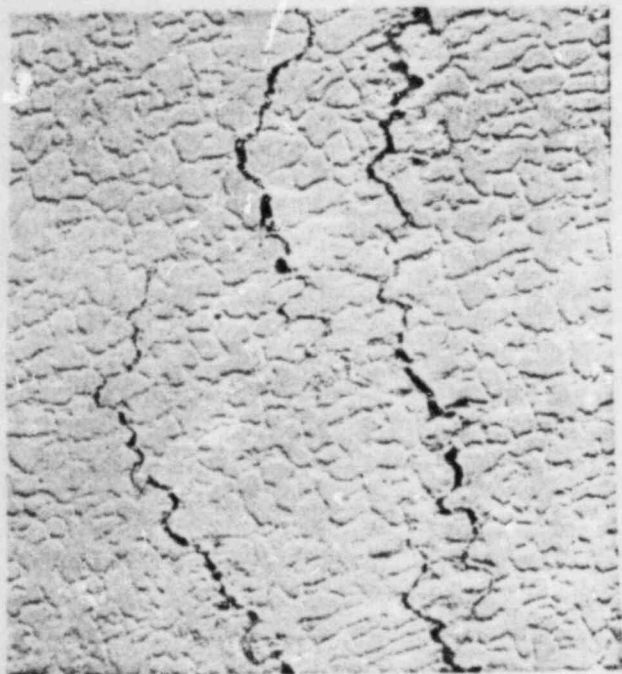
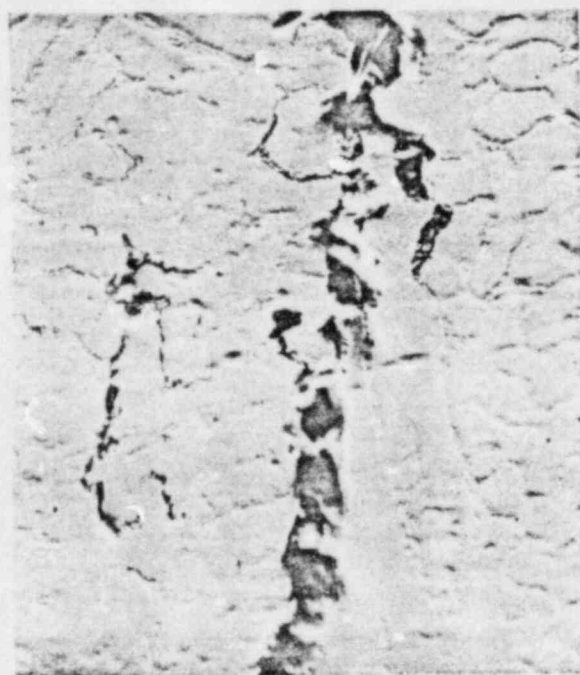
FIGURE 14: SEM Metallograph of Stellite Crack

The etched stellite specimen was examined using a scanning electron microscope (SEM). The purpose of this examination was to determine the morphology of the cracks. Figure 14 shows the SEM micrographs at two magnifications. The grain boundaries are clearly visible as a raised network. At the higher magnification the cracks show a tearing type behavior which confirms the causal mechanism to be one of shrinkage cracking. The edges of the cracks are sharp and show no sign of corrosion or erosion. The extensive cross checking of the crack is also visible.

Metallograph taken after etching per reference 1. Grain boundary cracks and extensive cross-checking in cracks are evident.
