# MISSISSIPPI POWER & LIGHT COMPANY

SUBJECT: Grand Gulf Nuclear Station  
Units 1 and 2  
Docket Nos. 50-416 and 50-417  
License No. NPF-13  
File: 0260/L-860.0  
Additional Information - TDI Engine  
Inspection  
AECM-84/0386

AECM-84/0386

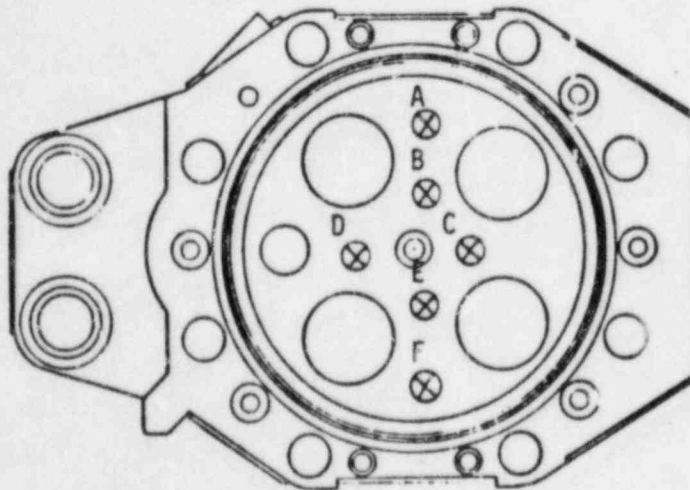
TABLE 1  
Cylinder Head Baseline  
Data for Flatness

A straight edge and micrometer were utilized to obtain baseline information for the cylinder head fire deck profiles. Measurements were taken at six different locations on the fire deck. Readings varied from head to head as to the depth of the fire deck depression. Results of the measurements are shown in TABLE 1.

Changes in readings taken across the fire deck were due to the curvature of the fire deck and were consistent for all heads and did not indicate a problem with head warpage. These readings were taken for baseline data to be used in the future to determine if warpage of the heads may have occurred.

Cylinder Head	A	B	C	D	E	F
RB-1	< .002	.004	.004	.004	.002	< .002
RB-2	< .002	.005	.008	.008	.005	< .002
RB-3	.002	.003	.004	.004	.003	< .002
RB-4	< .002	.007	.008	.006	.007	< .002
RB-5	< .002	.004	.012	.007	.003	< .002
RB-6	< .002	.002	.002	.003	.002	< .002
RB-7	< .002	.003	.009	.007	.003	< .002
RB-8	.003	.016	.019	.014	.015	.004
LB-1	.002	.007	.007	.005	.006	< .002
LB-2	< .002	.005	.008	.006	.004	< .002
LB-3	< .002	.004	.006	.006	.004	< .002
LB-4	< .002	.004	.007	.007	.004	< .002
LB-5	< .002	.005	.009	.004	.004	< .002
LB-6	< .002	.005	.006	.007	.004	< .002
LB-7	< .002	.006	.003	.003	.006	< .002
LB-8	< .002	.004	.006	.004	.004	< .002
