## **RADIOLOGICAL MEASUREMENTS**

**INTERNATIONAL NUTRONICS, INC.**

**DOVER, NEW JERSEY**

FINAL REPORT

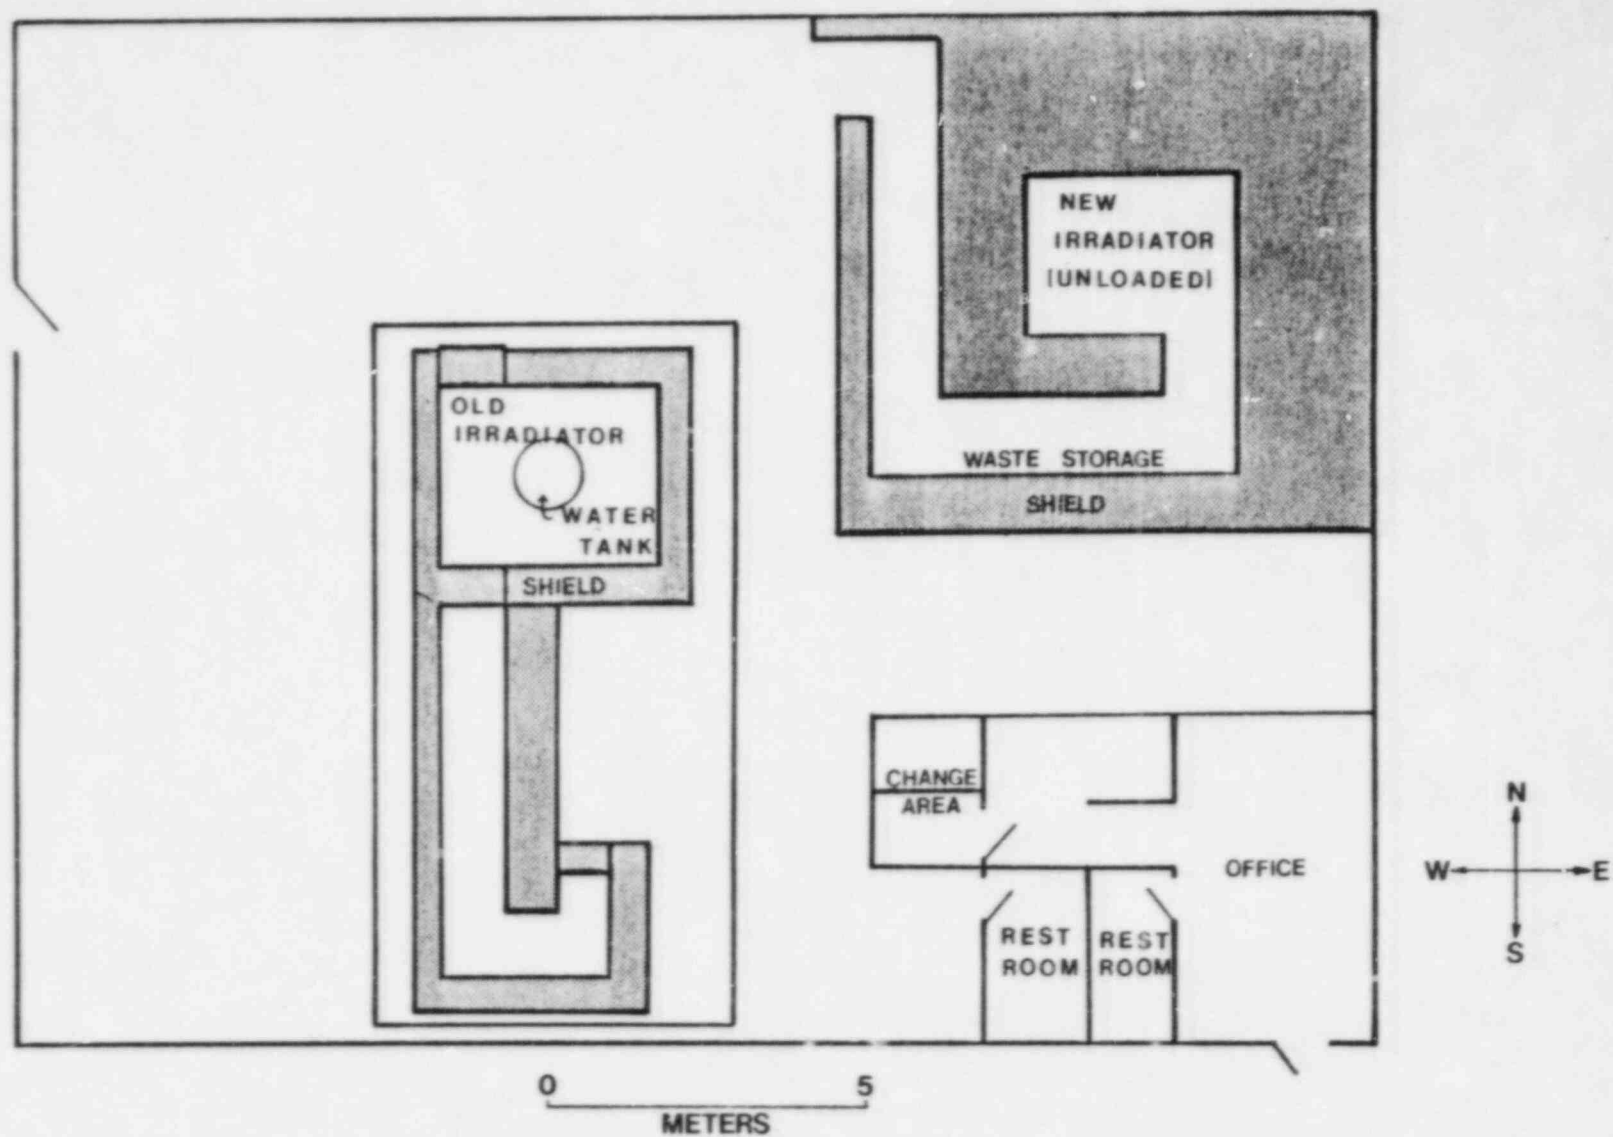
FIGURE 1: Floor Plan of the Irradiator Building.

International Nutronics, Inc., occupies two buildings on Rt. 46 in Dover, New Jersey. One of the buildings houses administrative operations; the other building contains the Co-60 irradiator unit. Figure 1 is a floor plan of the irradiator facility. The facility is located inside a concrete block building, approximately 15 m x 24 m with a 5 m high ceiling. The floor is slightly reinforced concrete, estimated to be 10-15 cm thick; there are several expansion joints in the floor slab. A 1.3 m diameter, 5 m high tank,

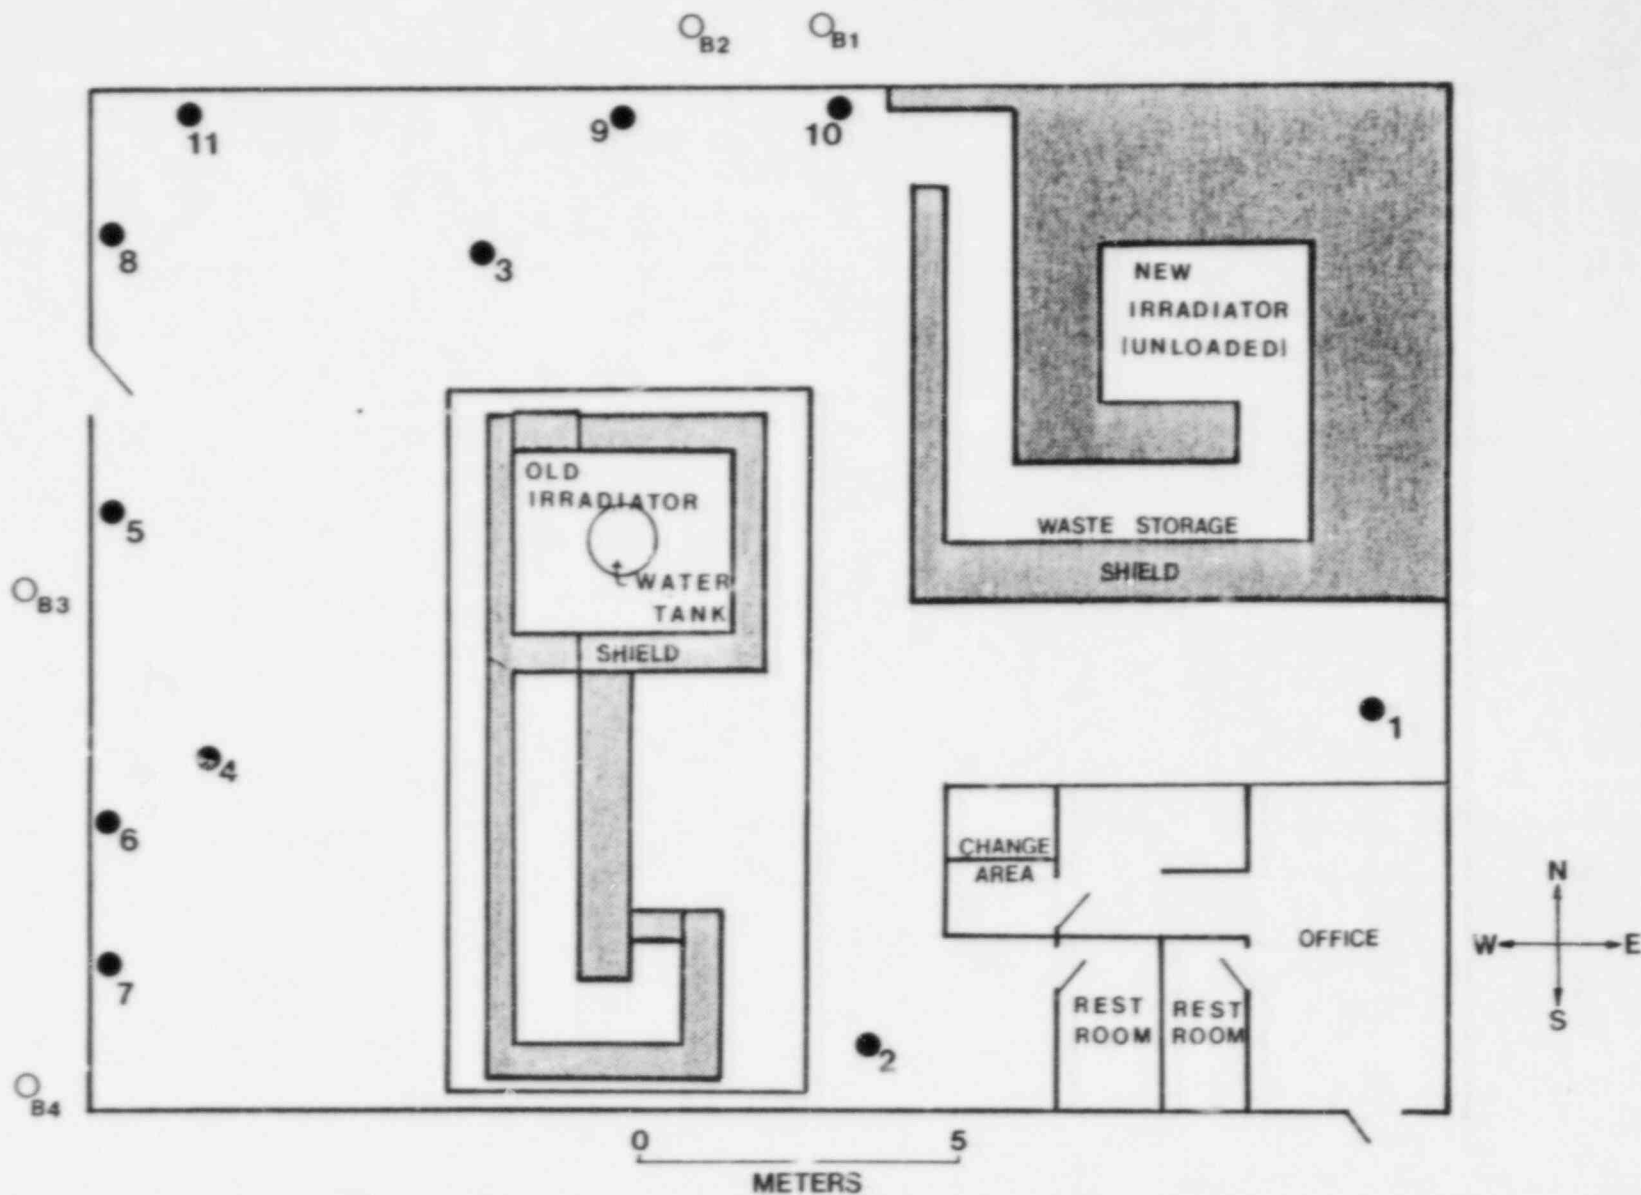
FIGURE 2. Locations of Floor Coring (1-11) and Boreholes (B1-B4) for Subsurface Investigations.

2. At eleven locations, 15 cm diameter holes were cut through the floor using a concrete coring drill. These locations are shown on Figure 2.
3. Samples of the soil immediately beneath the floor were collected. In holes where direct radiation monitoring did not indicate soil contamination, the initial sample was 0-15 cm; where soil contamination was indicated, samples were collected at 0-5 cm and 5-15 cm.
4. Deeper samples were collected from the core holes using a manually-operated bucket auger. Samples were collected at 30-40 cm below the soil-floor interface and at approximately 50 cm intervals below that depth.
5. A gamma scintillation detector was lowered into each hole and count rates noted at various depths to determine the radiation profile.
6. Soil samples were returned to Oak Ridge, Tennessee, for analysis of Co-60 concentrations.

Storch Engineering provided ORAU with soil samples, collected November 4-8, 1983, from four boreholes drilled outside the north and west walls of the irradiator building (refer to Figure 2). ORAU analyzed these samples for Co-60 content.

The concentrations of Co-60 measured in samples from beneath the building floor are presented in Table 1. The highest concentration was 3850 pCi/g from 5-15 cm deep at core location 5 along the west wall. (This location corresponds to the area of maximum direct radiation identified by the scans.) In the 0-5 cm depth sample from this location, the concentration was 3760 pCi/g. The highest concentration along the north wall was 716 pCi/g at the subfloor soil surface in core hole 9. Concentrations decreased with depth at each of the core locations along the north and west walls, with the exception of location 8. At this location, which, according to direct measurements, was outside the region of contamination, the concentration was a maximum of 7.58 pCi/g at 80-90 cm deep - the depth of the building footer. It is suspected that contaminated water reached this location by flowing along the footer from areas of higher contamination along the west wall.

At core locations 1 and 2, along the east and south walls, no significant Co-60 concentrations were measured. Location 3 contained only a slightly elevated concentration of 1.46 pCi/g, immediately below the flooring. Concentrations of Co-60 at core location 4 did not follow the depth distribution pattern observed at other locations. In this hole the concentration decreased from 20.7 pCi/g at 0-15 cm to 5.62 pCi/g at 80-90 cm, then increased to 48.2 pCi/g at 180-190 cm. Further sampling was not possible at this and several other locations because of debris or large rocks

Concentrations of Co-60 in samples from outside boreholes are presented in Table 2. The soil from boreholes B1 and B2, north of the building did not contain elevated Co-60 levels. Borehole B4 has an elevated level of 6.33 pCi/g on the surface; at 0.6-1.2 and 1.8-2.4 m the concentrations are 1.73 and 1.76 pCi/g, respectively. Borehole B3 provided the only subsurface sample containing a high concentration of Co-60. In this borehole the sample from 0.6-1.2 m contained 274 pCi/g. Samples from above and below that depth were considerably lower, i.e. 2.27 and 4.72 pCi/g. This is consistent with the results of direct measurements in this borehole that indicated a high gamma intensity at approximately 1 m below the ground surface.

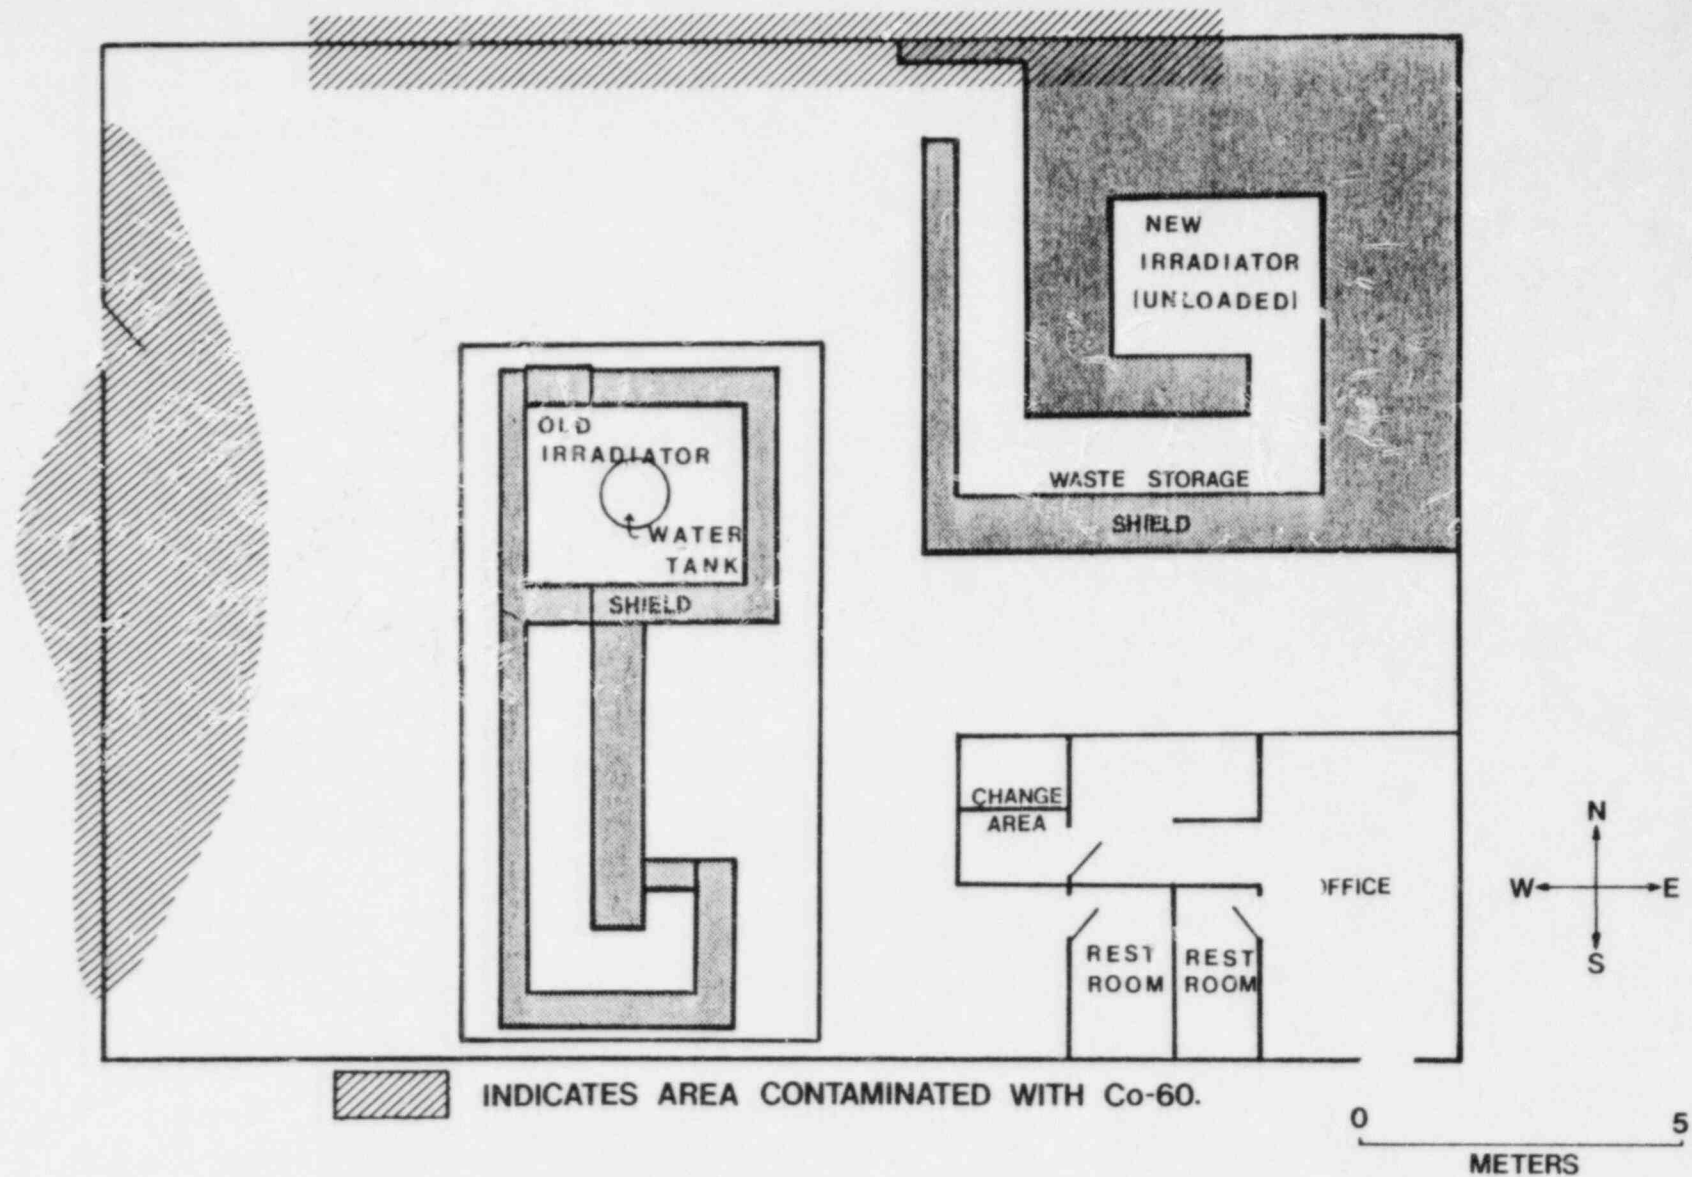
FIGURE 3. Floor Plan of the Irradiator Building, Indicating Areas of Subfloor and Outside Soil Contamination.

The results of direct measurements and sample analysis performed in connection with this survey confirm that Co-60 contamination is present beneath the building floor and adjacent to the building along the west and north walls. The estimated distribution of contamination is shown on Figure 3. This distribution is consistent with the available information regarding the water release incident and indicates that the water carried the contamination through cracks at the wall/floor joint. After reaching the floor/soil interface it probably followed the path of least resistance, flowing into depressions and voids beneath the floor and along the foundation. A small amount of leakage to the outside through wall mortar joints also apparently occurred. A larger than usual leakage path may explain the high concentration of Co-60 at about 1 m deep in borehole B3 along the west wall. The depth distribution of the contamination inside the facility suggests that the radionuclide is in a relatively insoluble form.

The distribution of contamination at coring location 4 is inconsistent with the pattern observed at other locations. One possible explanation may be the presence of additional leakage paths within the irradiator facility, i.e. other floor joints and stress cracks or around the water tank. If additional paths exist, substantially larger subfloor areas may be contaminated. Removal of the sources and dismantling of the irradiator shield will be required before such a determination can be made.
