Subject: Final Report - DER 83-51
A 50.55(e) Reportable Condition Relating to Unit 1 Auxiliary
Feedwater Pump Failed To Meet Requirements of Hot Functional
Tests.
File: 84-019-026; D.4.33.2

FINAL REPORT - DER 83-51
DEFICIENCY EVALUATION REPORT 50.55(e)
ARIZONA PUBLIC SERVICE COMPANY (APS)
PVNGS UNIT 1

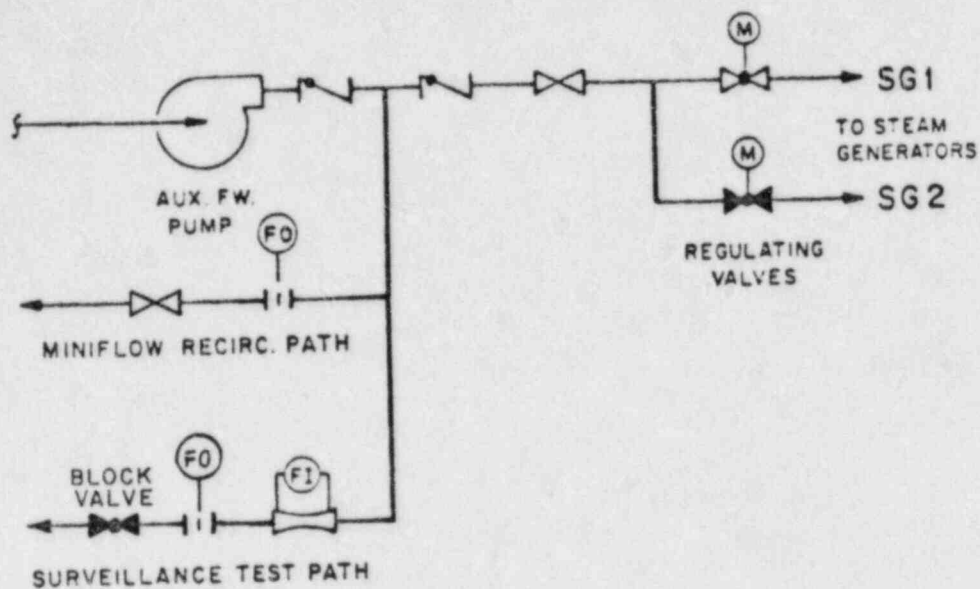
ORIGINAL TEST CONFIGURATION

Further investigation revealed that the root cause of the deficiency was that the surveillance test path block valve 1PAFAV018 was leaking. This condition is noted on NCR SM2961. As a result of the leaking block valve, the flow to the steam generator was reduced.

Investigation of the leaking block valve indicated that the valve leakage was common to both the "A" train and "B" train block valves. Even though the valves were not designed for flow modulation, they had to be throttled to obtain the required flow rates during surveillance testing. The valves did not withstand the conditions that resulted from throttling and as a result, were damaged and leaked. The subject valves were designed for use as isolating valves. As such, the installation of these valves in the surveillance path is a case of misapplication and incorrect installation.

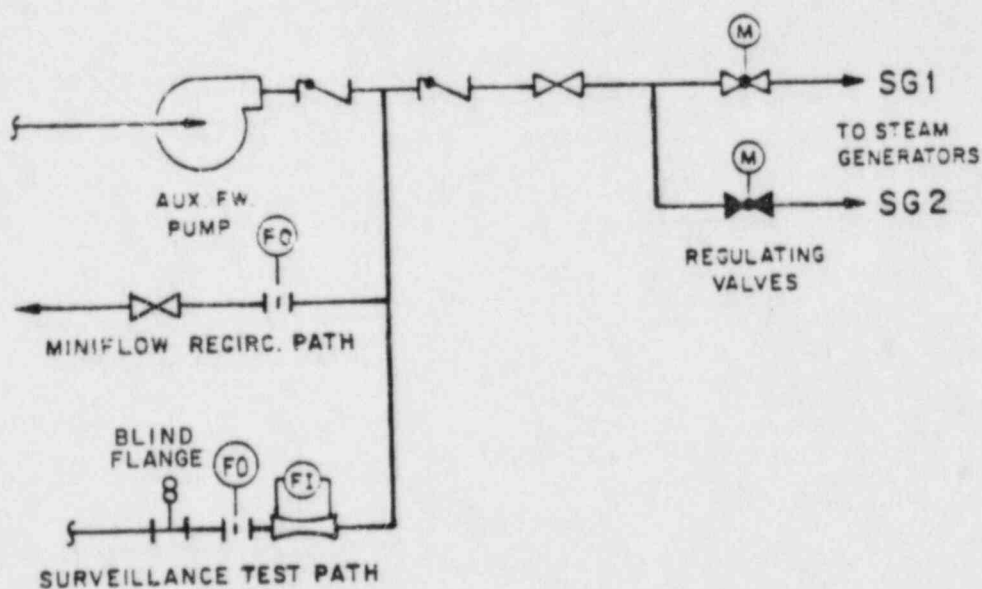
REVISED TEST CONFIGURATION

The surveillance test path was provided to perform full flow, periodic testing of the pump. However, there are no requirements for a full flow surveillance test loop in the ASME Codes and the technical specifications. The overall system operability is demonstrated at 18-month intervals by directly pumping to the steam generators. Therefore a spectacle blind flange was installed in the surveillance path and the block valves were removed. The pump was tested again in the same configuration as before except for the addition of the spectacle blind flange to eliminate the leak path as shown in the attached sketch. Evaluation of the test data indicates that the pump can deliver the required flow at rated head.

DCPs 1SM-AF-062, 2SM-AF-062, and 3CM-AF-062 have been issued to eliminate the surveillance path by removing the block valves and adding a spectacle blind flange. SARCEN 1165 has been issued to delete reference to the surveillance flow path from the FSAR. These DCPs will be implemented prior to fuel load in each unit.
