## LICENSEE EVENT REPORT (LER)

FACILITY NAME (1)  
Susquehanna Steam Electric Station - Unit 2DOCKET NUMBER (2)  
0 5 0 0 0 3 8 8 1 OF 0 3TITLE (4)  
Power Load Unbalance, Reactor Scram.EVENT DATE (5)  
MONTH DAY YEAR  
0 9 0 8 8 4 8 4  
LER NUMBER (6)  
YEAR SEQUENTIAL NUMBER REVISION NUMBER  
8 4 - 0 1 8 - 0 0  
REPORT DATE (7)  
MONTH DAY YEAR  
1 0 0 8 8 4  
OTHER FACILITIES INVOLVED (8)  
FACILITY NAMES  
DOCKET NUMBER(S)  
0 5 0 0 0 0 0 0 0 0 0 0OPERATING MODE (9)  
1  
THIS REPORT IS SUBMITTED PURSUANT TO THE REQUIREMENTS OF 10 CFR 8: (Check one or more of the following) (11)

SUSQUEHANNA STEAM ELECTRIC STATION  
LICENSEE EVENT REPORT 84-018-00  
ER 100450 FILE 841-23  
PLA-2333

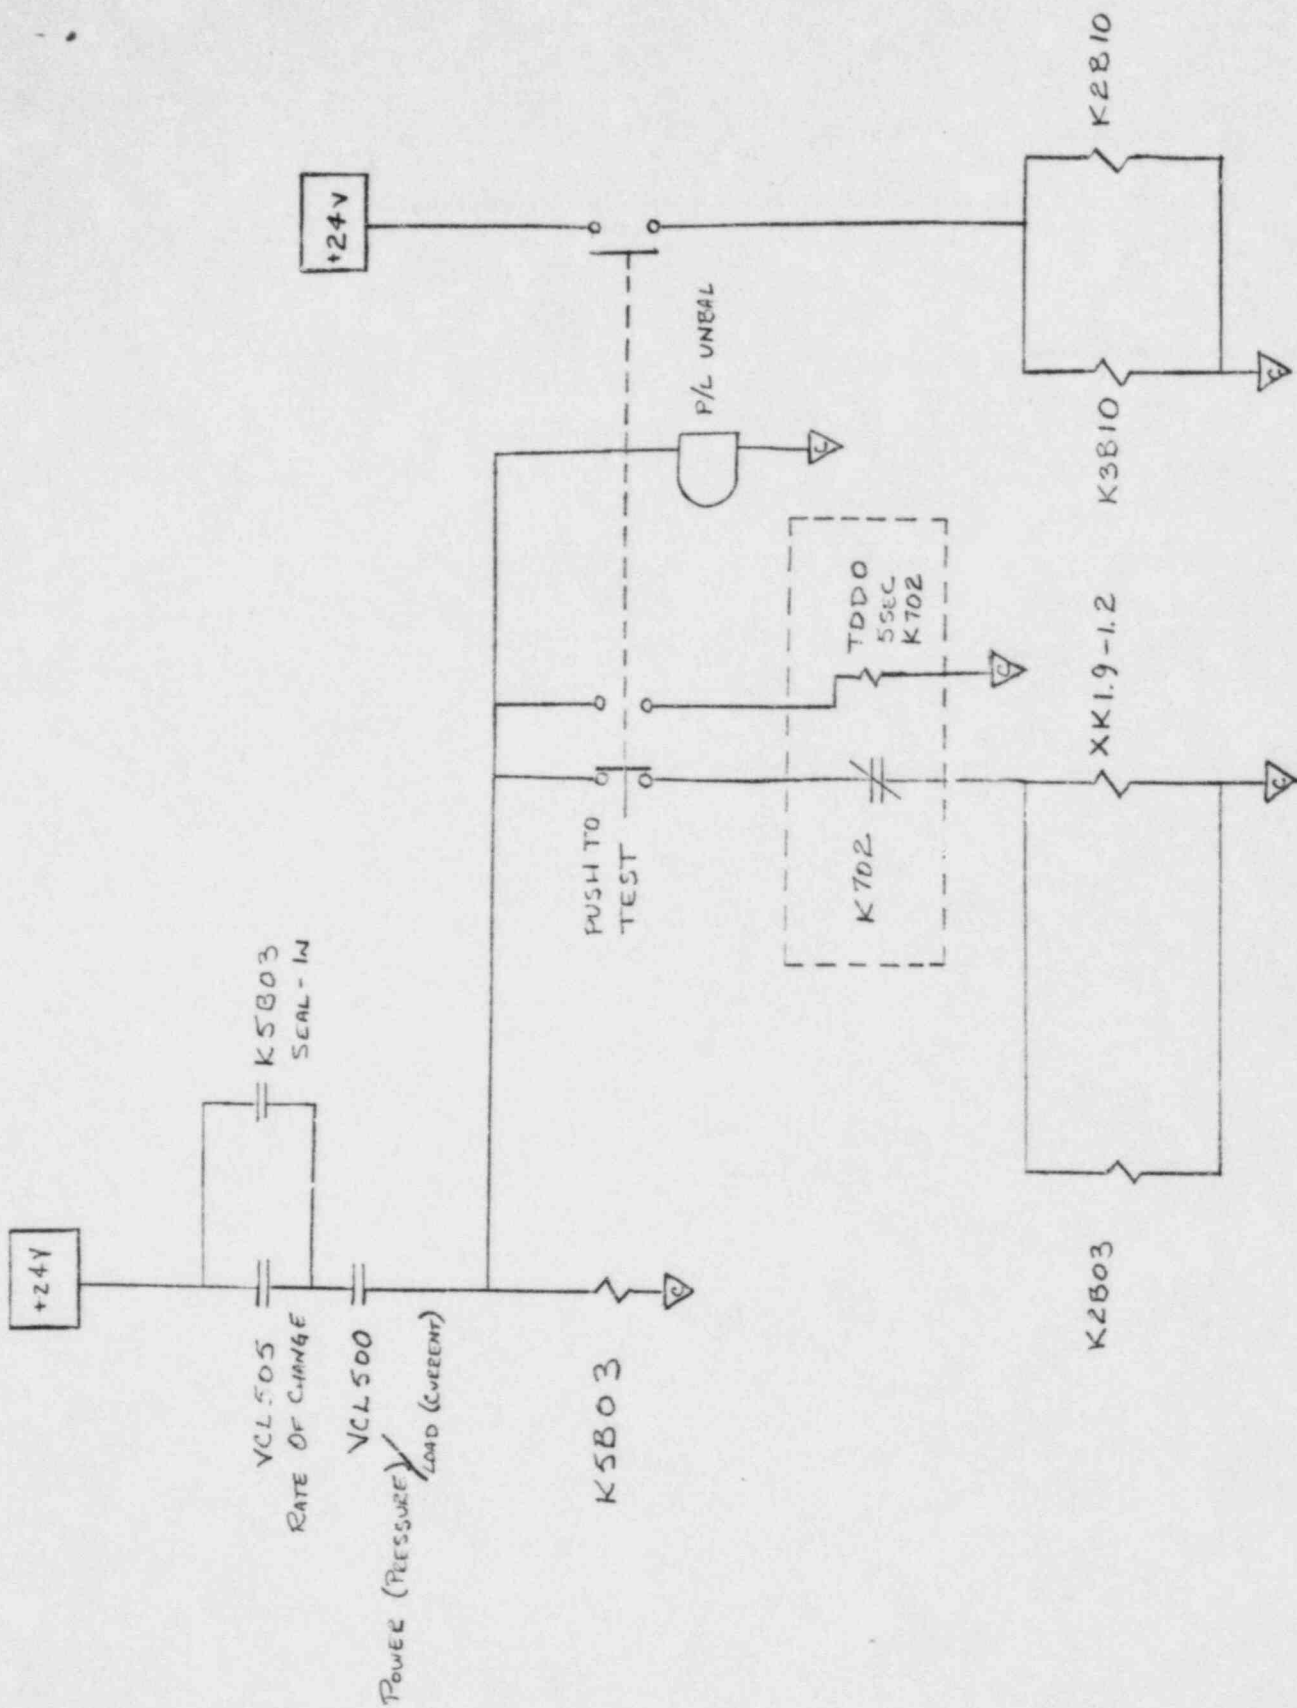
SIMPLIFIED RATE SENSITIVE POWER LOAD UNBALANCE CIRCUIT AND RELAYS

The Turbine Control Valve Fast Closure and resultant reactor scram was caused by a "Zero Shift" of Pressure Transmitter PT-20107. The Pressure Transmitter which senses the cross-around steam pressure to the "A" moisture/separator and inputs a signal to the rate sensitive power/load unbalance (PLU) circuit has a two fold purpose: 1) to initiate control valve fast closure action under load rejection conditions that might lead to a rapid acceleration and subsequent over-speed of the unit, and 2) to prevent any valve action under stable fault conditions which are self clearing within a reasonable amount of time.

At this point, a discussion of the PLU test would be helpful to the remainder of this report. Refer as necessary to the schematic (attached). During the PLU test, the PLU PUSH-TO-TEST pushbutton is depressed. This action: 1) Inhibits the Fast Closure Relays (X2B03, XK19-1.2), 2) Energizes the Time Delay Relay (K702), and 3) energizes Relays (K3B10, K2B10) which ground the generator current signals to the rate sensitive power load unbalance circuit. With pushbutton depressed and the turbine load greater than 40% (a prerequisite), the two conditions to simulate a load rejection are present: 1) power (cross-around steam pressure) more than 40% greater than load (generator output current), and 2) a change in generator current output equal to 0-100% rated occurring within 39 msec, are satisfied which results in: 1) the Power (pressure)/Load (current) Relay VCL500 contacts close, and 2) the rate of Change Relay VCL505 contacts close.

Since these relays are in series the closure of the contacts results in the test pushbutton light illuminating and energizes Relay K5B03 which seals in the rate function.

To restore the circuit, the PLU Push-To-Test pushbutton is released and the following actions occur: 1) The relays grounding the current input signal are deenergized restoring the signal, and 2) the time delay relay (time delay drop out) is deenergized and a 5 second time delay begins.

The restoration of current input signal to the rate sensitive power/load unbalance circuit resets the voltage comparators. This clears the power/load function and deenergizes its relay. When the relay contacts open: 1) the indicator lamp is extinguished, and 2) relay K5B03 is deenergized removing the seal in on the rate change function. The valve fast closure relays are enabled after, the 5 second delay.

During the performance of OP-293-002 on 9/8/84, the power/load function did not clear. Therefore, when the valve fast closure relays were enabled the circuit was in the tripped condition. The test was performed at approximately 45% load. Because of the "zero shift" previously described, PT-20107 would have an output which appeared to the PLU circuit as greater than 100%. Thus, the power/load mismatch appeared to be at least 55% ( $\geq 100-45$ ). When the pushbutton was released, the power/load function was in and the rate change function seal in was maintained. This maintained the circuit in the tripped condition, which resulted in the Turbine Control Valve Fast Closure. The unit responded per design through out the transient. The Reactor Recirculation Pumps tripped as per design on the end of cycle-recirculation pump trip.

To correct the problem Pressure Transmitter PT-20107 was recalibrated as documented on WA V47786. The sensing lines for the instrument were inspected and no evidence of damage was found.

A note was added to OP-293-002 (currently under revision) to prevent recurrence.

NOTE: If the Power-Load Unbalance Push to Test button light does not de-energize within 3 seconds after the Power-Load Unbalance Push to Test pushbutton is released, depress and hold the Power-Load Unbalance Push to Test pushbutton to avoid a Turbine Trip. Maintain the pushbutton depressed until the problem is corrected.
