NYN-95081

Subject: Relief Request From ASME Code Section XI Requirements

ENCLOSURE TO NYN-95081

SEABROOK STATION
FORM FOR RELIEF REQUEST FROM ASME SECTION XI REQUIREMENTS

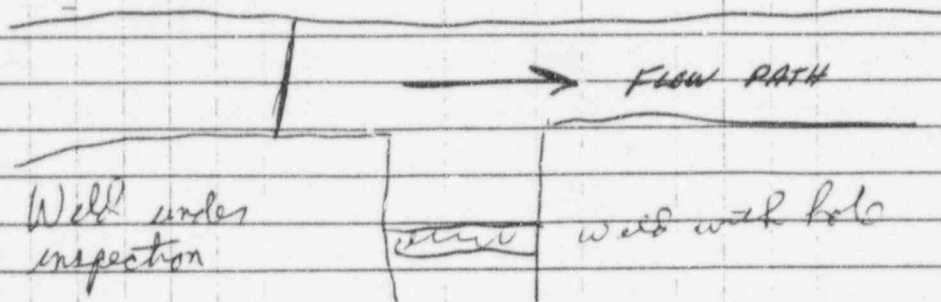
Scan show low point as .407 on pipe
and .548 on weld. Set is 7.600
No deterioration found

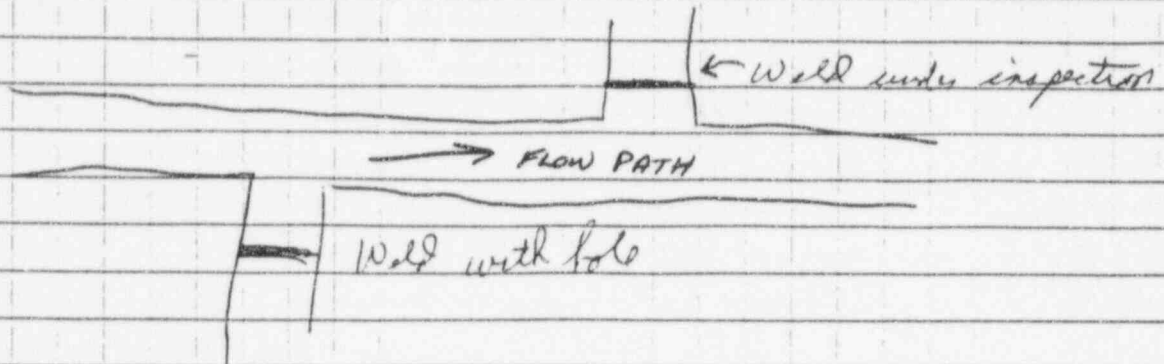
LOCATION 1802-1001 SYSTEM SW WORK REQUEST _____

General area lowest points

Pipe .362

Weld .313

tee \approx .500

No deformation found

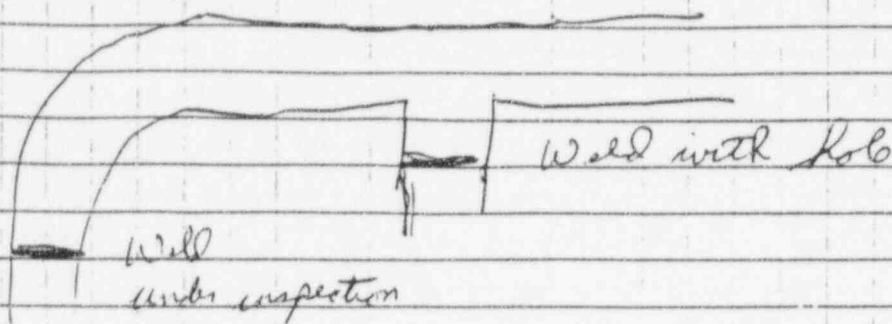
LOCATION 1802-FO301SYSTEM SLD

General area scan is
 elbows .330
 weld .290

No deformation noted

Subsurface indication interfering with UT
 yield found reading is .097.
 Indication most likely due to lack of
 fusion Area ~ 1 1/2" location is
 on upper elbow lower joint outside
 radius
