TMI-1 REACTOR COOLANT PUMP SHAFT FAILURE ANALYSIS

TMI-1 REACTOR COOLANT PUMP SHAFT
FAILURE ANALYSIS

Lynchburg Research Center Report
RDD:84:5183-06:01

August 1984

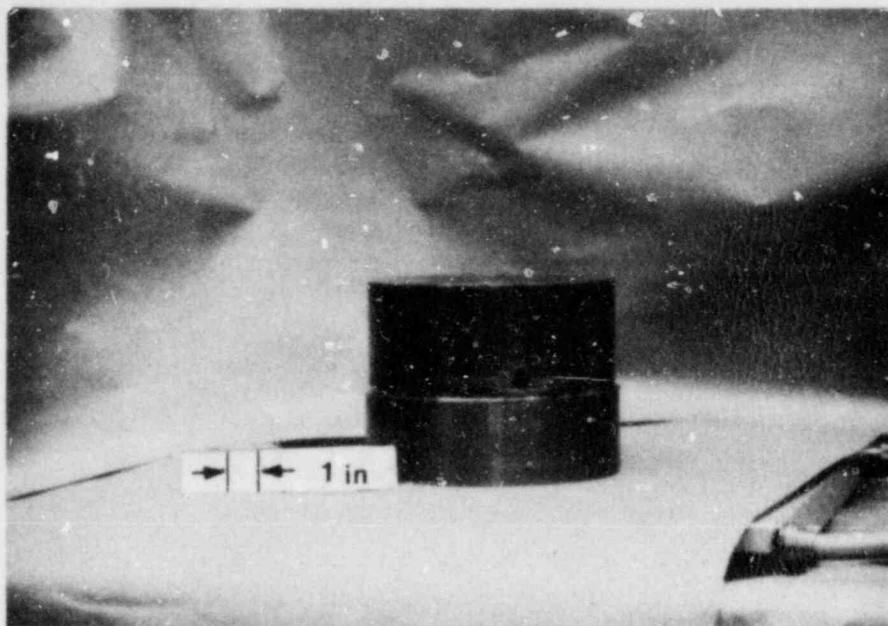
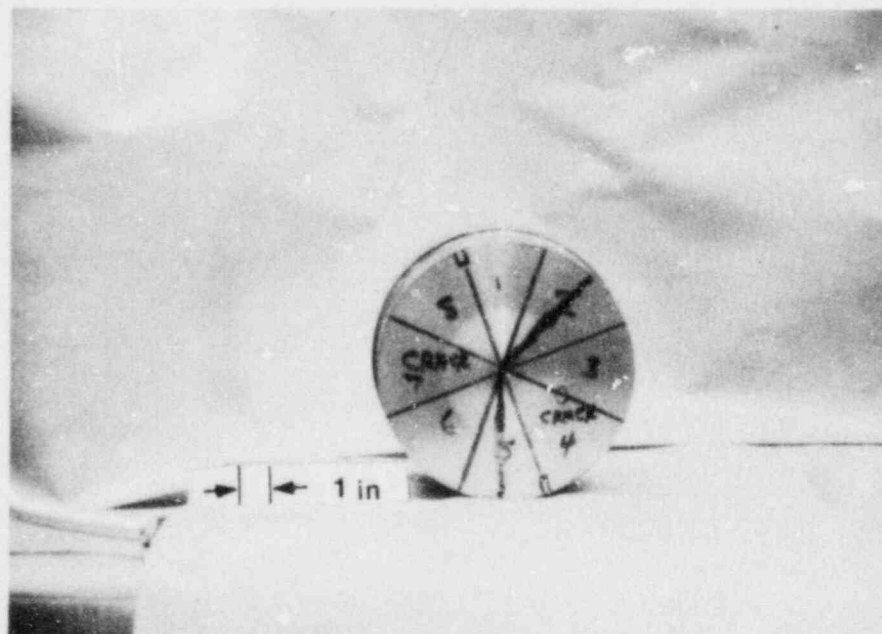
Figure 3.1-1. Reduced Magnification View of Pump Shaft
Section Containing Crack at Pin Hole in A;
B Shows Orientation Markings

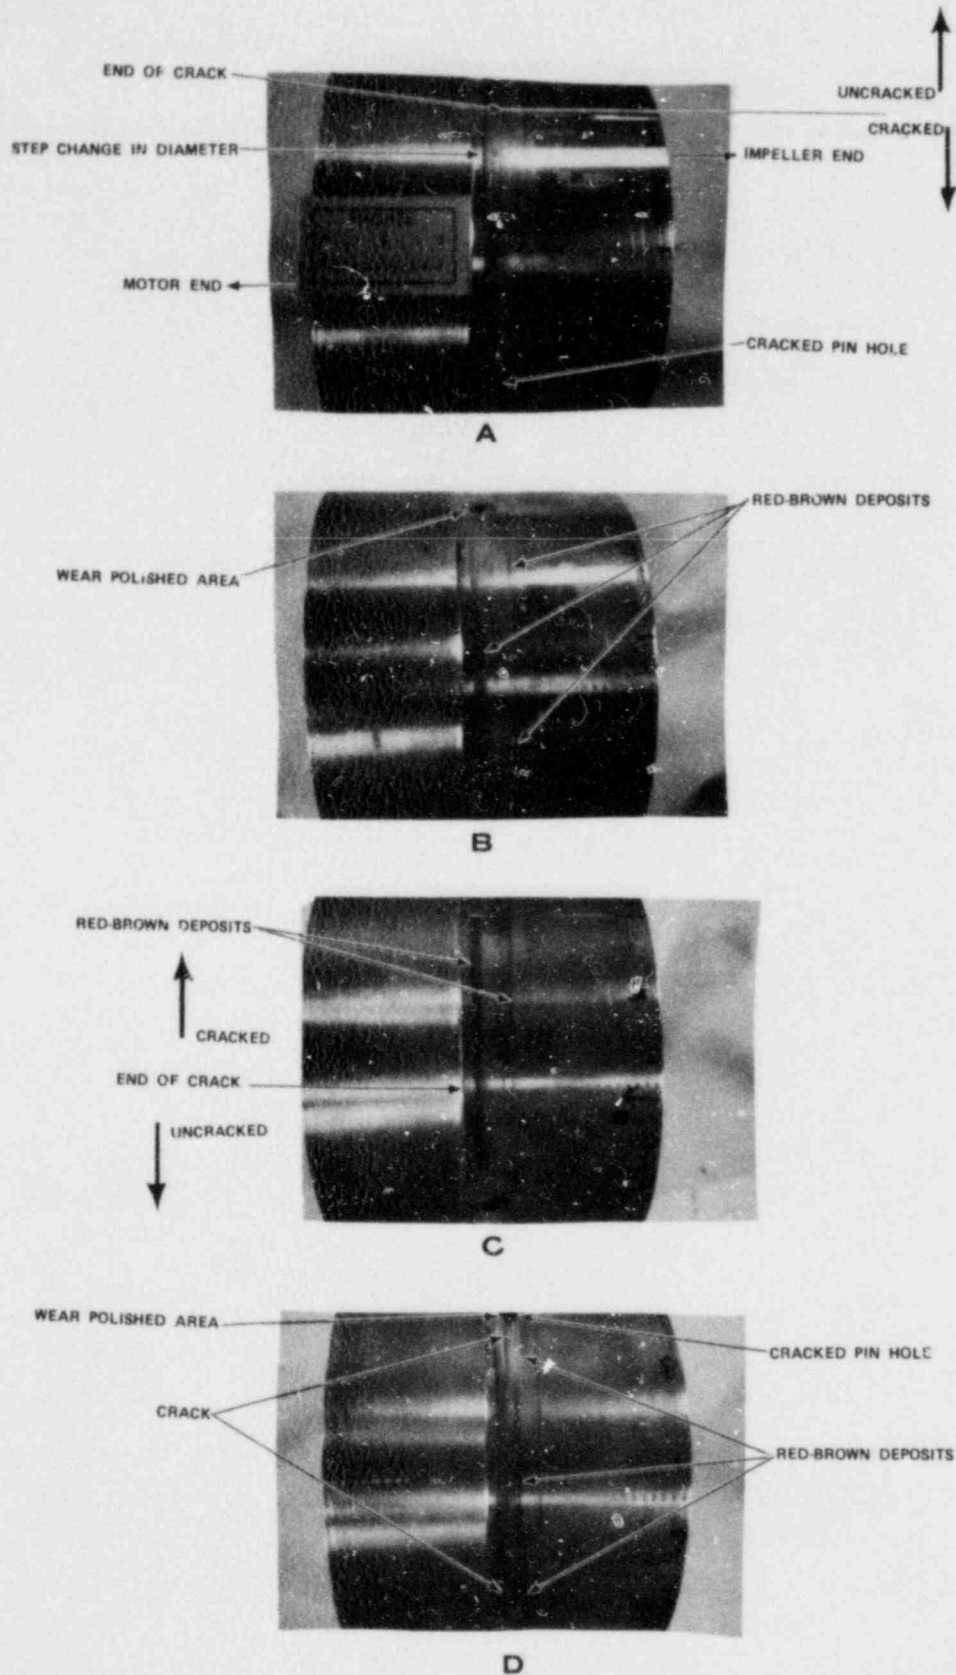
Figure 3.1-2. Reduced Magnification Views of Pump Shaft;
Rolled Down the Page From A to D

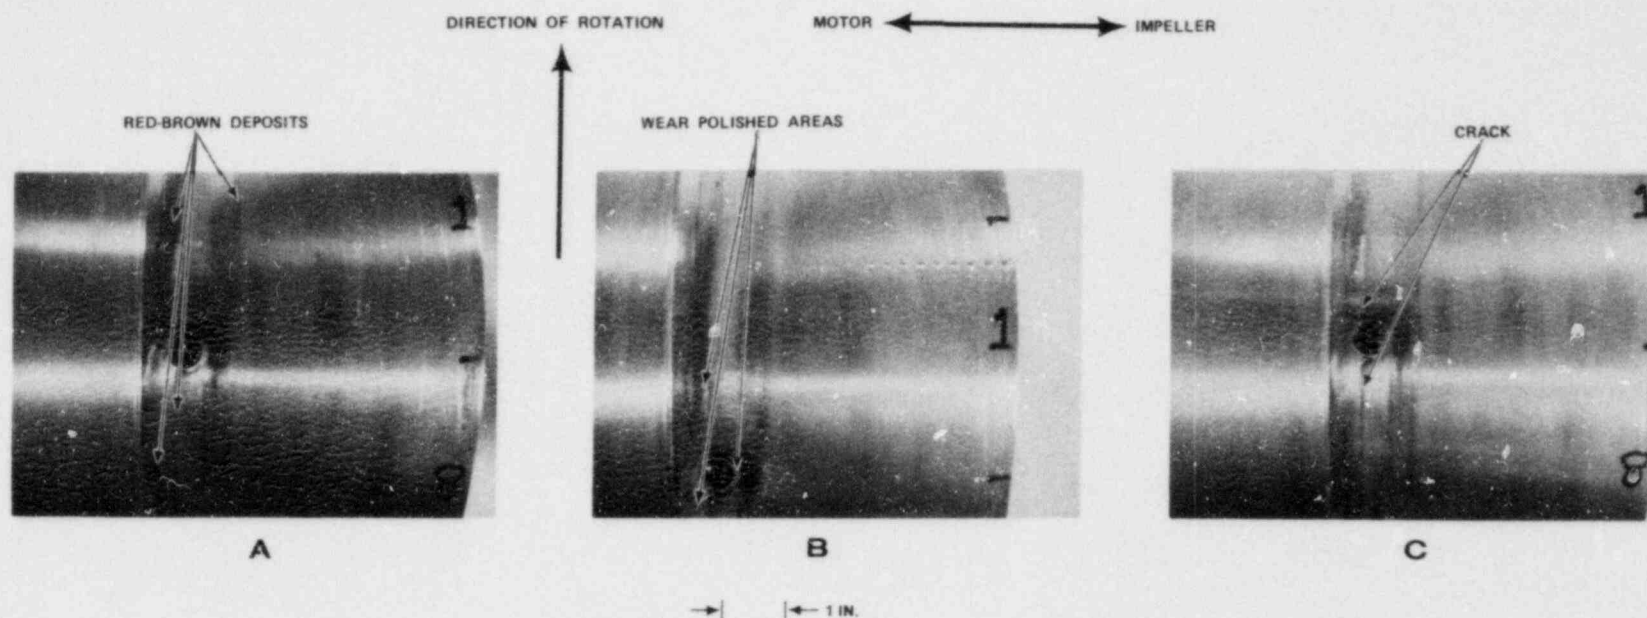
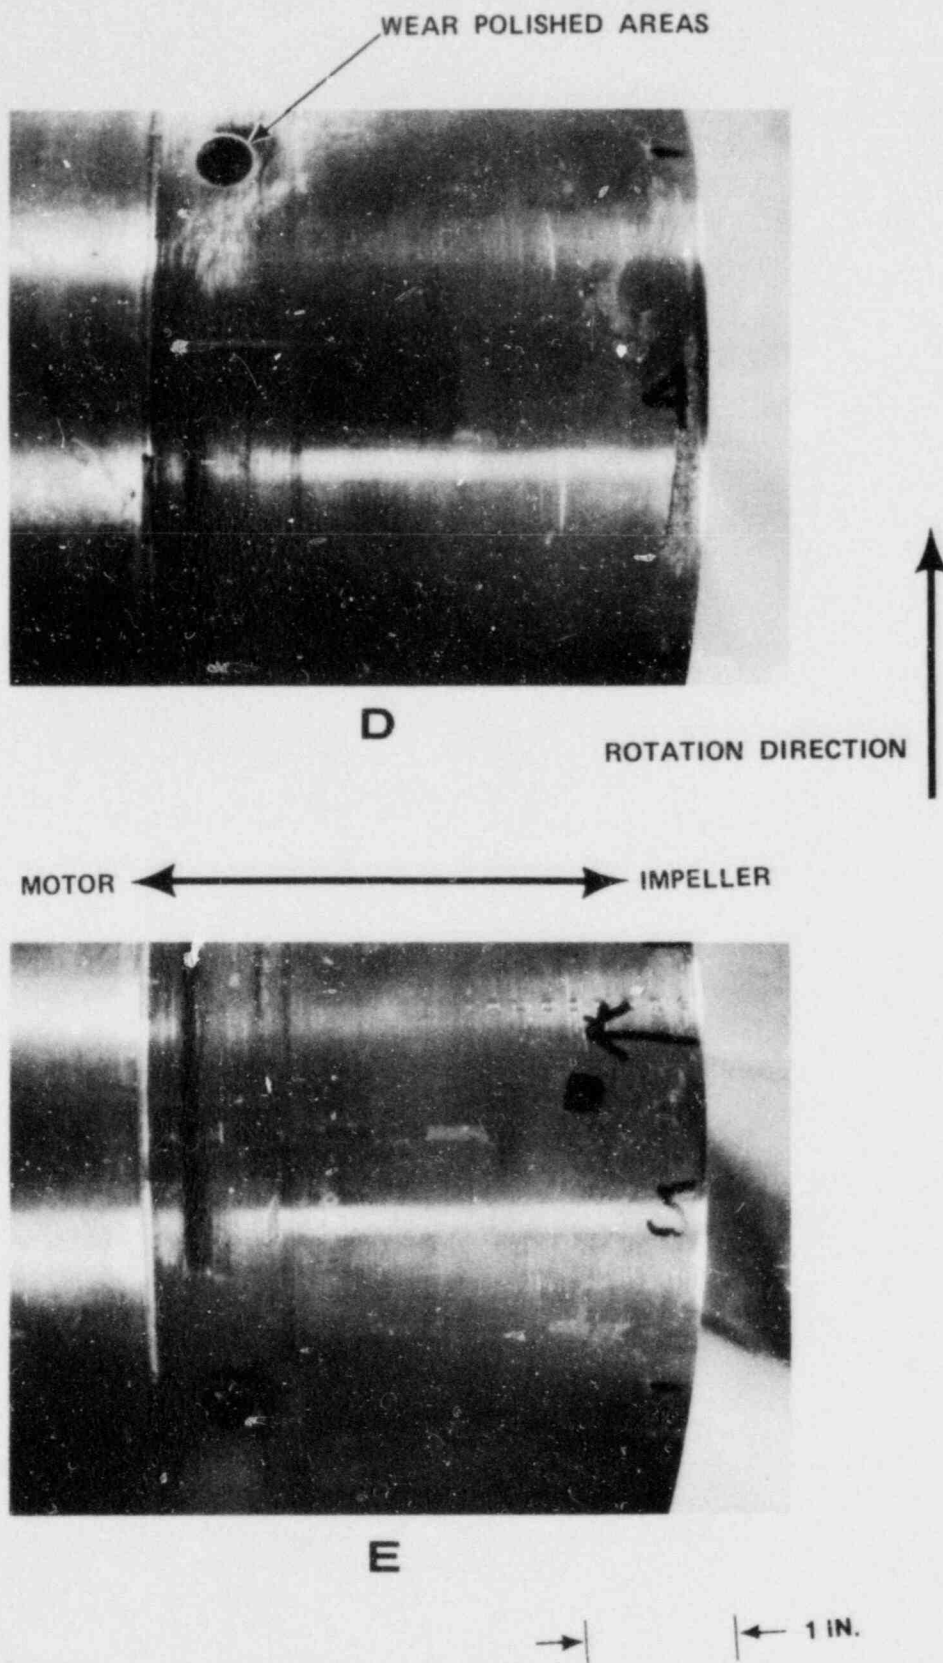
Figure 3.1-3. Enlarged Views of Pin Holes. A, B, and C Shot at Different Angles or Different Illumination at Cracked Pin Hole. D and E Shot at Uncracked Pin Hole

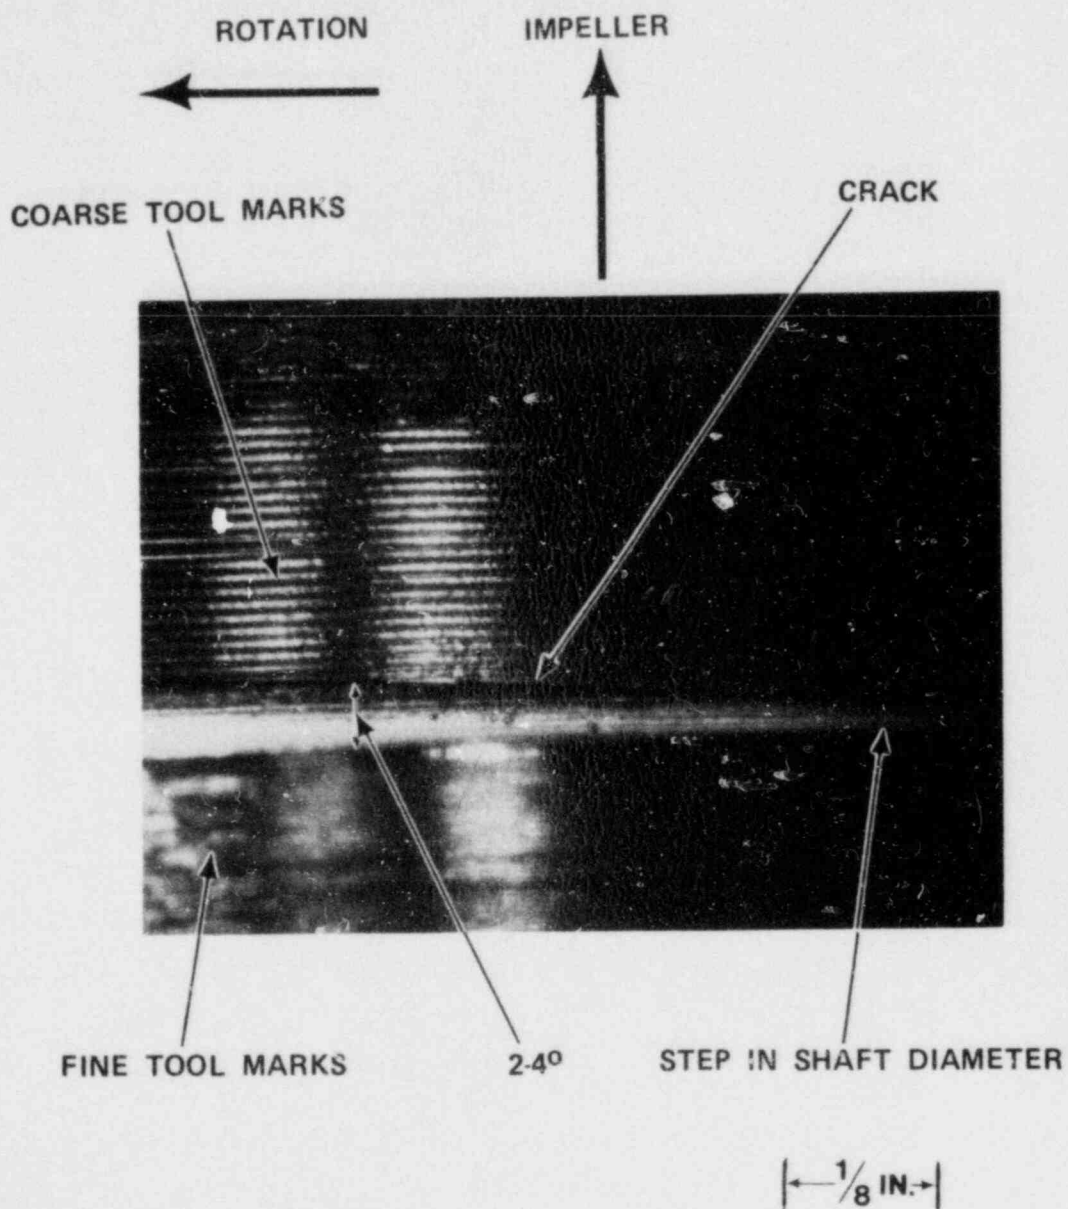
Figure 3.1-4. Angle of Crack to Shaft
Circumferential Direction

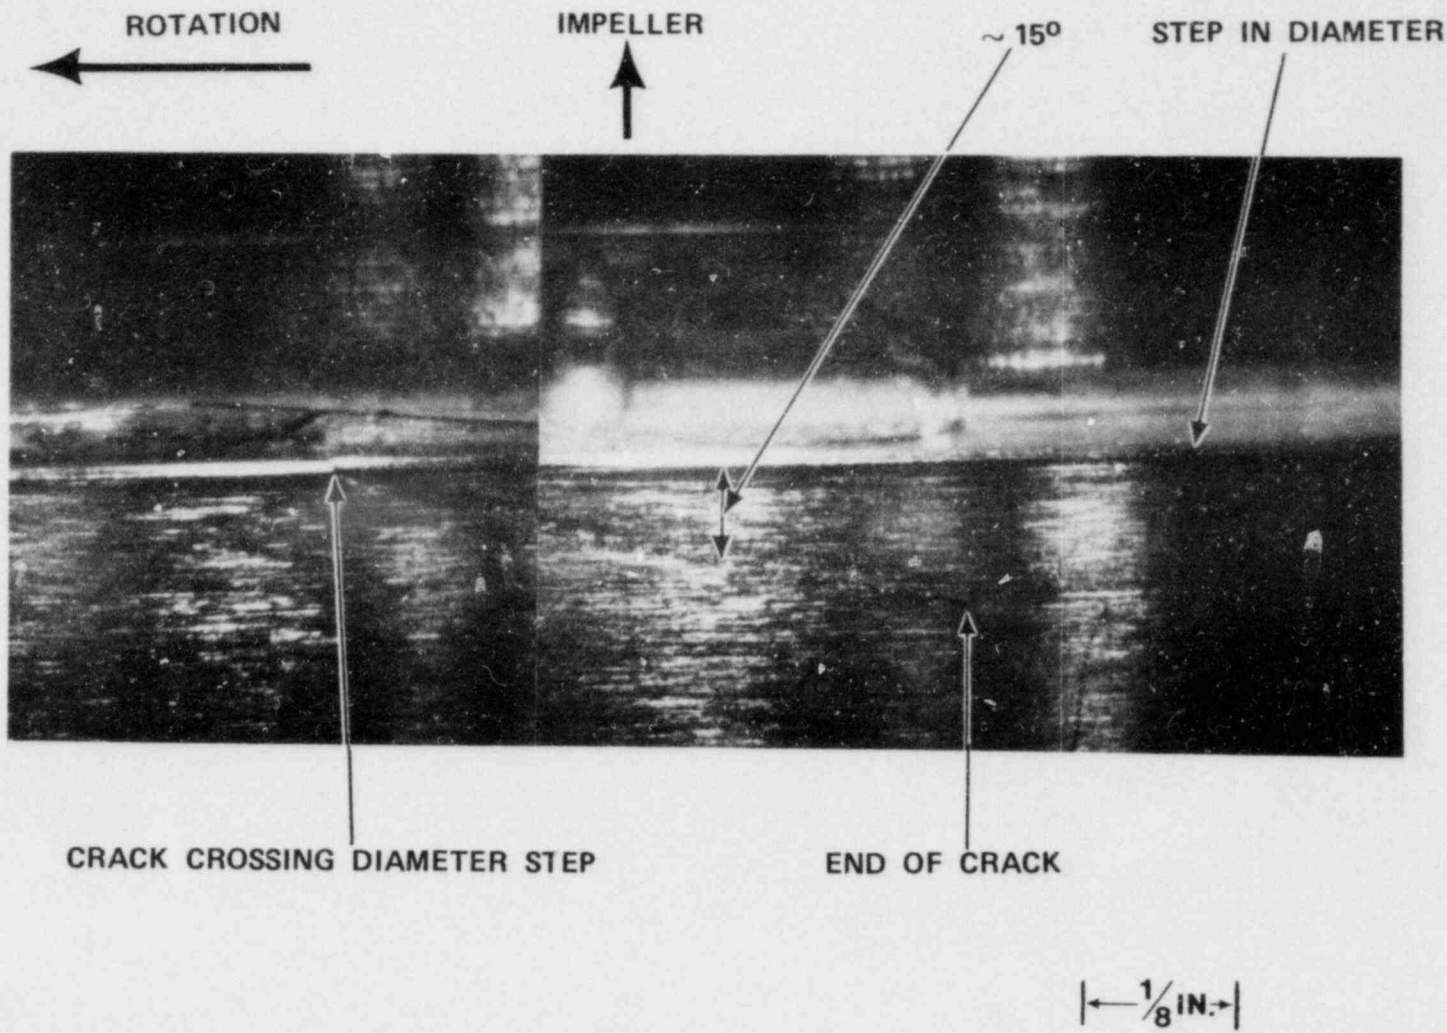
Figure 3.1-5. End of Crack at Surface in Octant 5

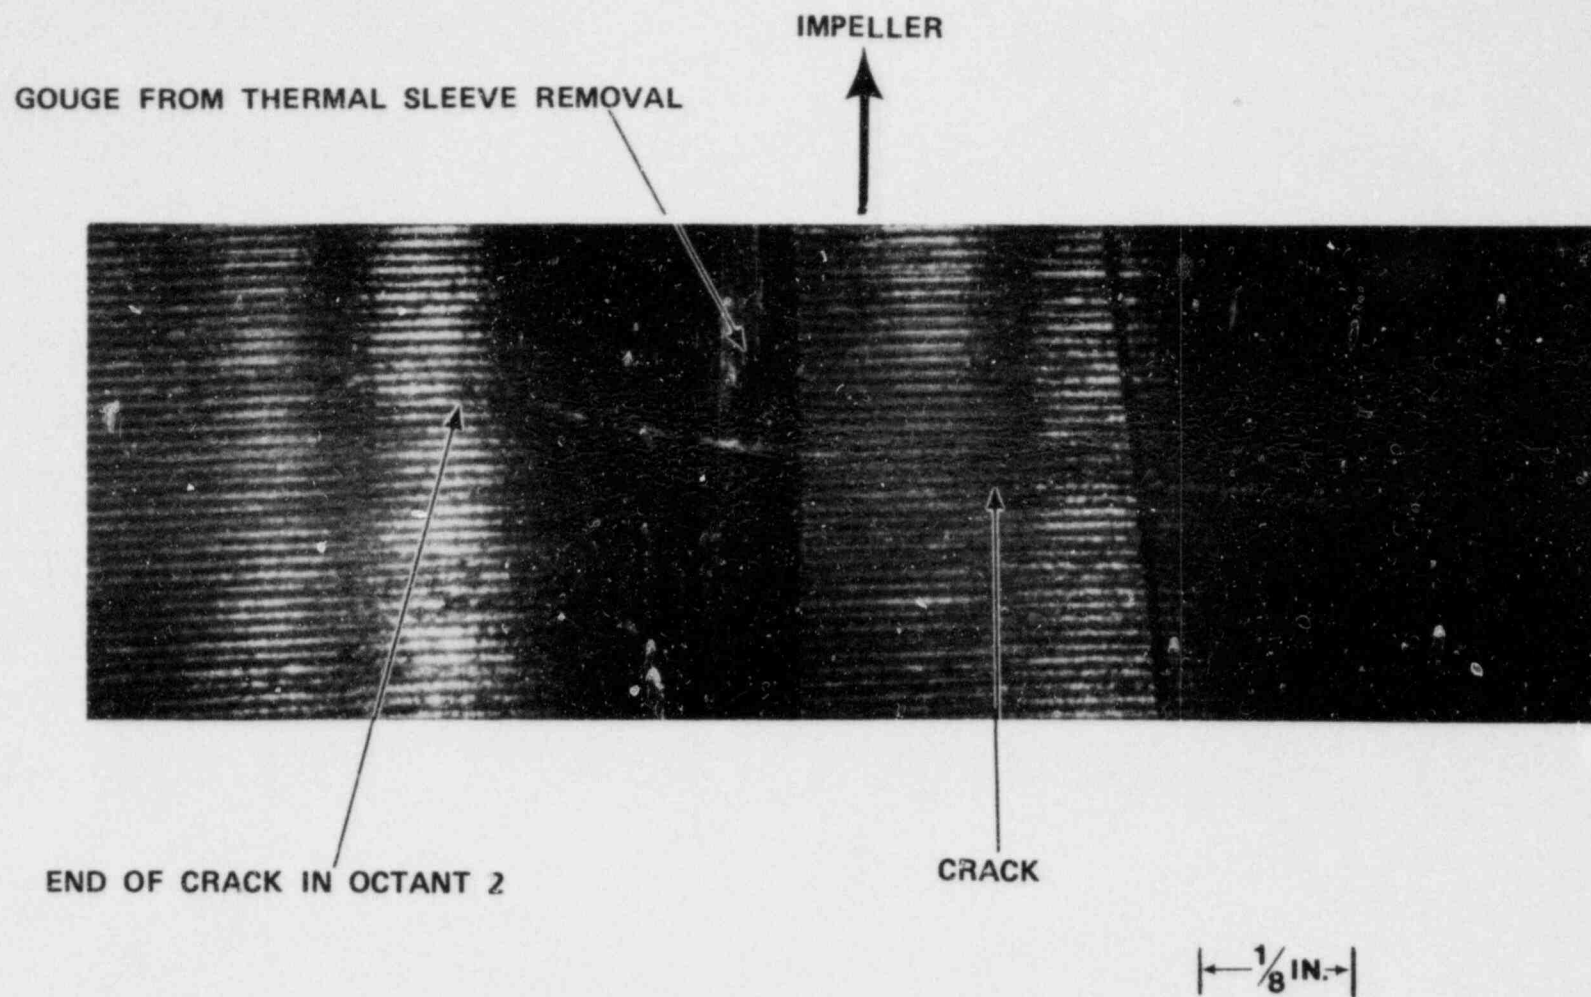
Figure 3.1-6. End of Crack at Surface in Octant 2

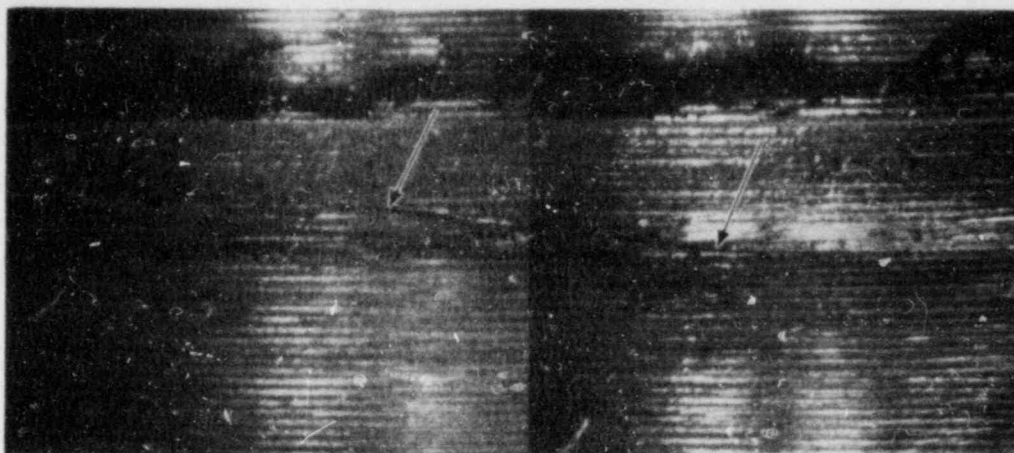
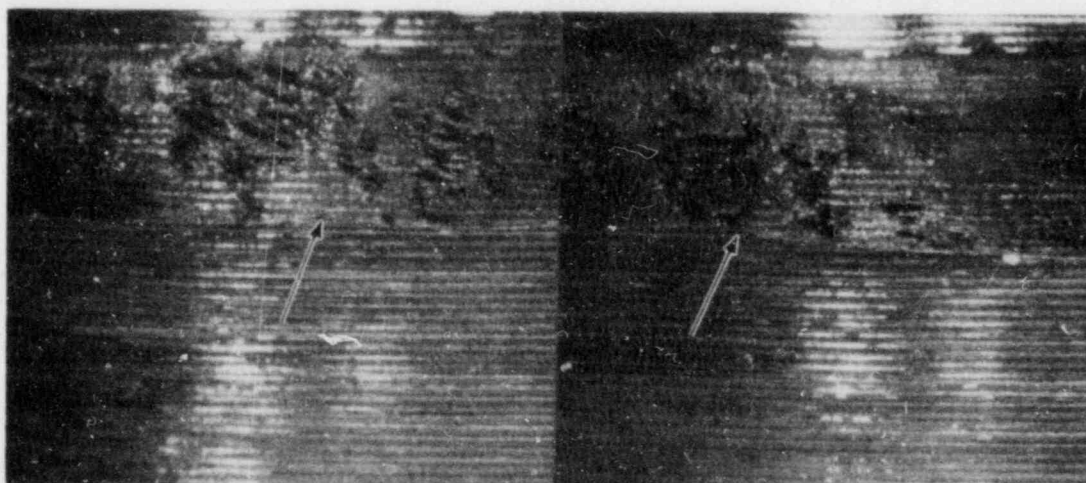
The sharp changes in crack path noted suggest that changes in stress state on fracture mode were occurring in these areas. The sharp change at the extremes of the crack are in the directions expected for entering shear overload. The general orientation of the crack path suggests a predominantly axial stress is driving crack growth. However, the slight pitch of the crack path indicates that a small torsional stress may also be influencing crack growth direction.

Figure 3.1-7. Local Change in Crack Path Direction at
Arrows A in Octant 8, B in Octant 1

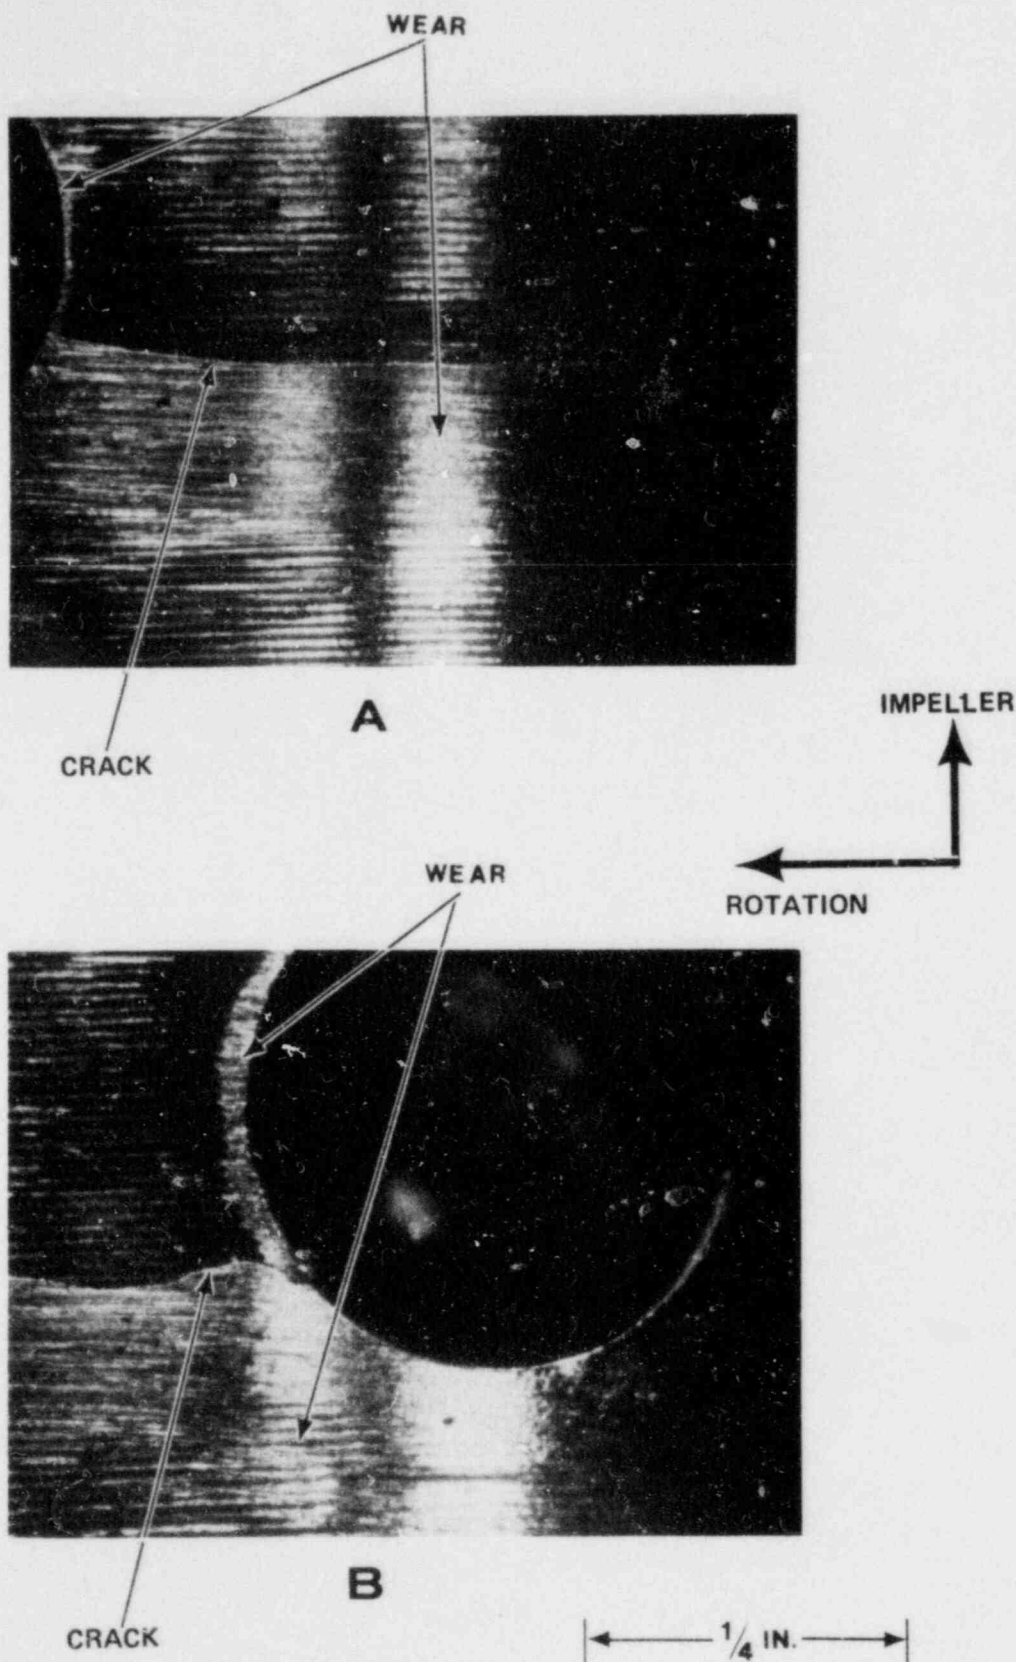
Figure 3.1-8. Change in Crack Path Near Pin Hole
A. Octant 8 Side of Pin Hole
B. Octant 1 Side of Pin Hole

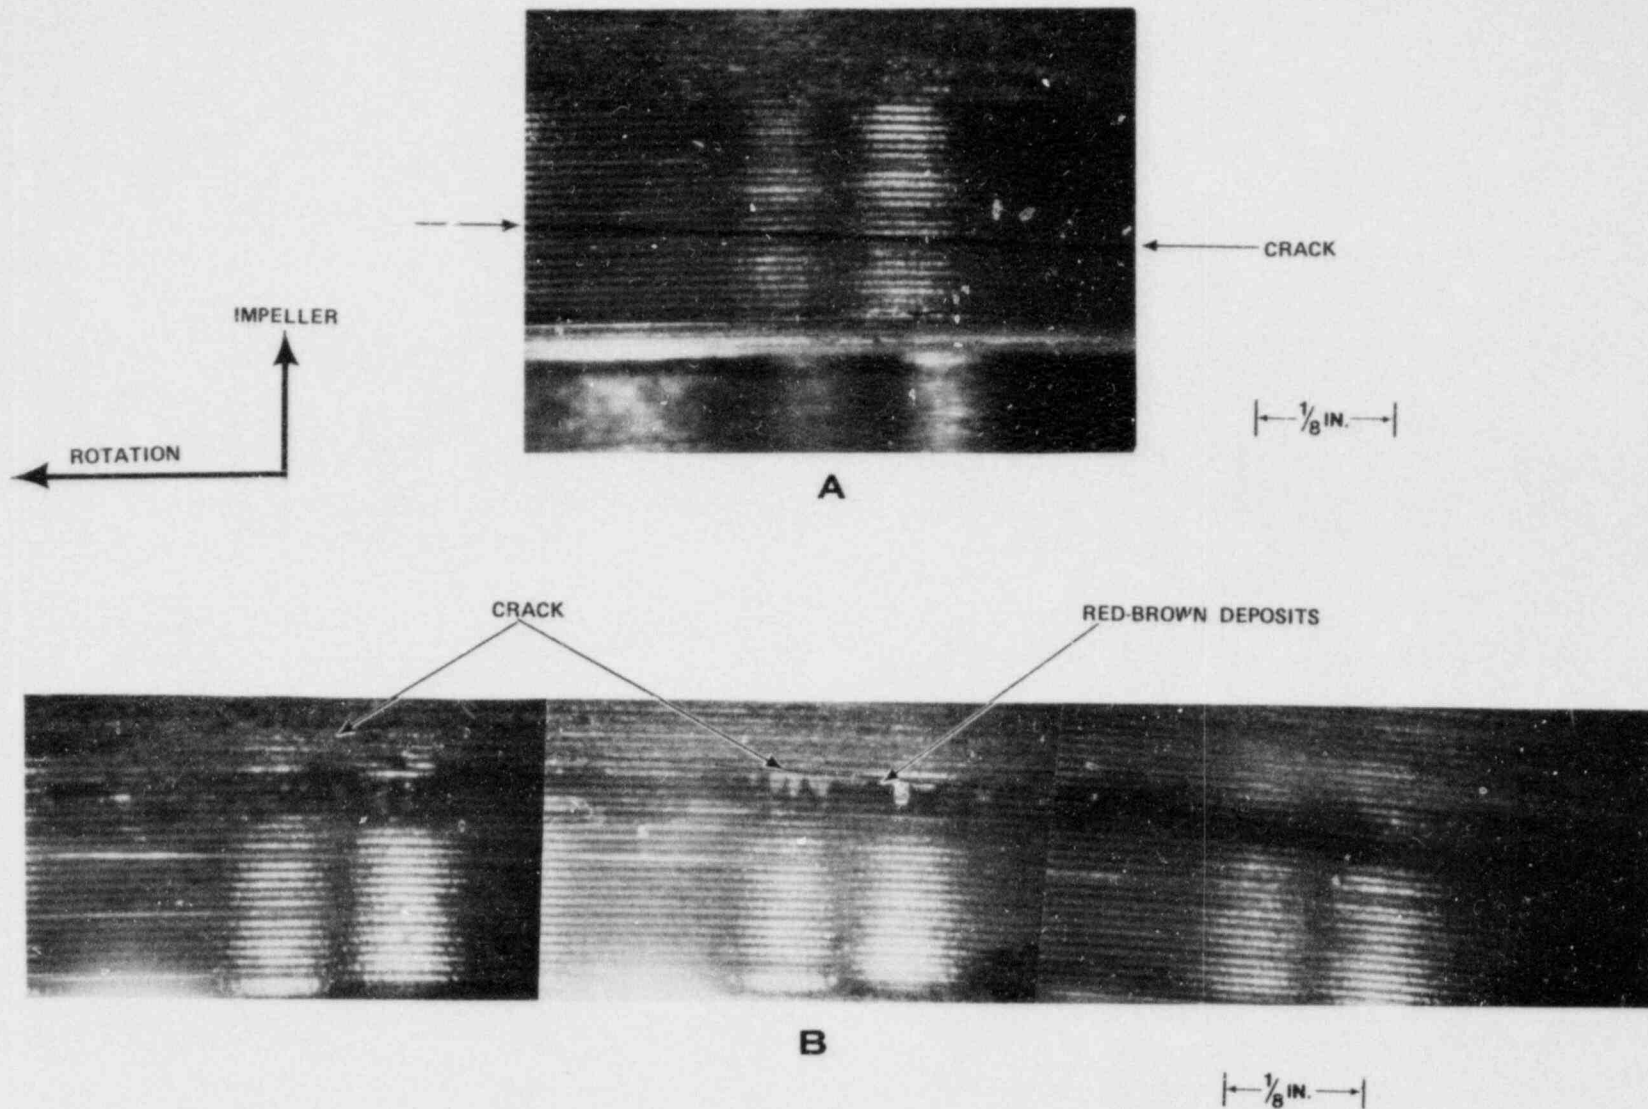
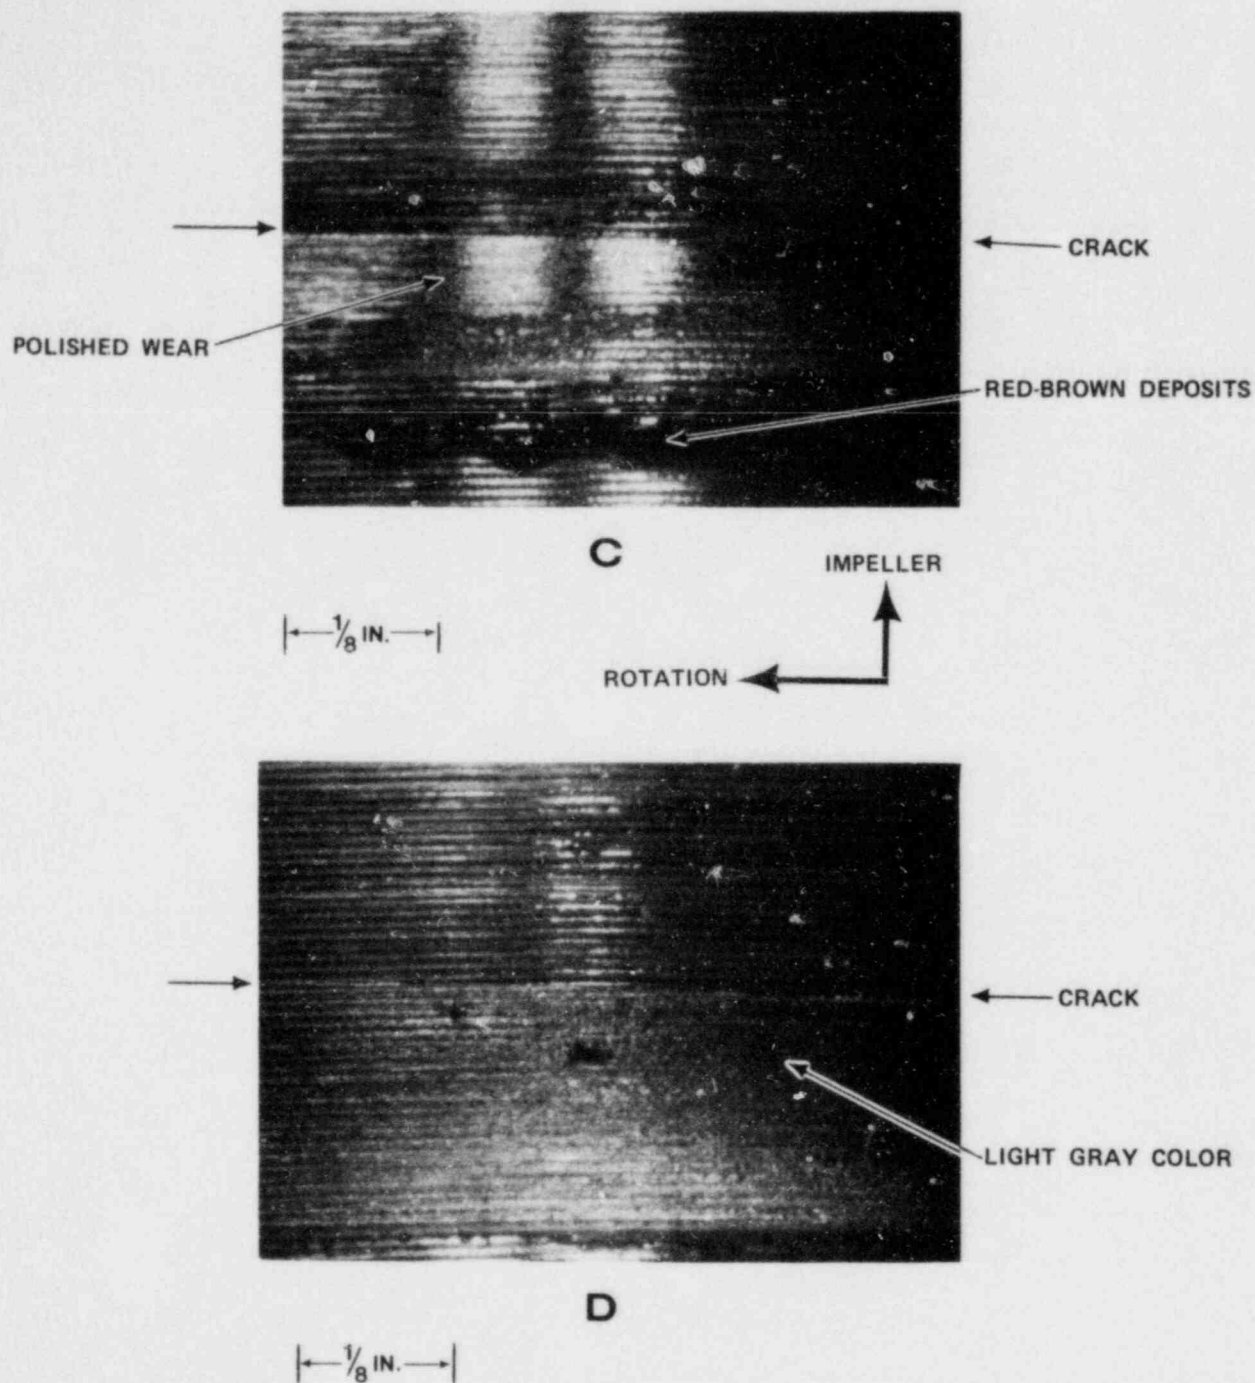
Figure 3.1-9. Surface Appearance of Shaft Near Crack
A. Unworn and Un-corroded Area With Crack
B. Crack Passing Through Spalled Deposits

C. Polished Wear Area Next to Crack

D. Gray Deposit Area Adjacent to Crack

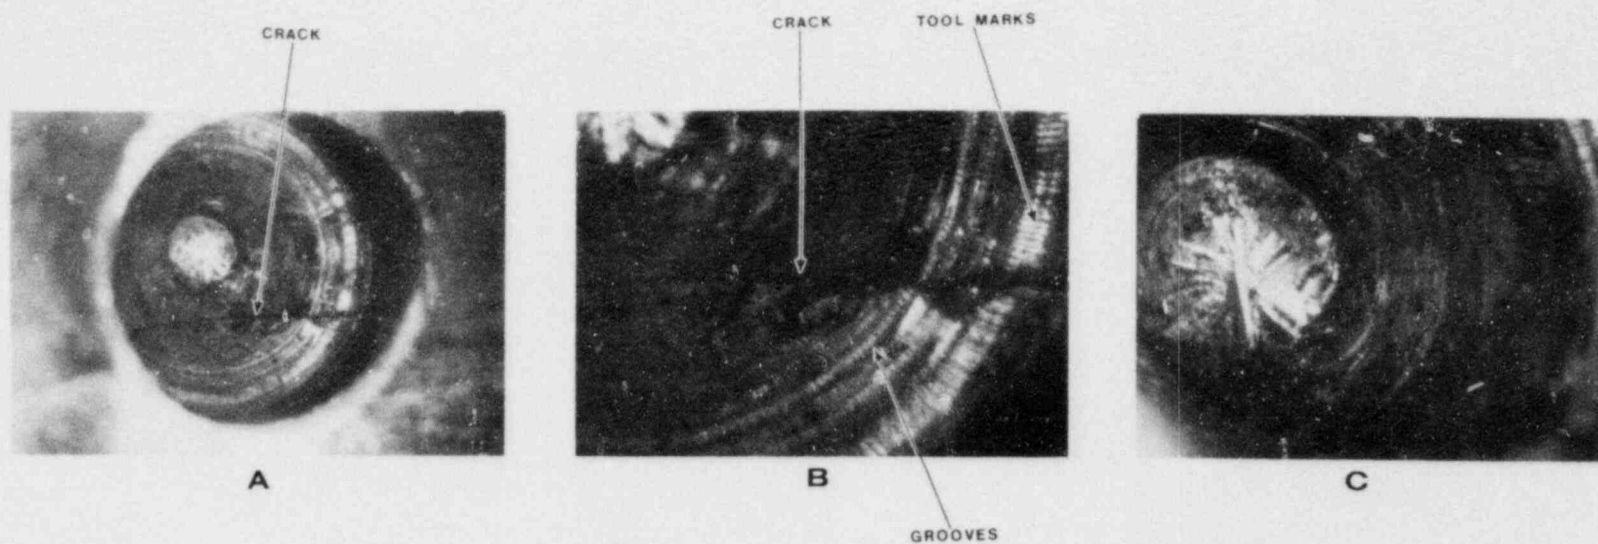
The non-symmetric wear along the crack path under the thermal sleeve and on the pin hole suggests that permanent deformation, possibly from torsion has occurred leaving one side of the shaft crack in contact with the sleeve and the other side twisted away. The band of corrosion film outlining the edges of the thermal sleeve seating surface on the shaft suggests that localized corrosion was occurring around the circumference of the shaft at this location.

Figure 3.1-10. Internal Surface Condition of Cracked Pin Hole
A. General View Showing Crack
B. Enlarged View of Crack
C. View of Hole Bottom

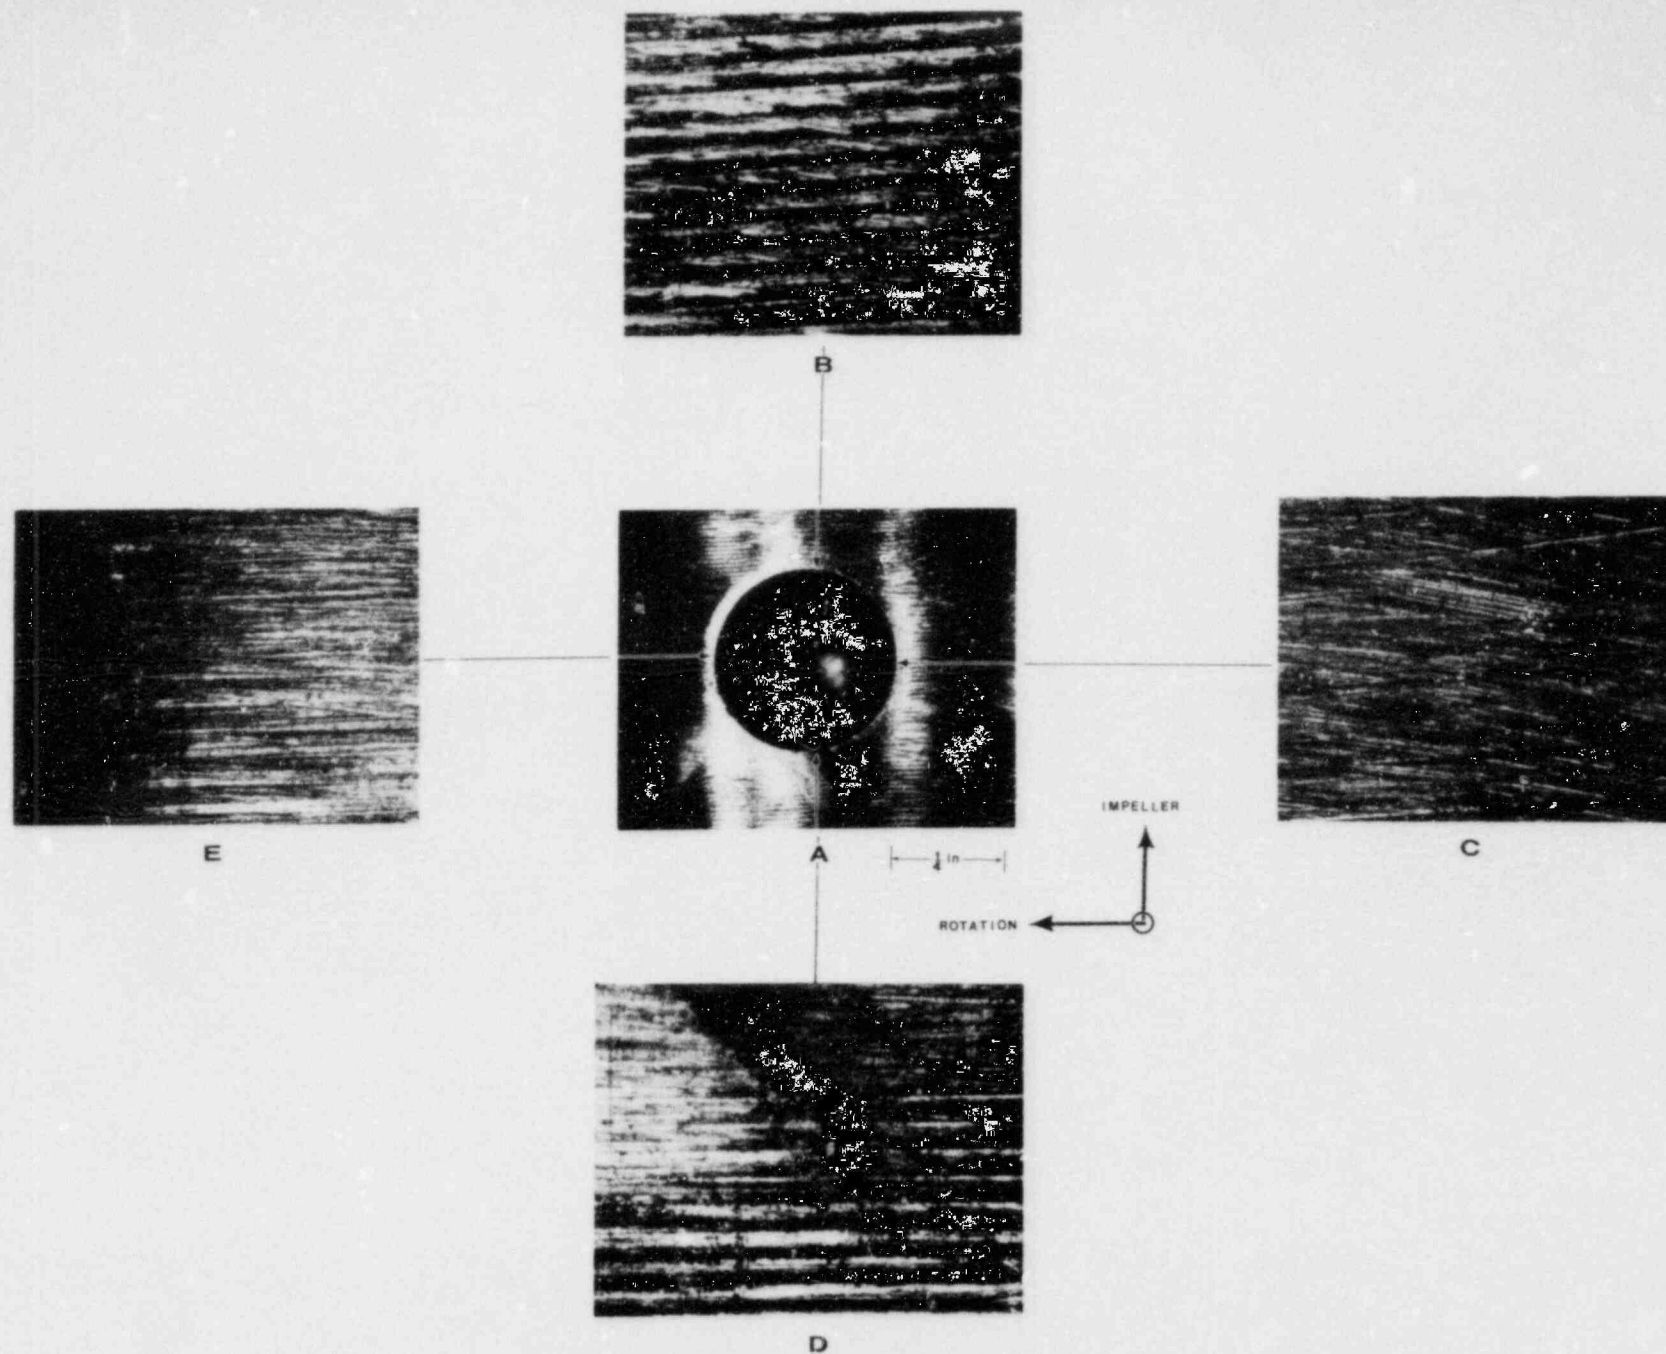
Figure 3.1-11. Shaft Surface Appearance Near Uncracked Pin Hole. View A Shows Pin Hole. Views B, C, D, and E Show Coarse Tooling Marks. Views C and E Show Wear Marks

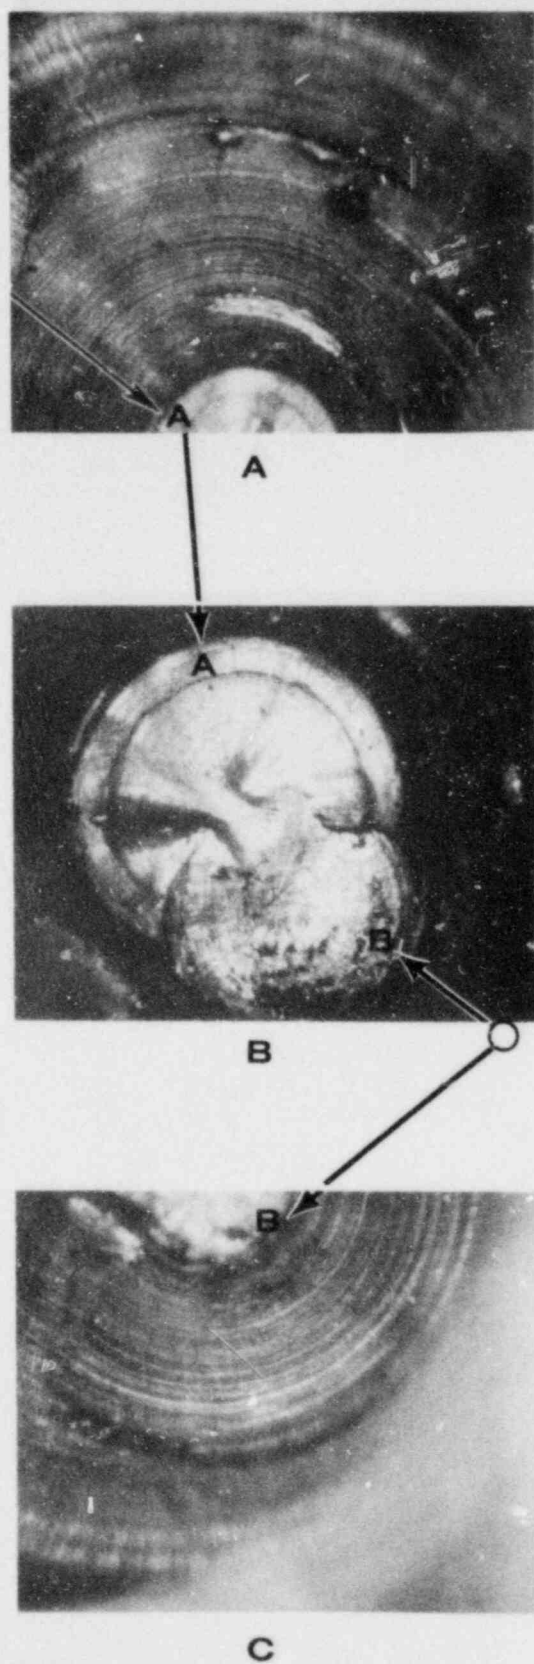
Figure 3.1-12. Internal Surface Features
of Uncracked Pin Hole

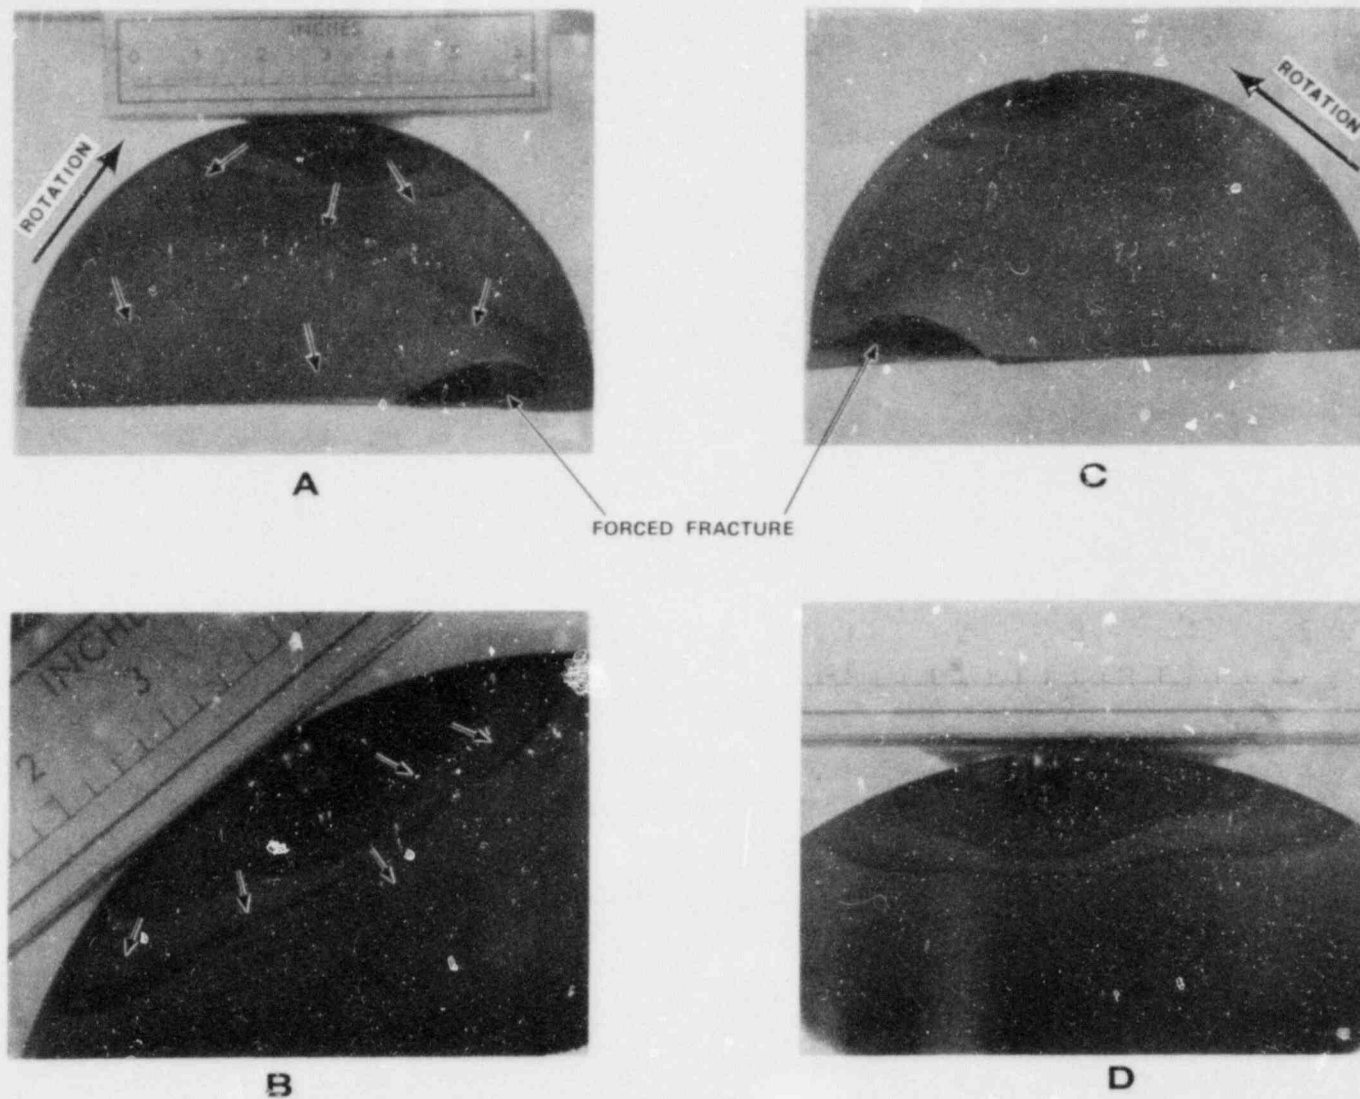
In summary, the fractographic data suggests that from about 1 to 2.5 inches, the crack growth rate was $<10^{-4} \text{ mm/cycle}$; and from 2.5 to 4.5 inches, the growth rate was $<10^{-5}$ to $<10^{-6} \text{ mm/cycle}$. From these growth rates a straight crack path of 3.5 inches could be traversed in about 148 hours at 1180 RPM shaft speed (10^{-4} mm/cycle from 1 to 2.5 inches, $5 \times 10^{-6} \text{ mm/cycle}$ from 2.5 to 4.5 inches), assuming each cycle produces incremental crack growth and no additional cycles are needed to cross microstructural boundaries. As an upper bound on growth rate, if 10^{-4} mm/cycle is assumed for the entire crack path, only 12.6 hours would be needed to propagate the crack to its final position. As a lower bound on rate, if $5 \times 10^{-7} \text{ mm/cycle}$ is assumed for the entire path, 2511 hours would be required. Considering that the actual curved fracture path would add a fractional increase in total path length and that the macroscopic rate may be less than that observed on the fractography, the time required to move the crack from beachmark #15 to its final position would take

Figure 3.3-1. Shaft Fracture Surface on Piece "B" Sections
A, B: Overall View and Initiation Area on B1
C, D: Overall View and Initiation Area on B2
