TMI-1 REACTOR COOLANT PUMP SHAFT FAILURE ANALYSIS

TMI-1 REACTOR COOLANT PUMP SHAFT
FAILURE ANALYSIS

Lynchburg Research Center Report
RDD:84:5183-06:01

August 1984

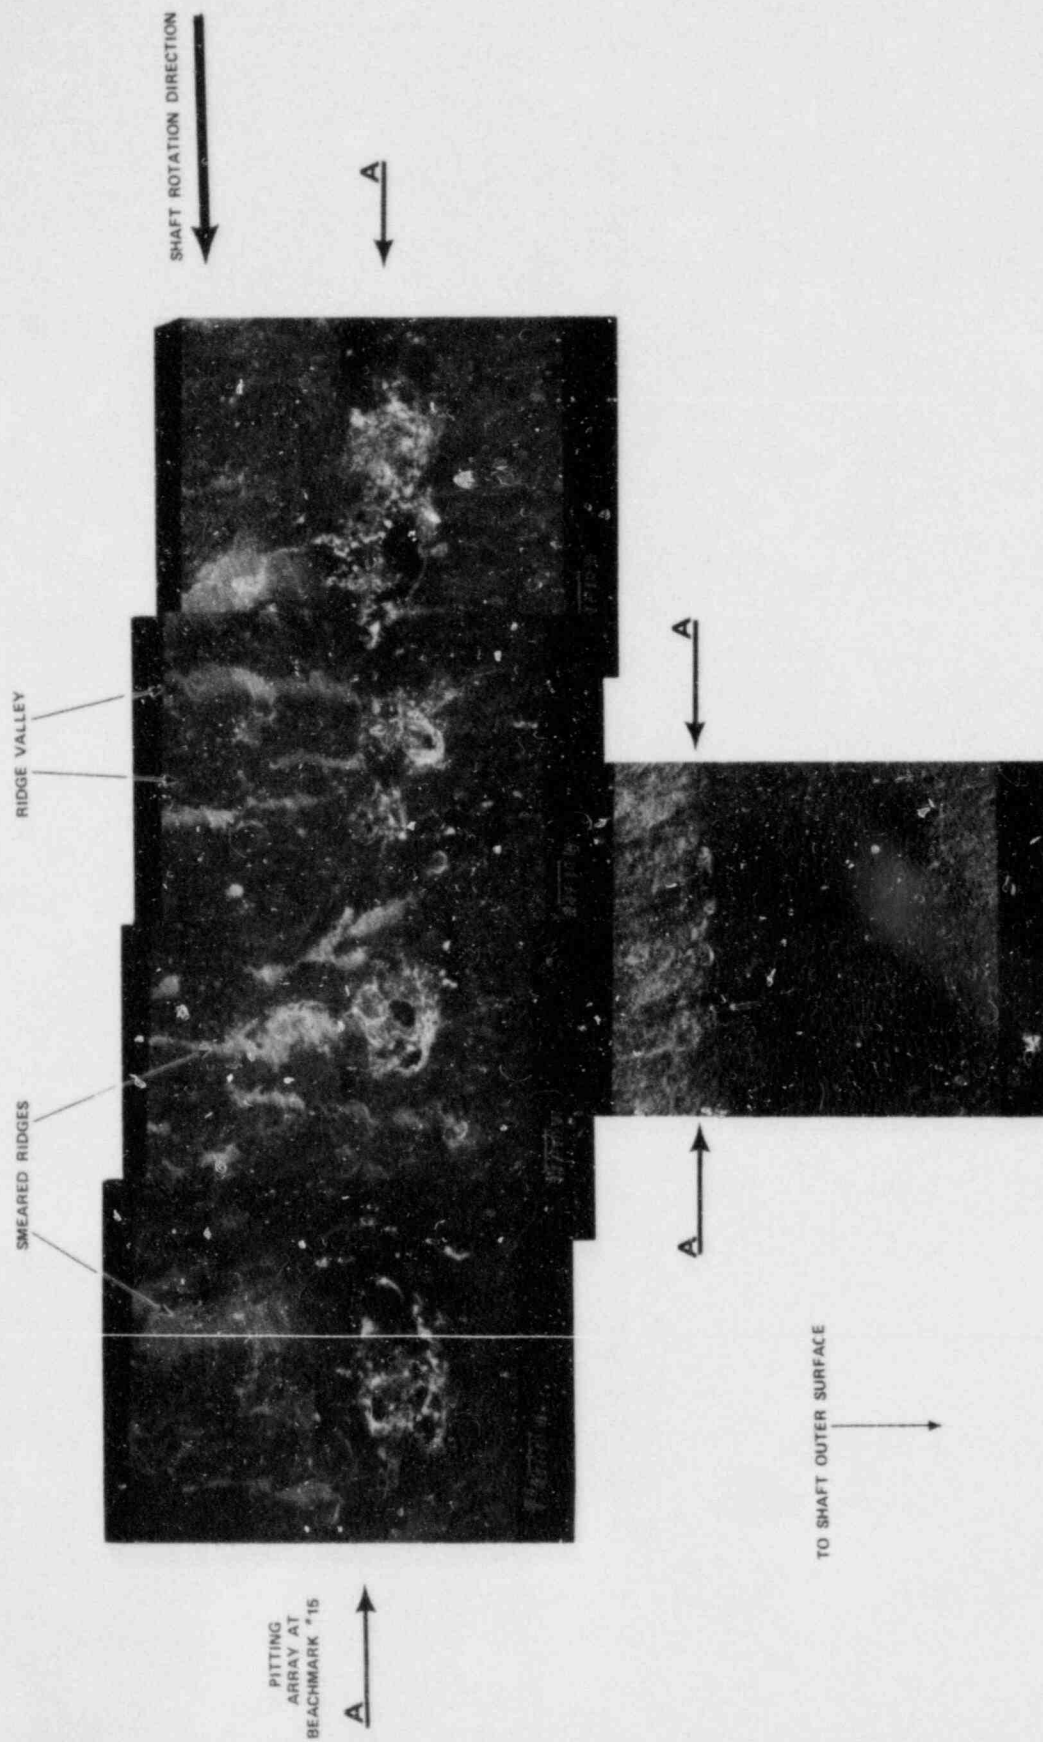
Figure 3.3-8. Transition From Flat Fracture Surface to Ridge and Valley Structure at Pitted Beachmark #15

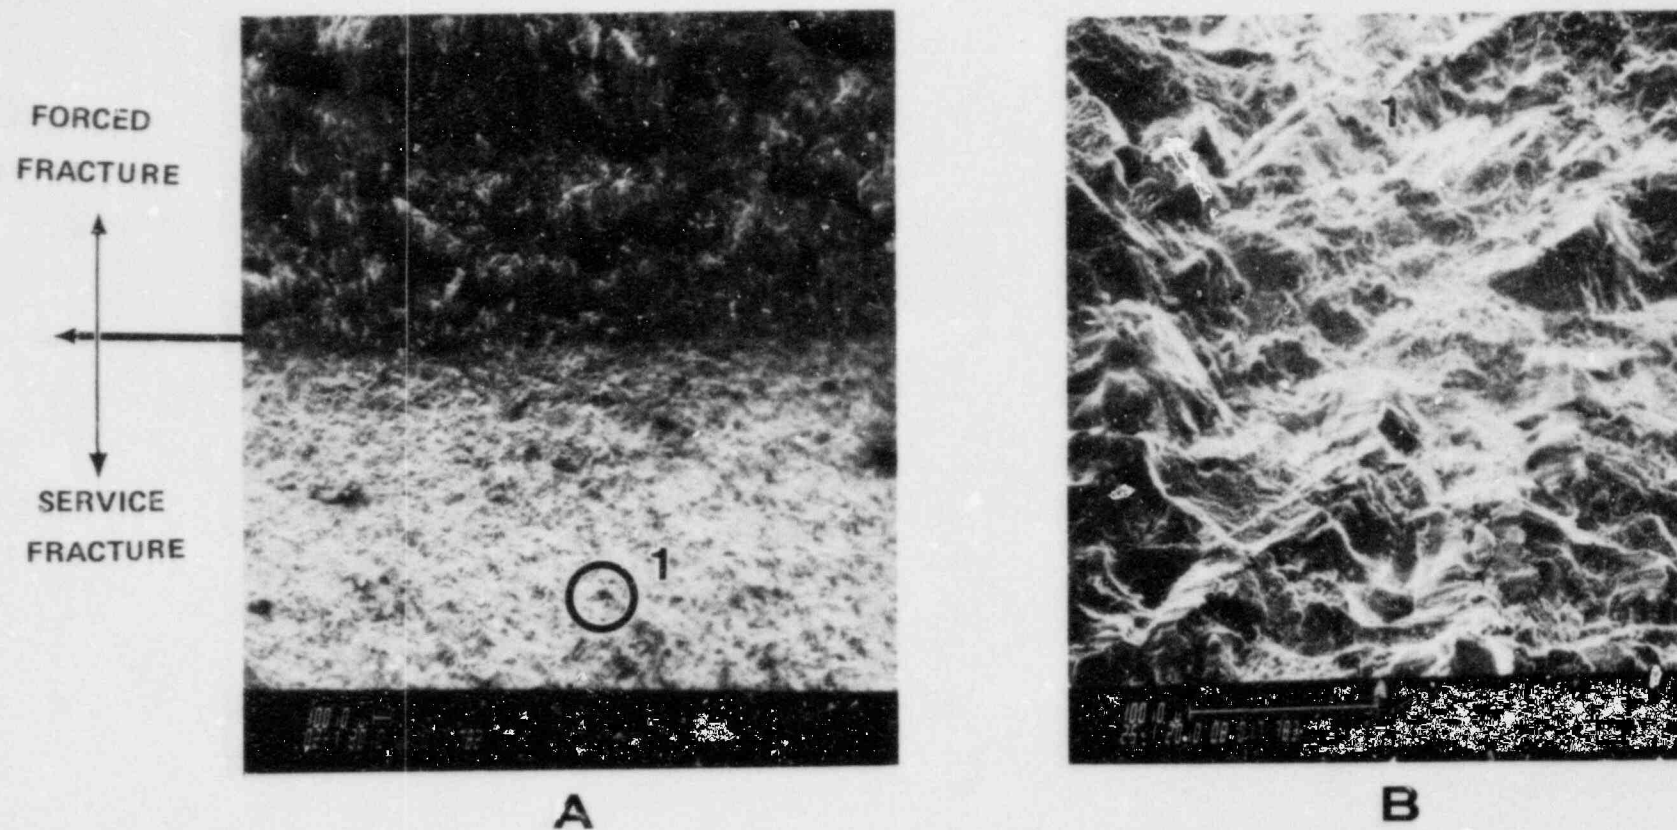
Figure 3.3-13. Typical Fracture Structure on Specimen 17-20.
B Shows Enlarged View of Location 1 in A

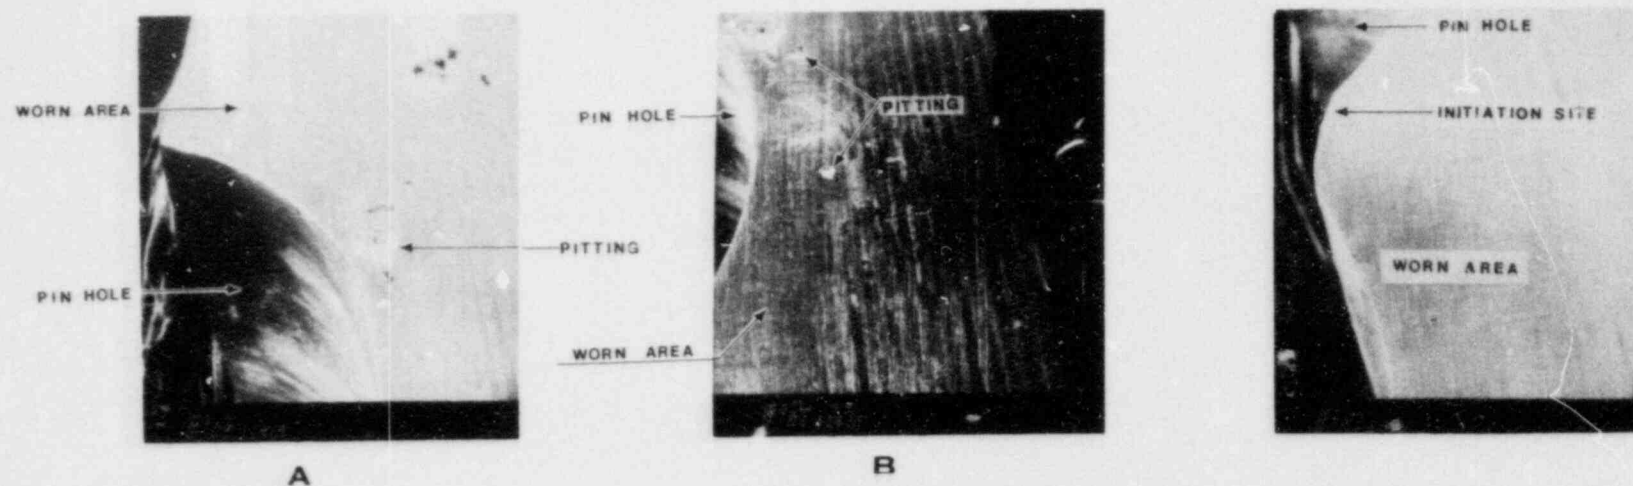
Figure 3.3-15. Shaft Surface Condition Near Cracked Pin Hole. View A on Octant 2 Side; B in Octant 81, Boundary; C on Octant 1 Side

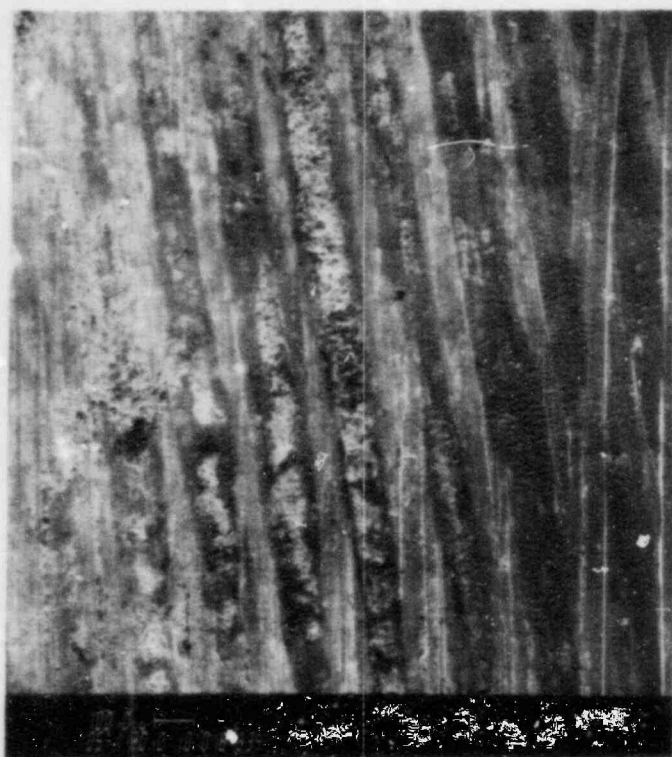
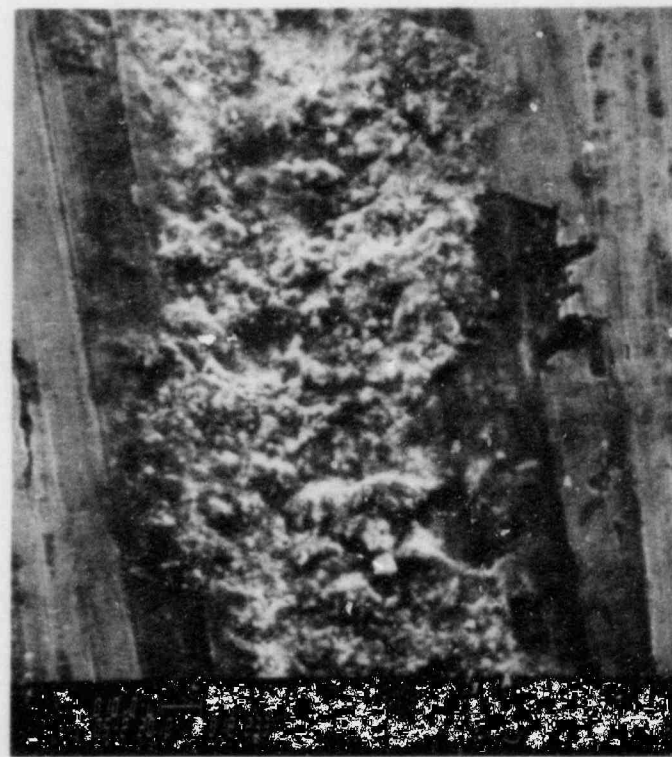
Figure 3.3-17. Debris or Corrosion Product Accumulation in Coarse Machine Marks

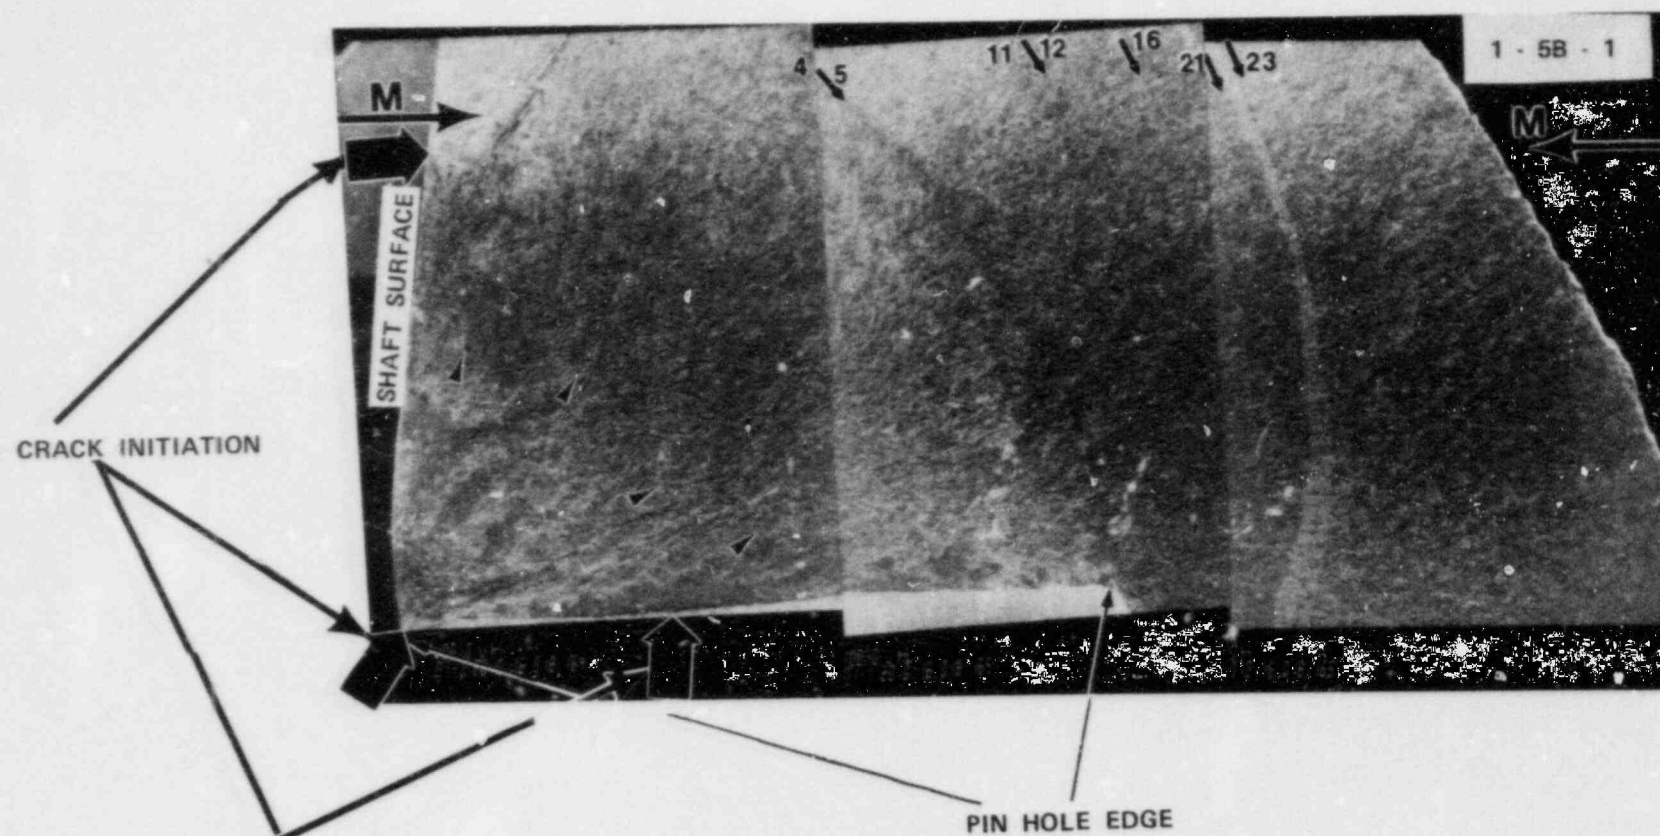
Figure 3.3-19. SEM Photomontage of Crack Initiation Area and Examination Path Along Line M-M. Prominent Crack Arrest Marks Seen by SEM Are Numbered

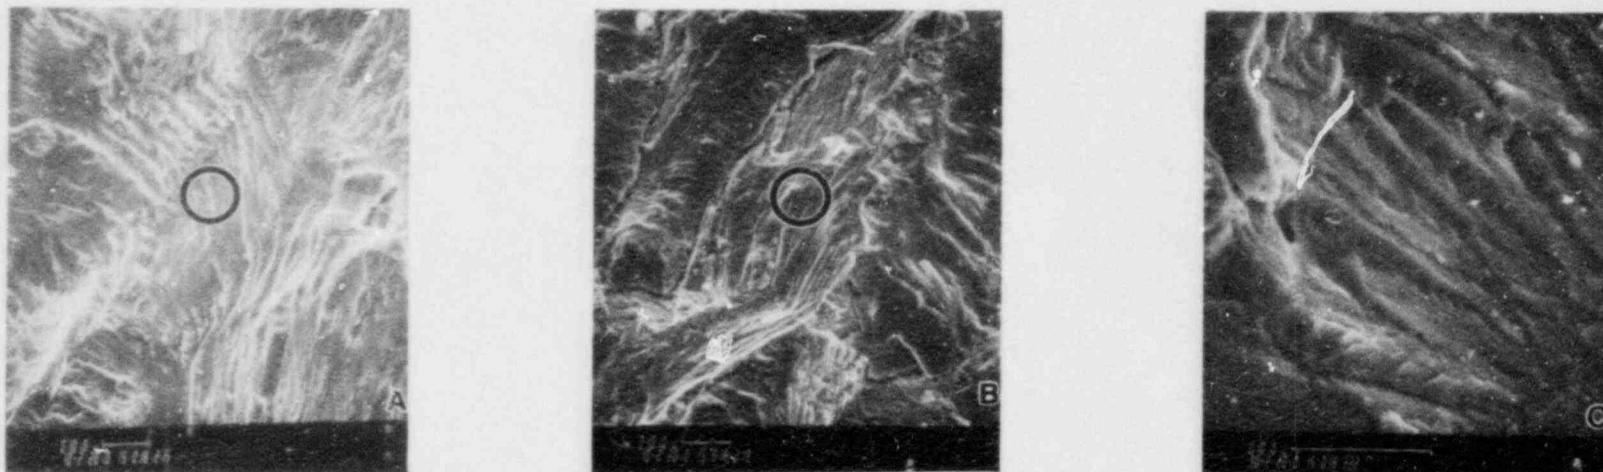
Figure 3.3-20. Typical Fractography in Crack Initiation Area. Locations A, B, and C Show in SEM Views of Initiation Area

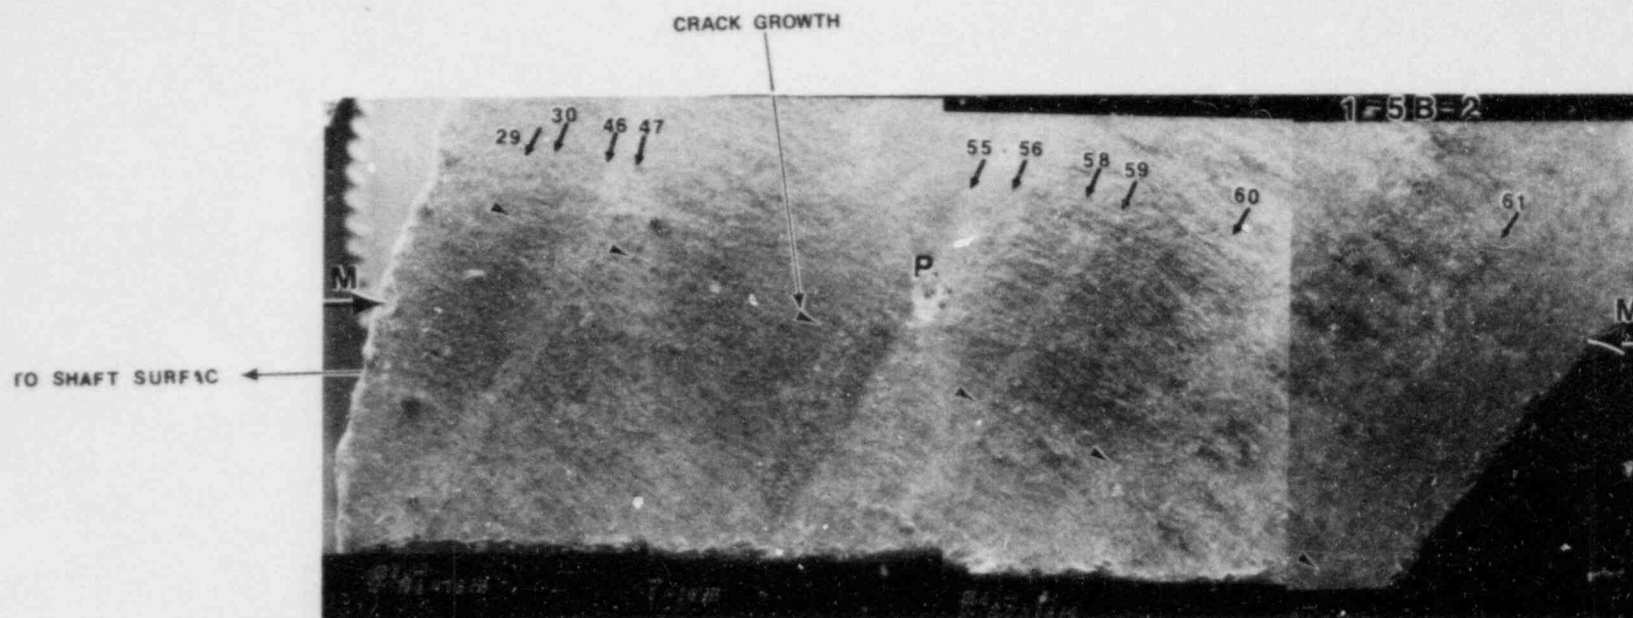
Figure 3.3-23. SEM Photomontage of Specimen 1-5B-2. Fracture Examination Along Line M-M. Prominent Crack Arrest Marks Are Numbered

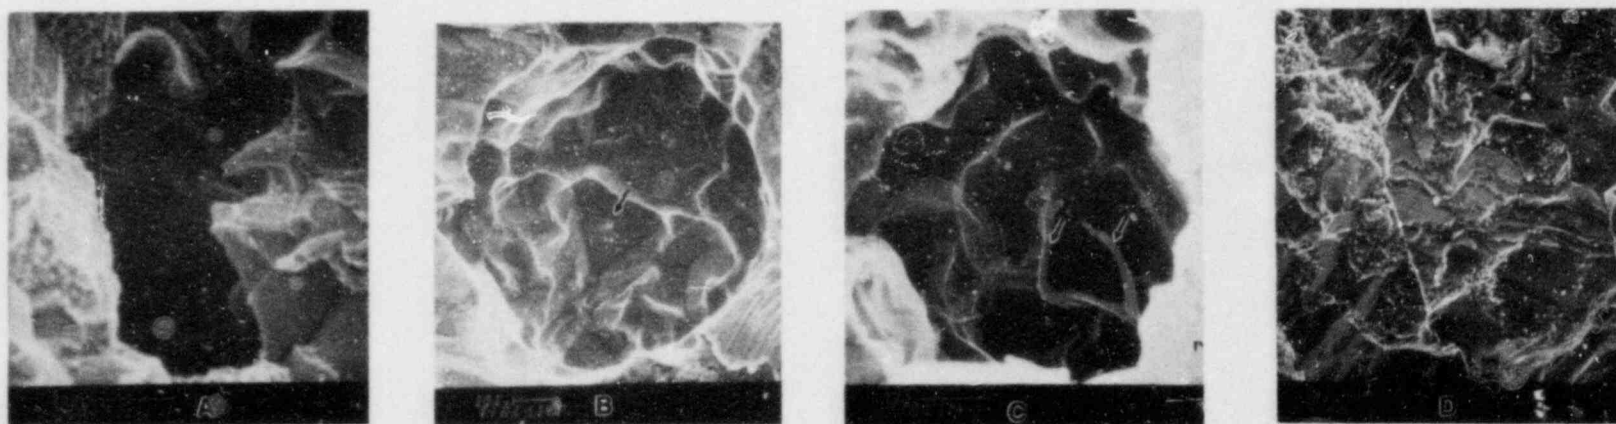
Figure 3.3-26. Typical Structure Inside Pits in Specimen 1-5B-2.
Arrows Show Inclusions or Inclusion Sites

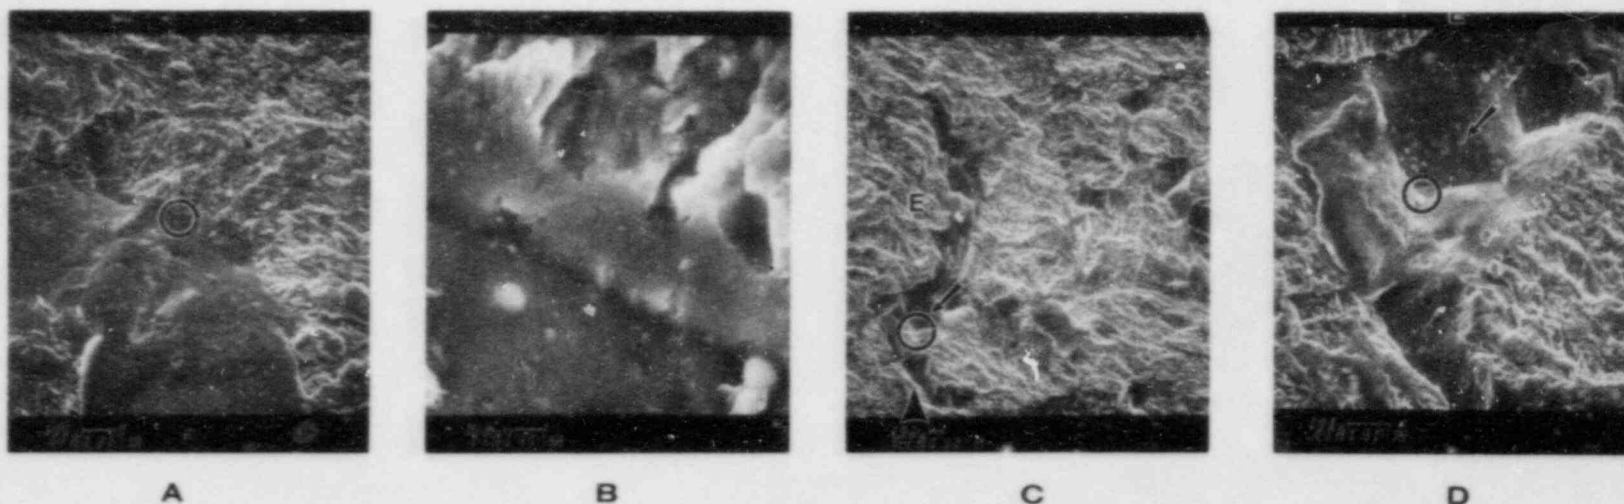
Figure 3.3-31. Typical Mixed Mode Fractography Seen on Specimen 10-13. Letter at Top of Photo Refer to Location on Previous Montage). Cleavage and Intergranular Separation Facets Occur in Colonies Surround by a Fine Transgranular Structure. A. Intergranular Separation, Enlarged in B, C. Intergranular Separation, Enlarged in D

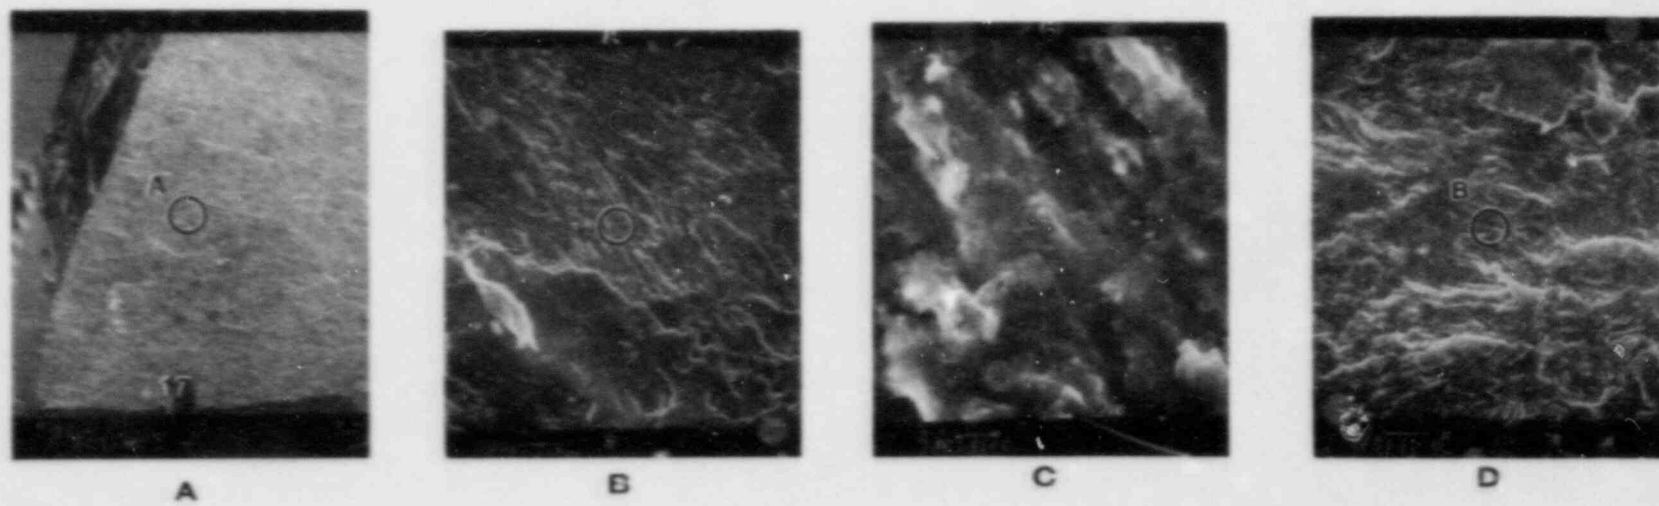
Figure 3.3-35. Higher Magnification Views of Fracture Surface Structure on Specimen
Views B and C Taken at Location A. Views D and E Taken at Location
B Shown on Previous Montage. Views F and G Taken at Location C.

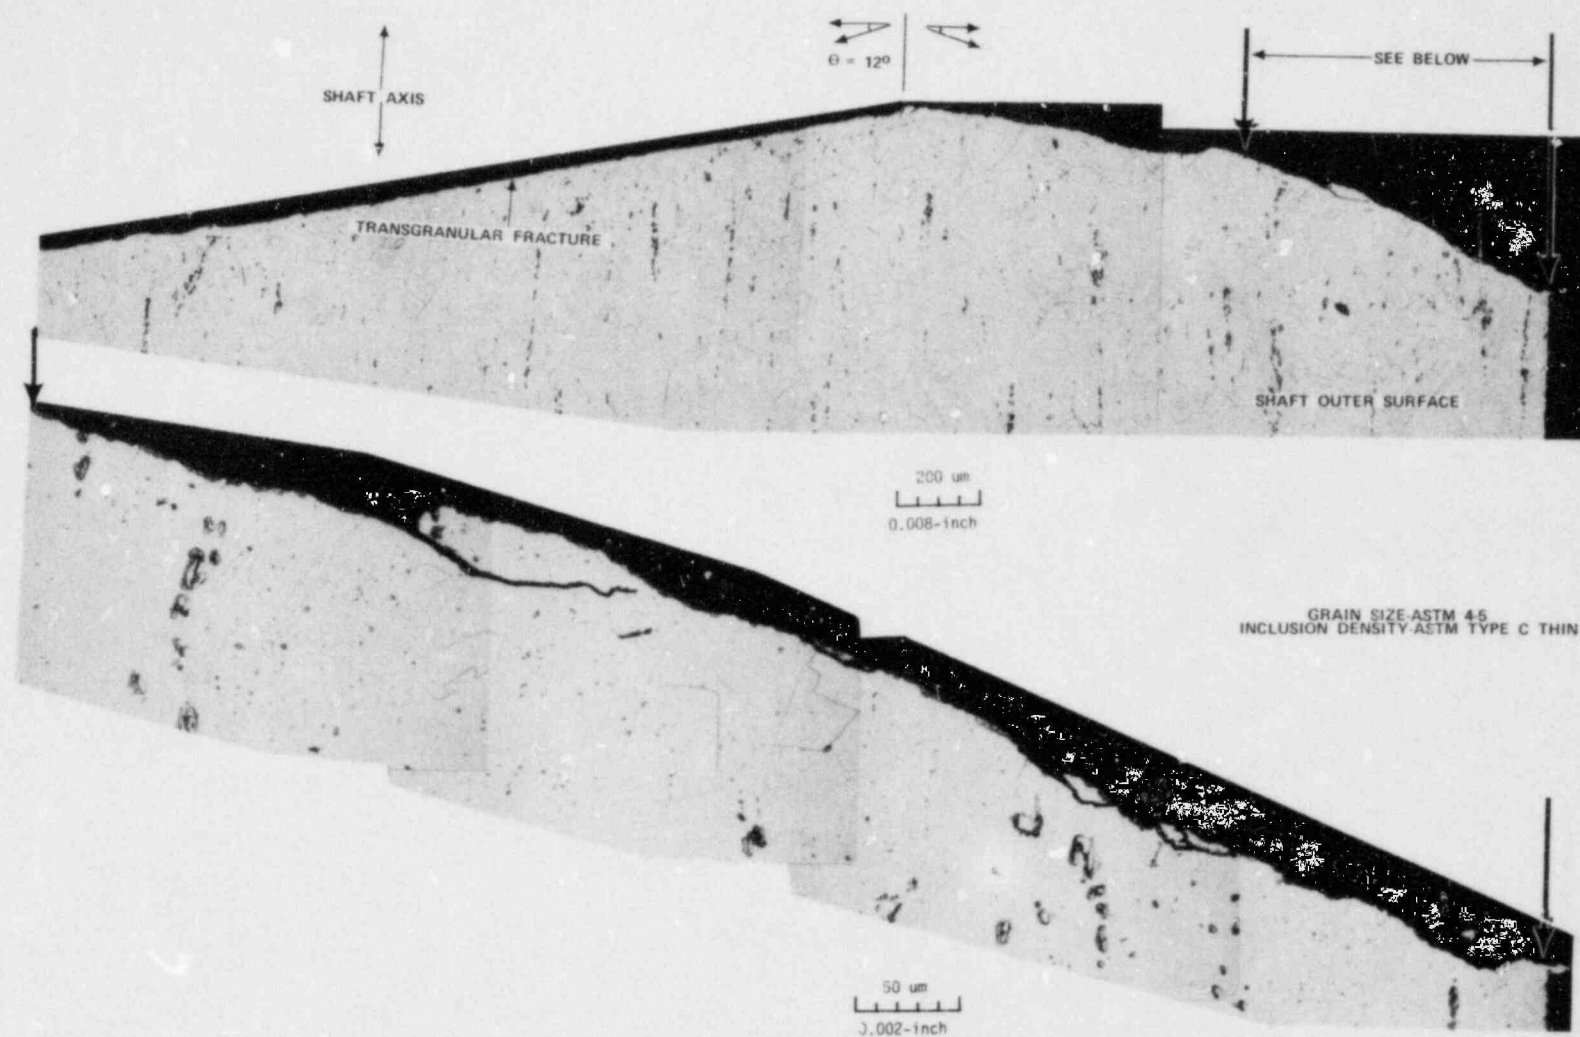
Figure 3.3-40. Longitudinal View of Specimen B1A1-1-5 at Crack Origin
