**ENRICO FERMI ATOMIC POWER PLANT  
UNIT NO. 2  
EVALUATION OF  
CONTAINMENT COATINGS**

REPORT NO. DECO-12-2191  
REVISION 3

MULTIPLE DYNAMICS CORPORATION  
29200 SOUTHFIELD, SUITE 103  
SOUTHFIELD, MICHIGAN 48076  
(313) 557-7766

OCTOBER 1984

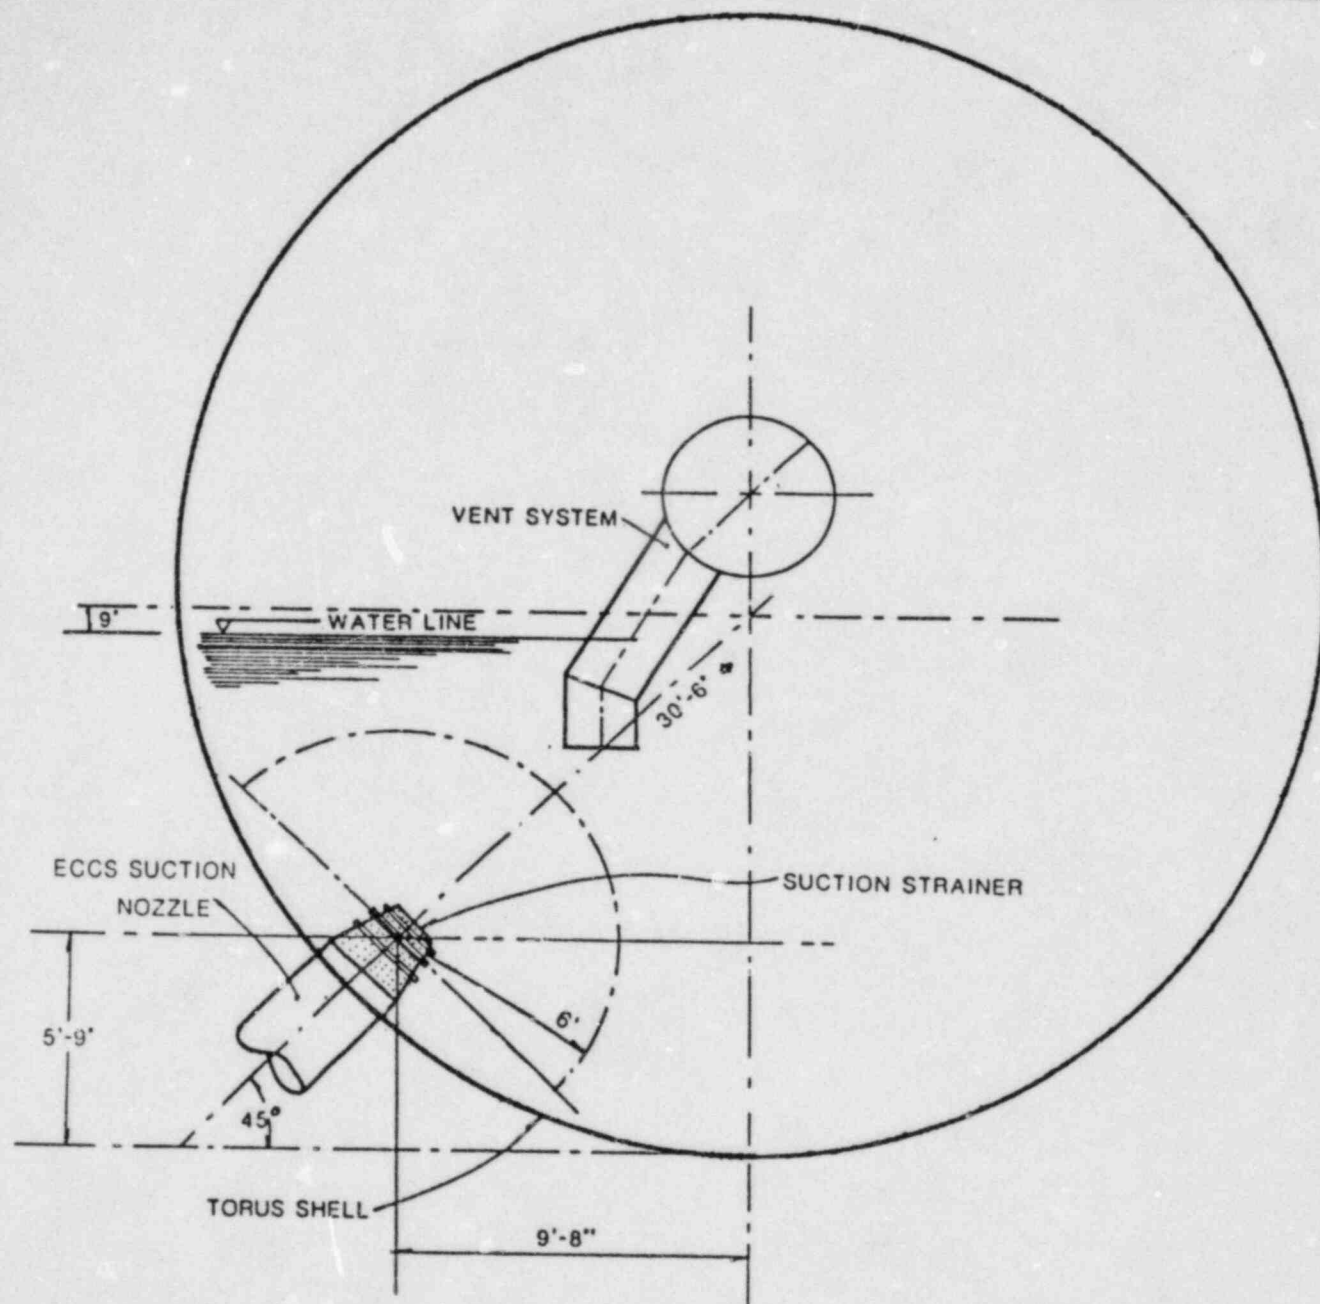
FIGURE 1

Average water velocities within the torus following the initial transient are below 0.25 ft/sec, but approach 0.3 ft/sec within a 4 foot hemisphere of the largest suction strainers at maximum RHR pump capacity. Refer to Figure 1 for the dimension and arrangement within the torus. The maximum surface velocity at the strainer surface was calculated to be 2.5 ft/sec. The strainer intakes are located 9'-8" from the center of the torus and 5'-9" above dead bottom. For these pool velocities hydroxide type particles are therefore not postulated to reach the strainers in a realistic situation.

Unqualified paints with DFT's of less than 3 mils that fail in a peeling or flaking mode are expected to float on the pool surface or remain suspended in water, where they could ultimately migrate toward the ECCS suction strainers. The particles of these thin coatings are expected to be small enough to pass through the strainers as discussed in Section 6.0.

ECCS SUCTION STRAINER LOCATION
