LICENSEE EVENT REPORT (LER)

FACILITY NAME (1) Fort St. Vrain, Unit No. 1										DOCKET NUMBER (2) 0 5 0 0 0 2 6 7										PAGE (3) 1 OF 1	
TITLE (4) High Reactor Pressure Scram & Ensuing Control Rod Automatic Insertion Failures																					
EVENT DATE (5)			LER NUMBER (6)				REPORT DATE (7)			OTHER FACILITIES INVOLVED (8)											
MONTH	DAY	YEAR	YEAR	SEQUENTIAL NUMBER	REVISION NUMBER	MONTH	DAY	YEAR	FACILITY NAMES N/A						DOCKET NUMBER(S) 0 5 0 0 0						
0 6	2	3	8	4	8 4	0 0	8	0 0	0 7	2	3	8	4	0 5 0 0 0							
OPERATING MODE (9) N		THIS REPORT IS SUBMITTED PURSUANT TO THE REQUIREMENTS OF 10 CFR 5: (Check one or more of the following) (11)																			
POWER LEVEL (10) 0 2 3		20.402(b)				20.405(a)				X 50.73(a)(2)(iv)				73.71(b)

FACILITY NAME (1)	DOCKET NUMBER (2)	LER NUMBER (8)			PAGE (3)		
		YEAR	SEQUENTIAL NUMBER	REVISION NUMBER			
Fort St. Vrain, Unit No. 1	0500026784	—	008	—	00	02	OF 11

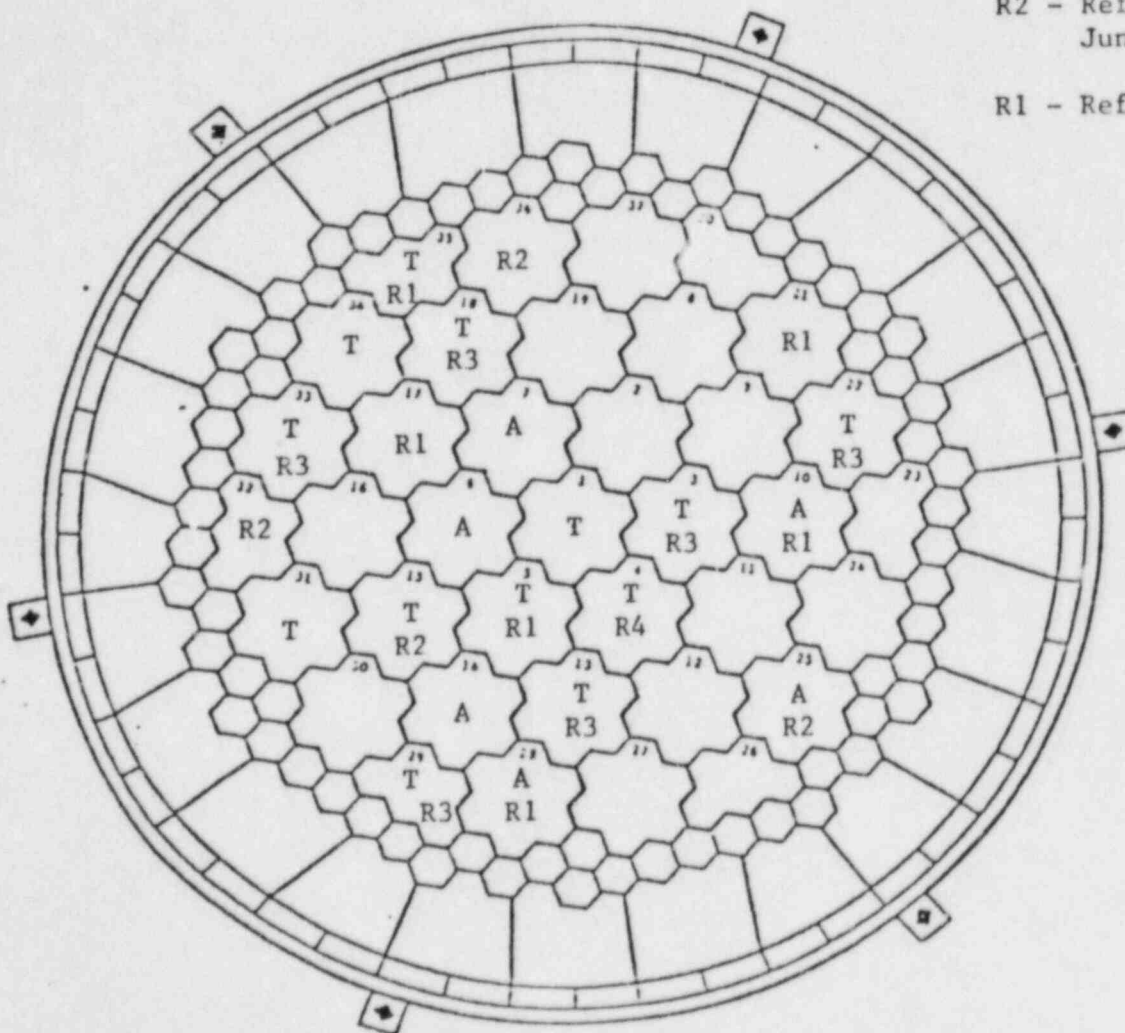
FIGURE 4

At 0029, with reactor power at 23% and being decreased, the reactor automatically scrammed on programmed vessel pressure high. Although the reactor was verified subcritical following the automatic scram, it was noted that 6 of the 37 control rods (in Regions 6, 7, 10, 14, 25, and 28) had failed to automatically insert and these were manually driven in over the following 20 minute interval (see Figure 4). A subsequent calculation using a computer code analysis (Gauge) verified that a shutdown margin of 0.0225 Δp ($K_{eff} = 0.976$) existed even with the above rods not scrammed. The Fort St. Vrain Technical Specifications consider 0.01 Δp to be an acceptable shutdown margin.
