(Shoreham Nuclear Power Station,)
Unit 1))

Docket No. 50-322-OL

SUPPLEMENTAL TESTIMONY OF DR. ROBERT N. ANDERSON,
PROFESSOR STANLEY CHRISTENSEN, G. DENNIS ELEY,
AND RICHARD B. HUBBARD
REGARDING SUFFOLK COUNTY'S EMERGENCY DIESEL
GENERATOR CONTENTION CONCERNING CYLINDER BLOCKS

SUFFOLK COUNTY
October 18, 1984

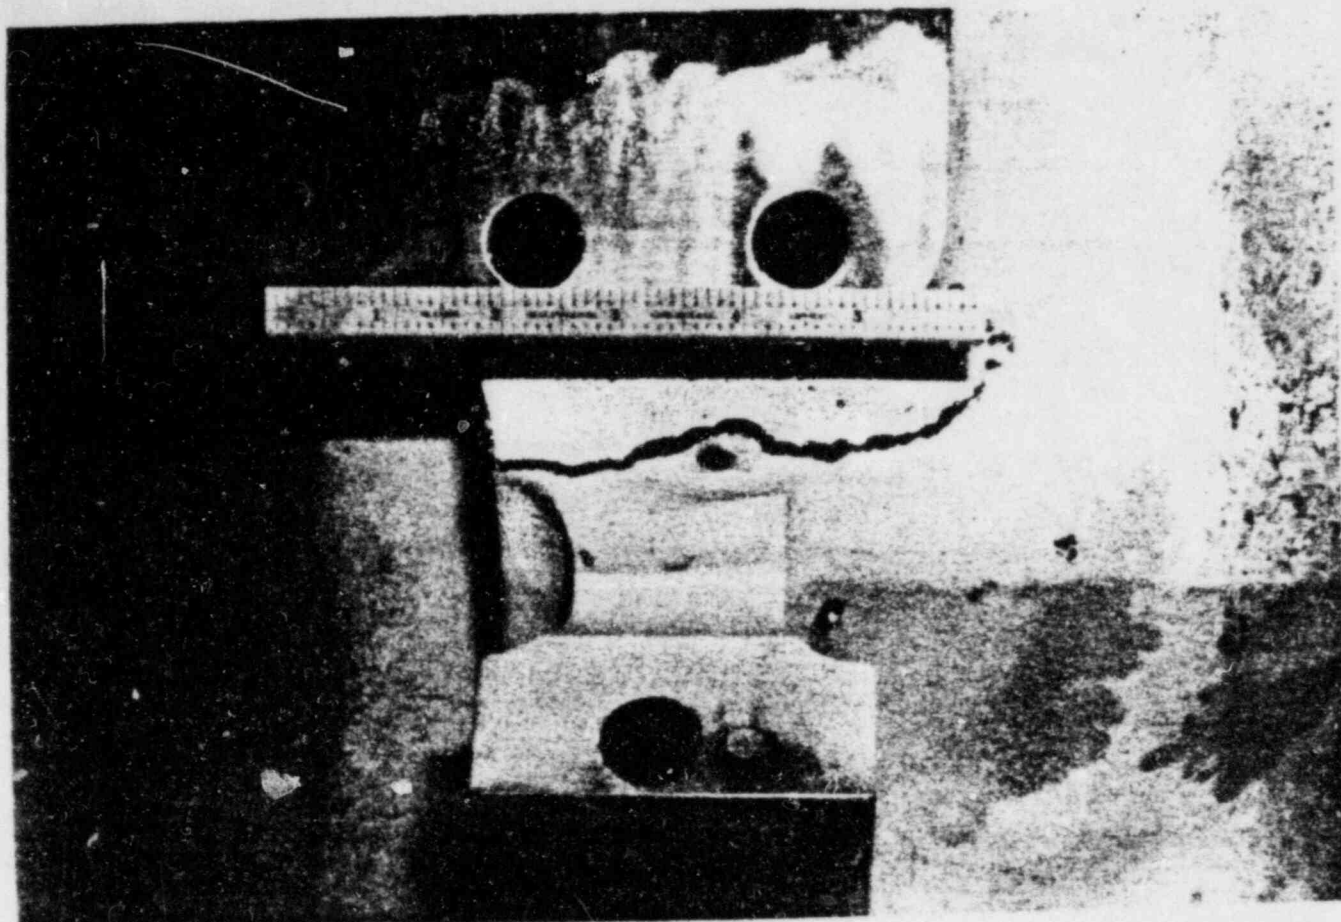
ORIGINAL BLOCK - EDG 103

inches.^{2/} Some of these cracks were measured by FaAA after sectioning and found to be from 0.5 inch to 0.906 inch deep in a block wall only 1.25 inches thick.^{3/} FaAA found that all of these cracks had been ground and welded. Some representative photographs of these cracks are shown in Exhibit S-3.

A. (Anderson). Based upon my examination of the sections removed by FaAA from the block and of numerous photographs of these cracks, they appear to be hot tears formed initially during fabrication of the block. This theory is supported by the fact that the cracks were filled with welding material in an apparent effort to repair them.

CAM GALLERY BEARING SADDLE #5

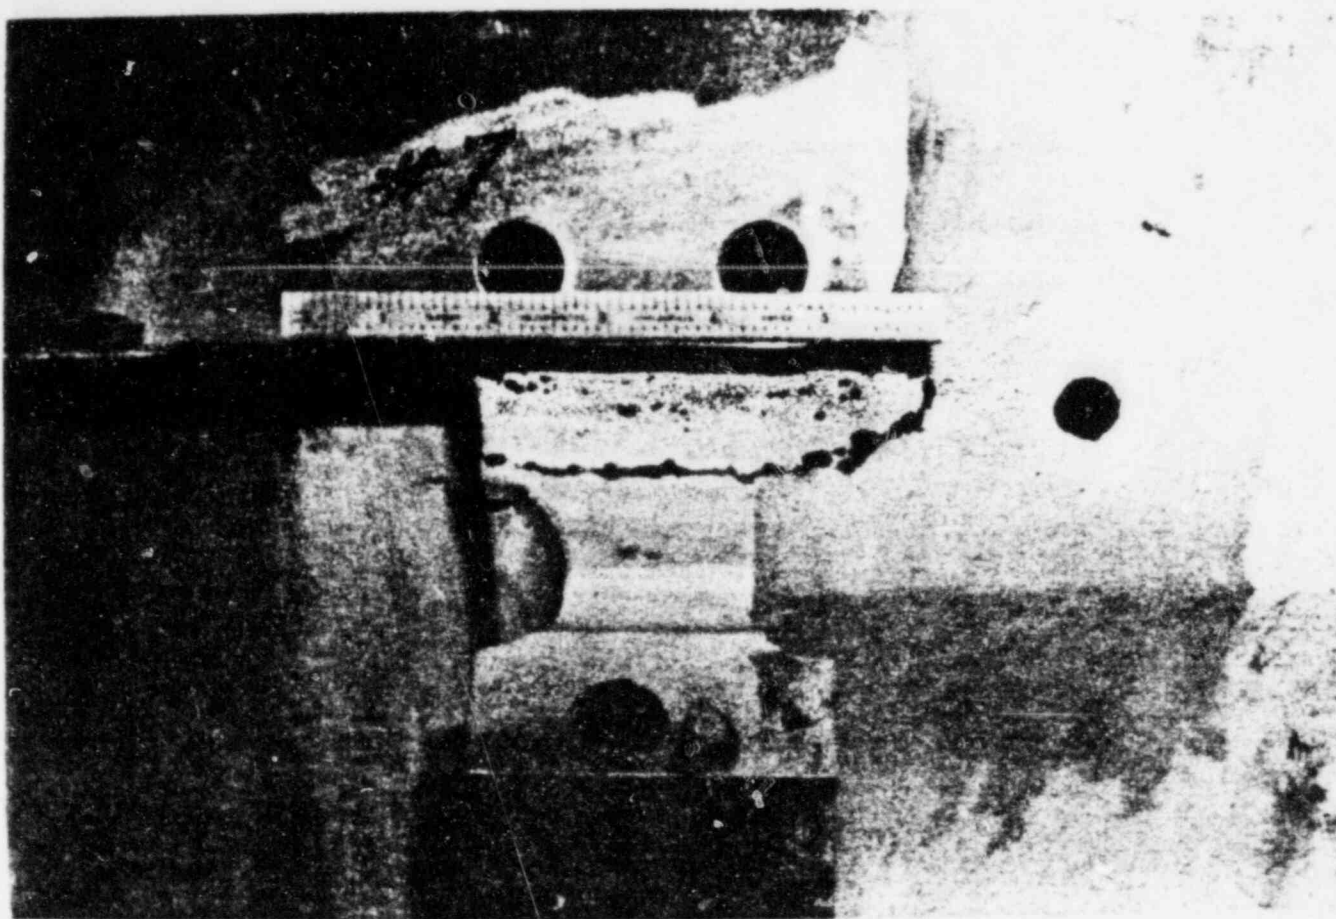
ORIGINAL BLOCK - EDG 103

A. (Anderson). No. That conclusion is based upon FaAA's erroneous interpretations of a "dark oxide" on the surface of a crack sectioned from cam gallery No. 7, the presence of high concentrations of calcium on the surface of that crack, the absence of a "rust-colored oxide," and the appearance of the crack surface.

CAM GALLERY BEARING SADDLE #7

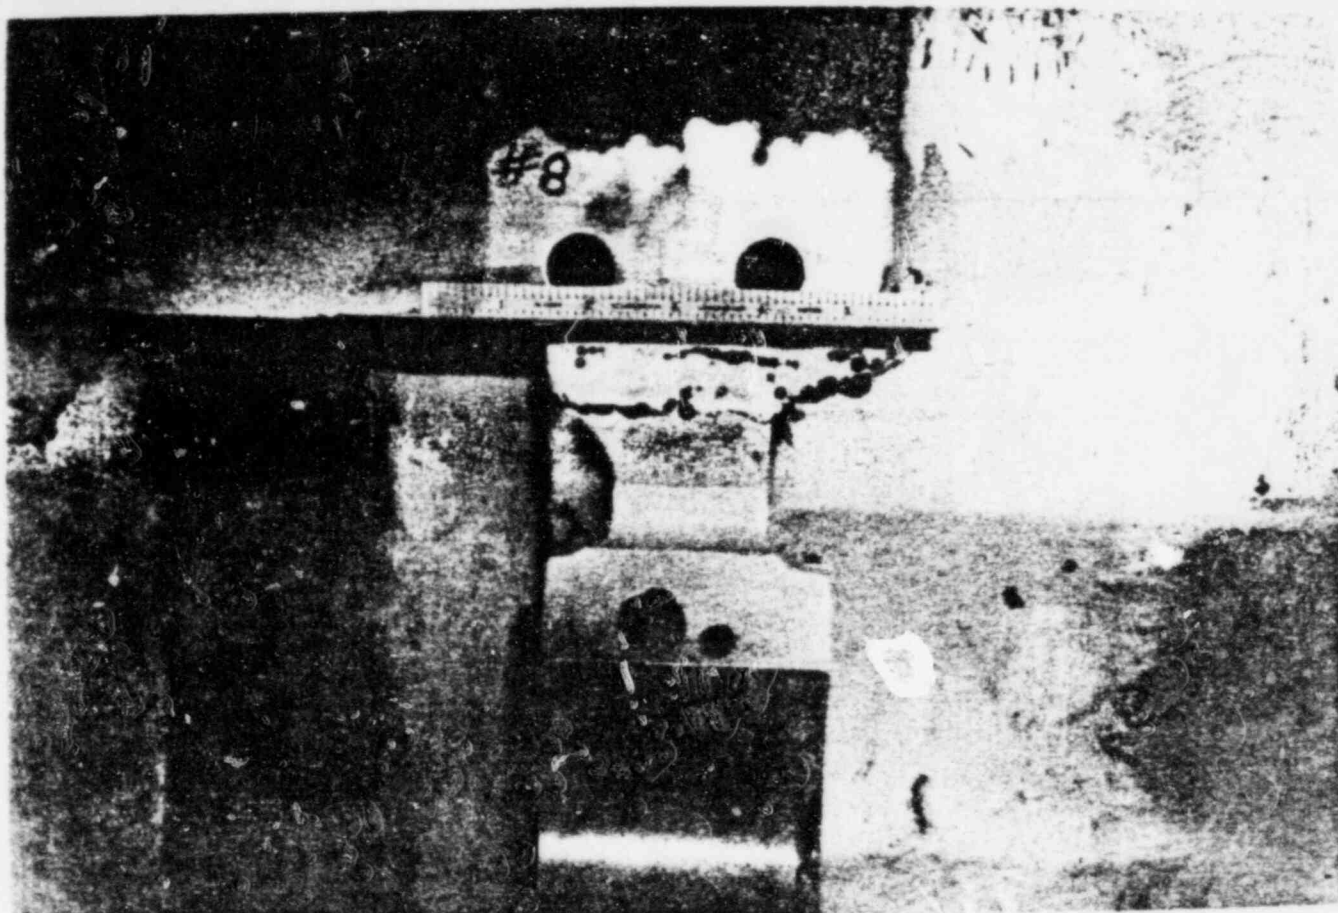
ORIGINAL BLOCK - EDG 103

CAM GALLERY BEARING SADDLE #8

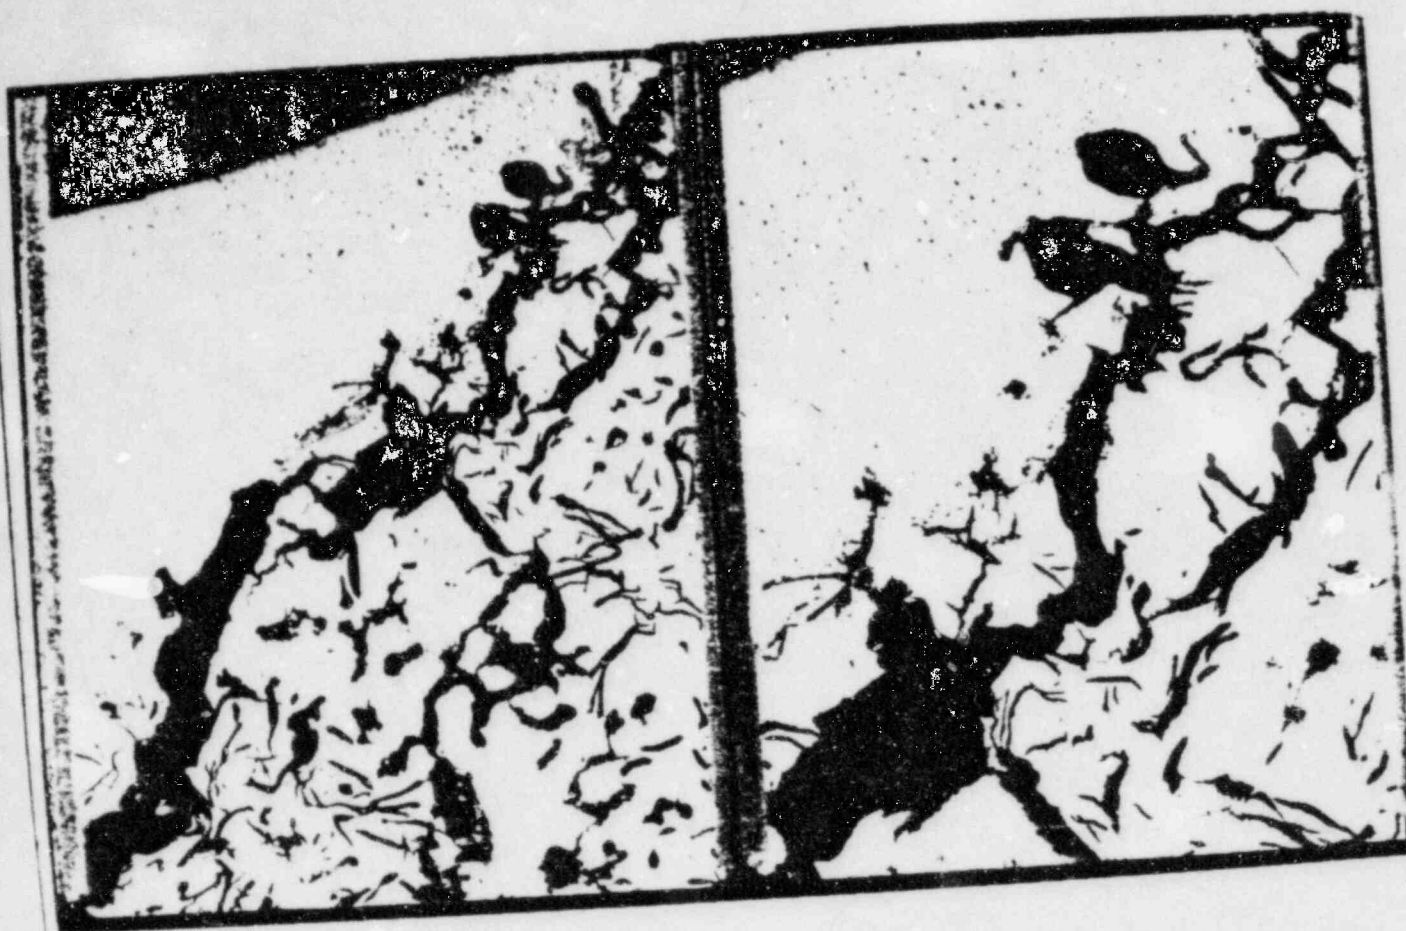
A. (Anderson). Yes. Exhibit S-4 is two photographs showing the magnified surface of a portion of a cam gallery crack that was sectioned by FaAA. The photographs show that the weld material (the white area in the upper left) has pulled loose from the cast iron surface of the crack, but that some cast iron was still adhering to the weld material. This shows that the weld material pulled free from the crack surface due to operating stresses, as opposed to heat shrinkage.

Cam Saddle #7
Face 1, I613
X50

Cam Saddle #7
Face 1, I613
X100

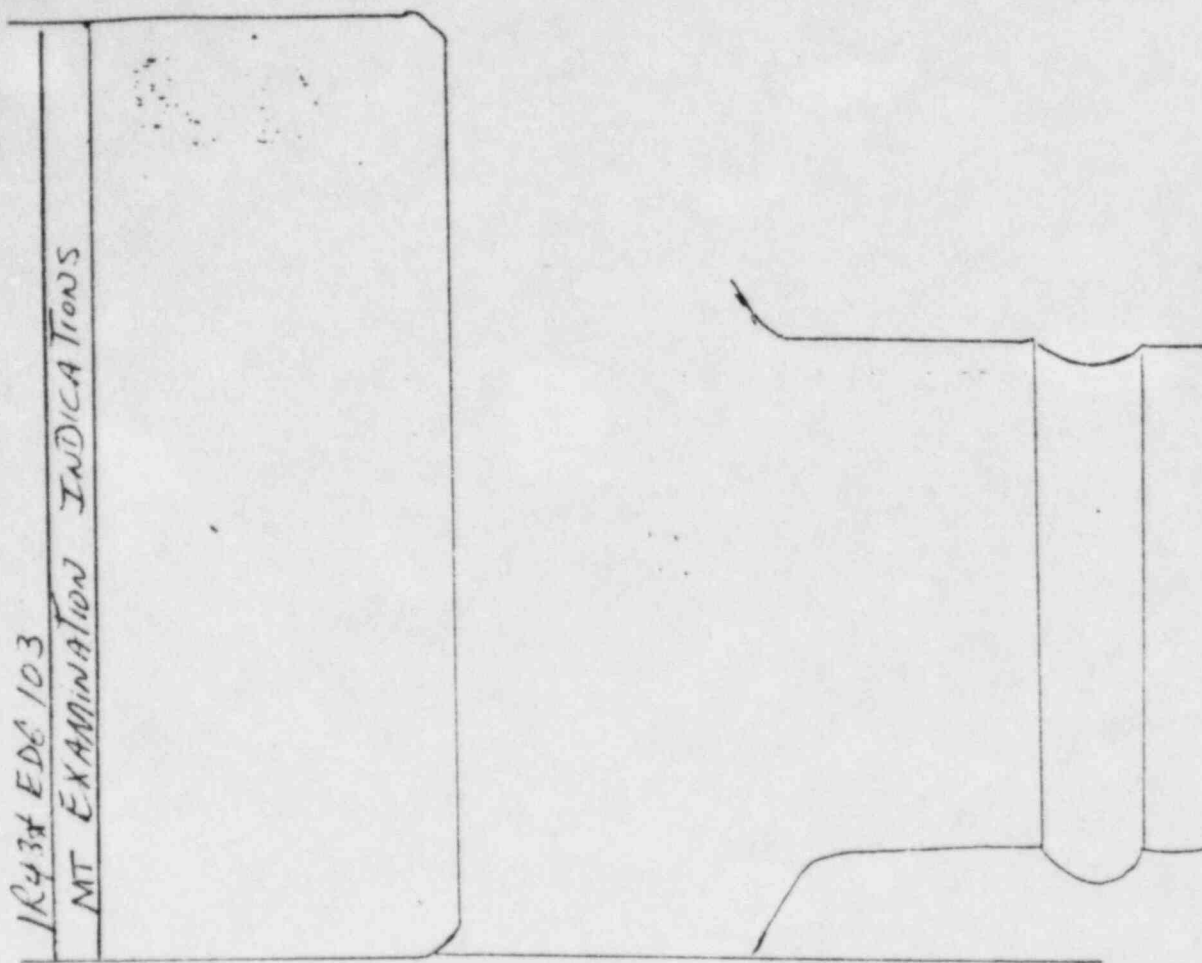
A. (Hubbard, Anderson). Yes. The areas of cam bearing saddles numbers 2 and 8 were inspected by LILCO both before and after grinding (on September 30 and October 1, 1984) while preparing EDG 103 for additional testing. The test reports show cracks in both of these areas, ranging up to 2 inches long.^{5/}

CYLINDER #8
CAM SADDLE AREA

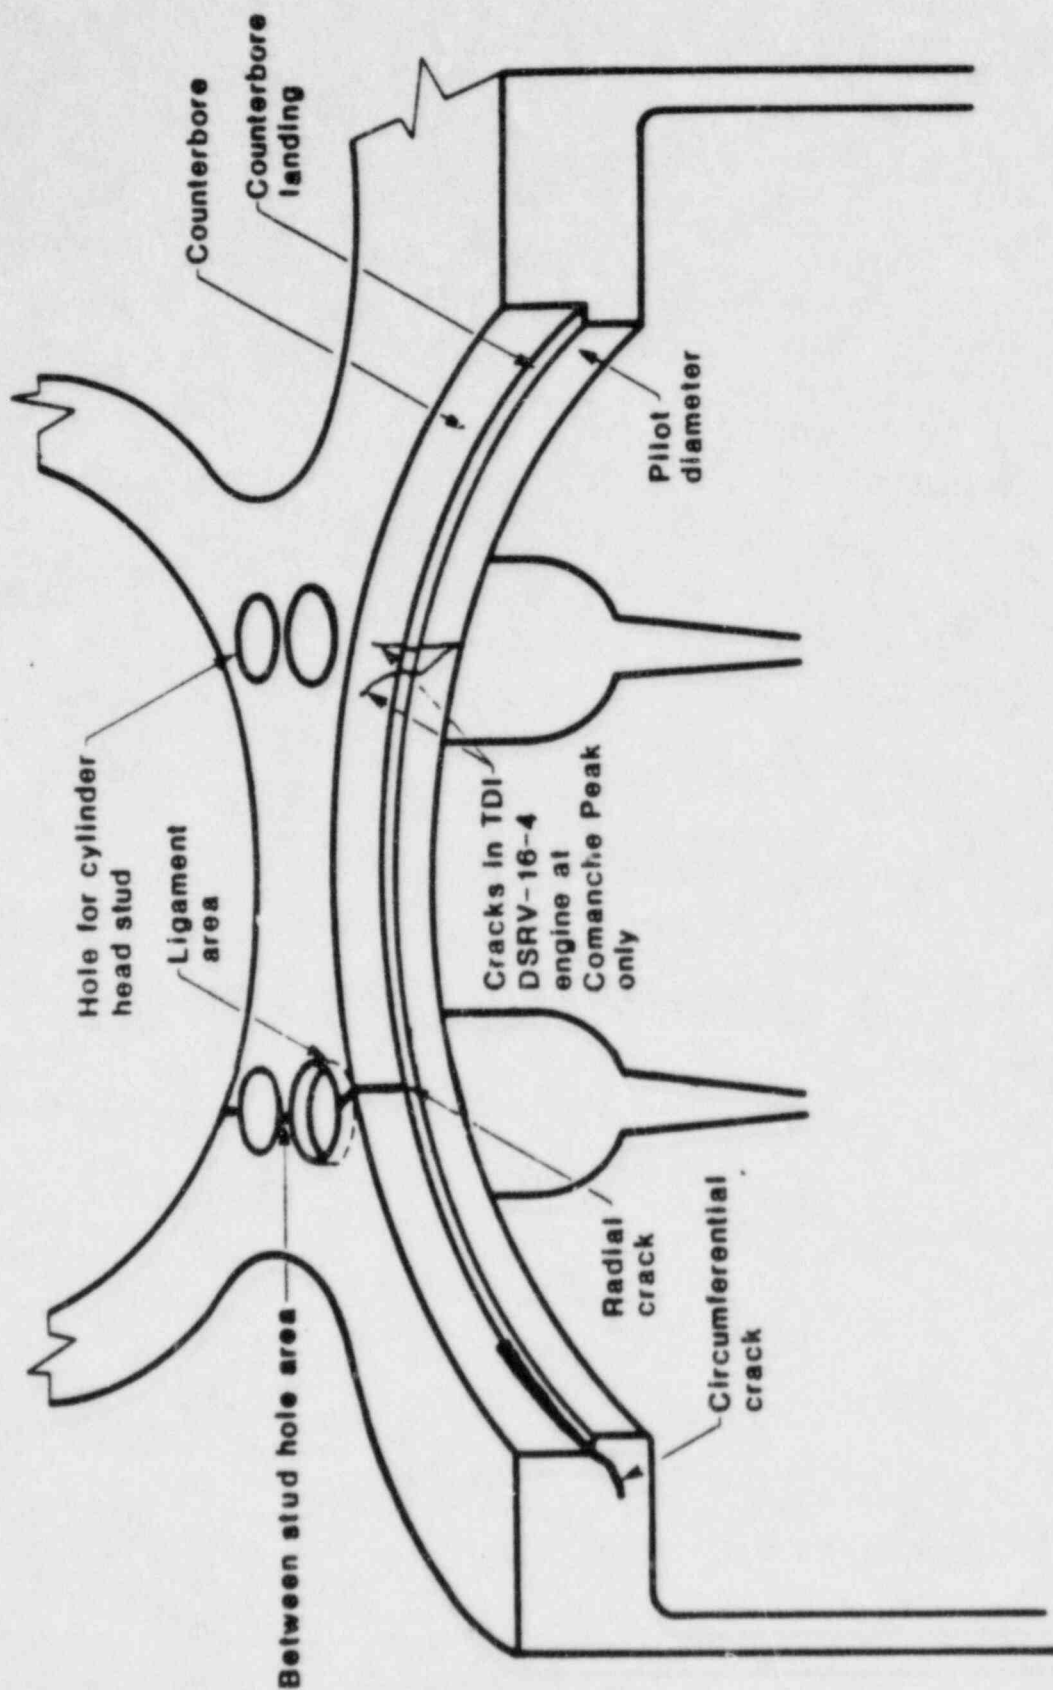
Figure 1-1. Location of cracks.

A. (Hubbard, Anderson). Yes. The FaAA Block Report erroneously stated that none of the EDG blocks had circumferential cracks. Circumferential cracks are cracks at the corner formed by the cylinder liner counterbore and the cylinder liner landing; a representational drawing of a circumferential crack is shown in
