GULF STATES UTILITIES COMPANY

River Bend Station - Unit 1
Docket No. 50-458

RIVER BEND TRANSAMERICA DELAVAL DIESEL 1A INSPECTION REPORT

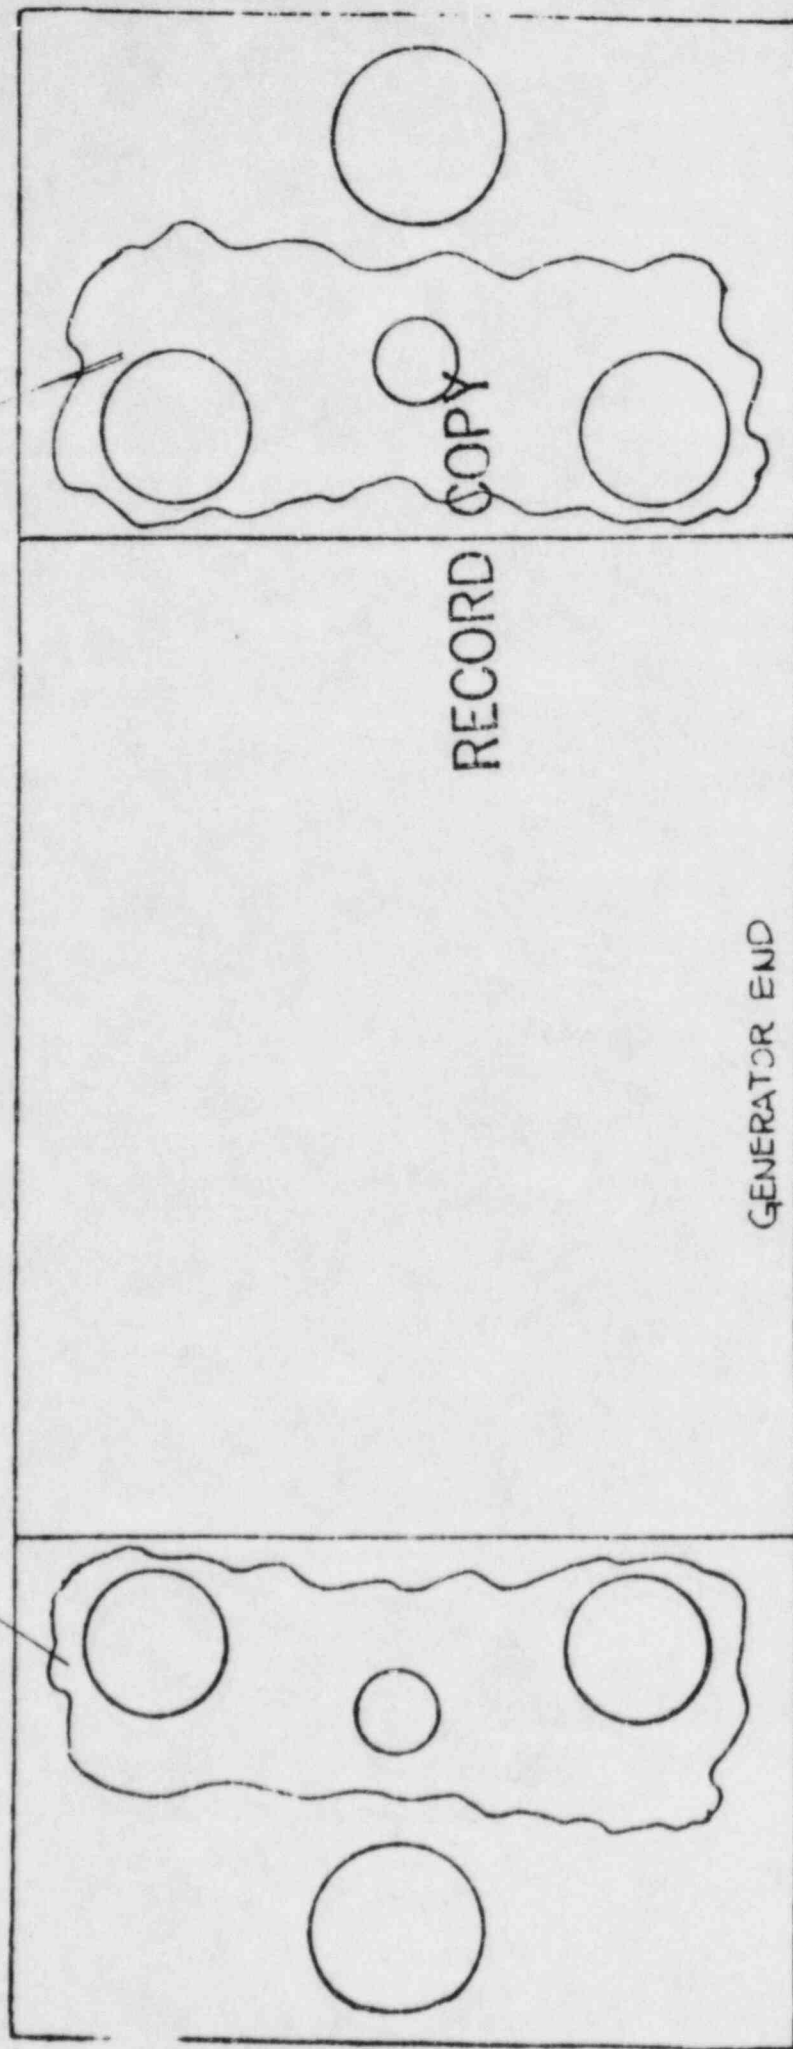
MAIN SADDLE BEARING NO 5

1. No indication of excessive wear, fretting, erosion or corrosion was observed in the main bearing saddle area (Satisfactory).
2. No indication of fretting was observed in the cap mating surfaces (Satisfactory).

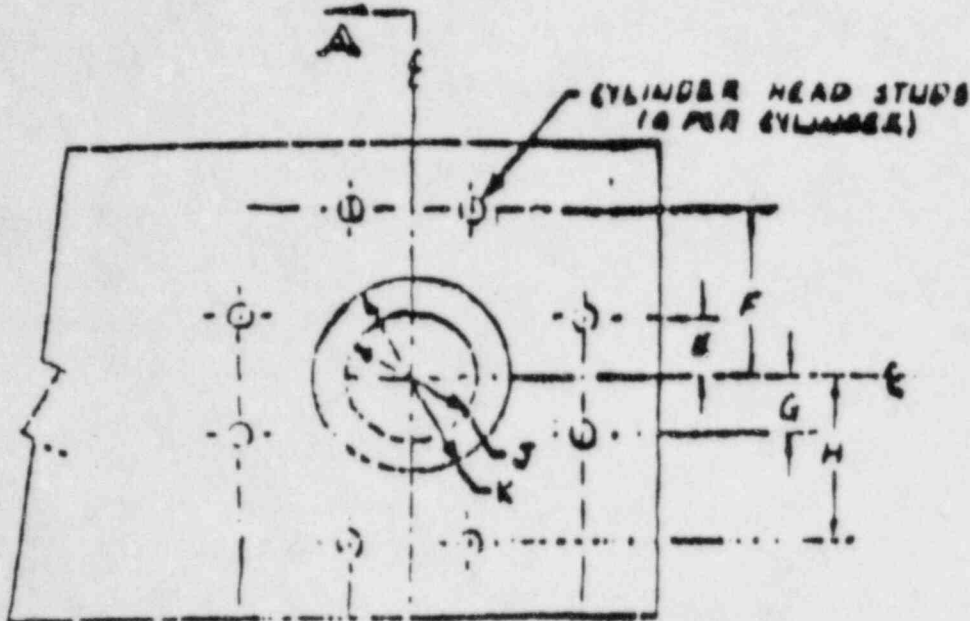
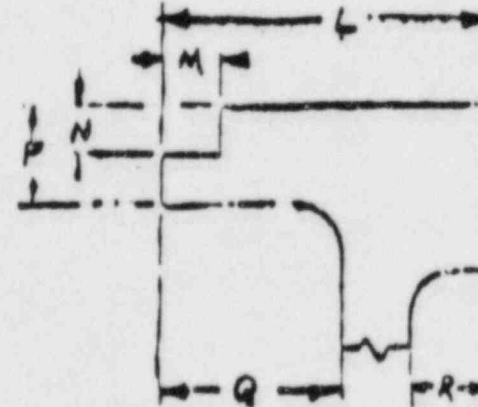
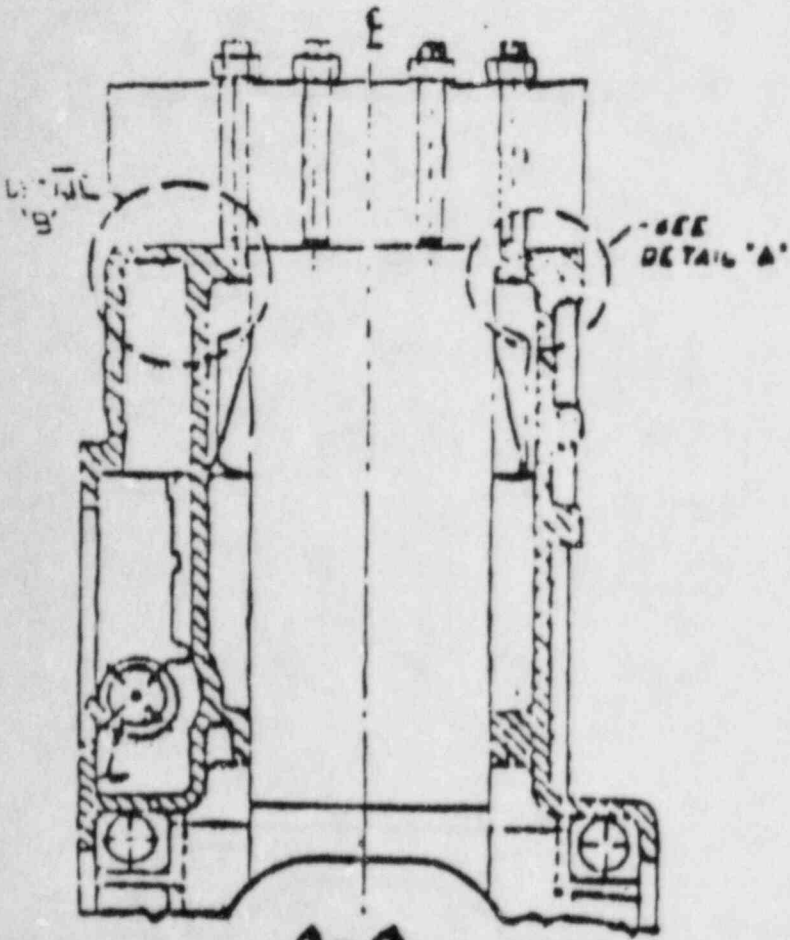
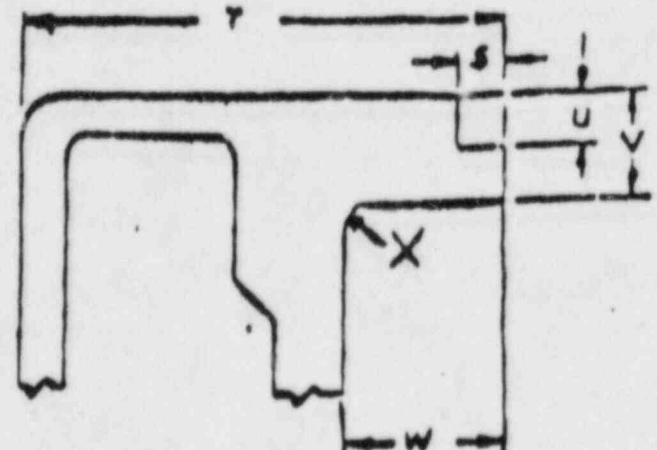
CYLINDER BLOCK

1. Dimensional inspection of cylinder block was performed and preliminary information is satisfactory. Awaiting final disposition from TDI Owners Group.
2. Completed LP inspection of the cylinder block liner landing. No indications evident (Satisfactory).
3. Completed MT of the engine block top. No indications observed (Satisfactory).
