UNITED STATES OF AMERICA
NUCLEAR REGULATORY COMMISSION

In the Matter of)	
)	
LONG ISLAND LIGHTING COMPANY)	Docket No. 50-322(OL)
)	
(Shoreham Nuclear Power Station,)	
Unit 1))

SUPPLEMENTAL TESTIMONY OF ROGER L. MCCARTHY,
CHARLES A. RAU, CLIFFORD H. WELLS,
HARRY F. WACHOB, DUANE P. JOHNSON,
CRAIG K. SEAMAN, EDWARD J. YOUNGLING
AND MILFORD H. SCHUSTER ON BEHALF OF
LONG ISLAND LIGHTING COMPANY ON SUFFOLK
COUNTY CONTENTION REGARDING CYLINDER BLOCKS

Exhibit B-59

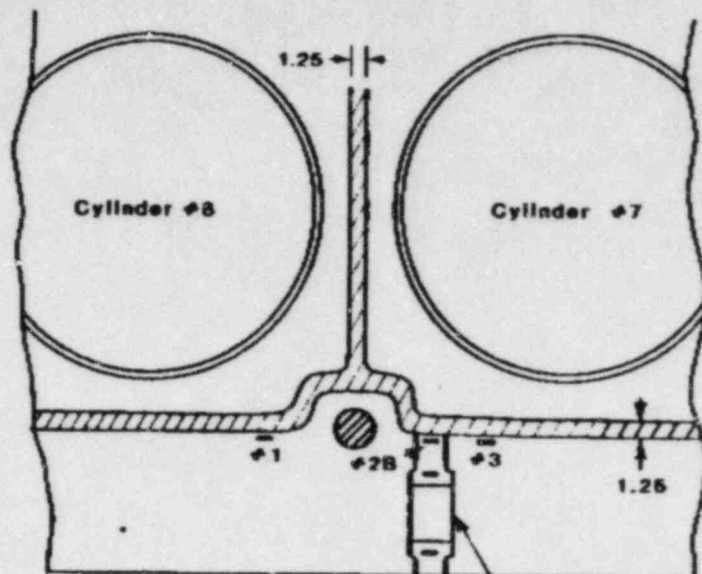
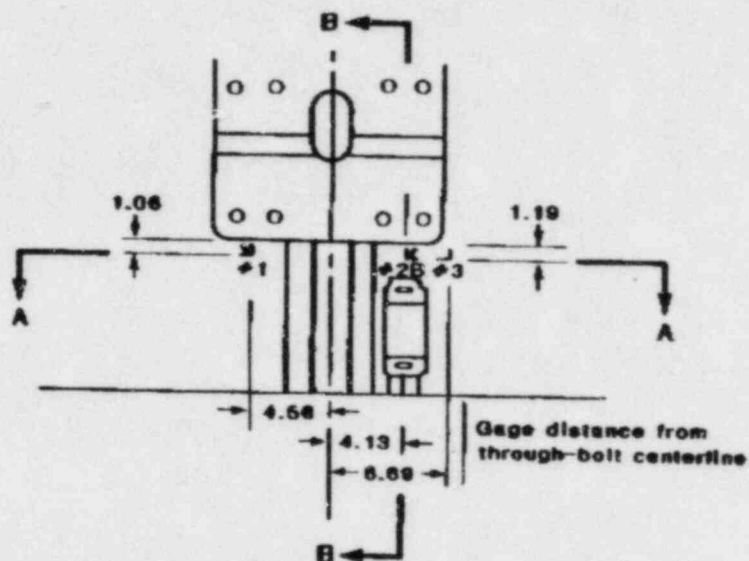
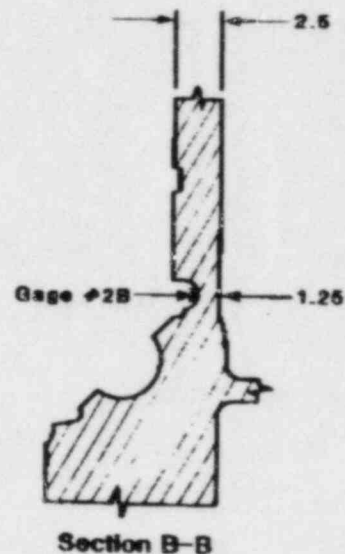
B-59-1

Gages

- #1, 2B Rosettes (vertical, 45°, horizontal)
- #3 Biaxial (vertical, horizontal)

SCHEMATIC OF SHOREHAM EDG-103
CAM GALLERY
CAM SADDLE #8 STRAIN GAGE LOCATIONS

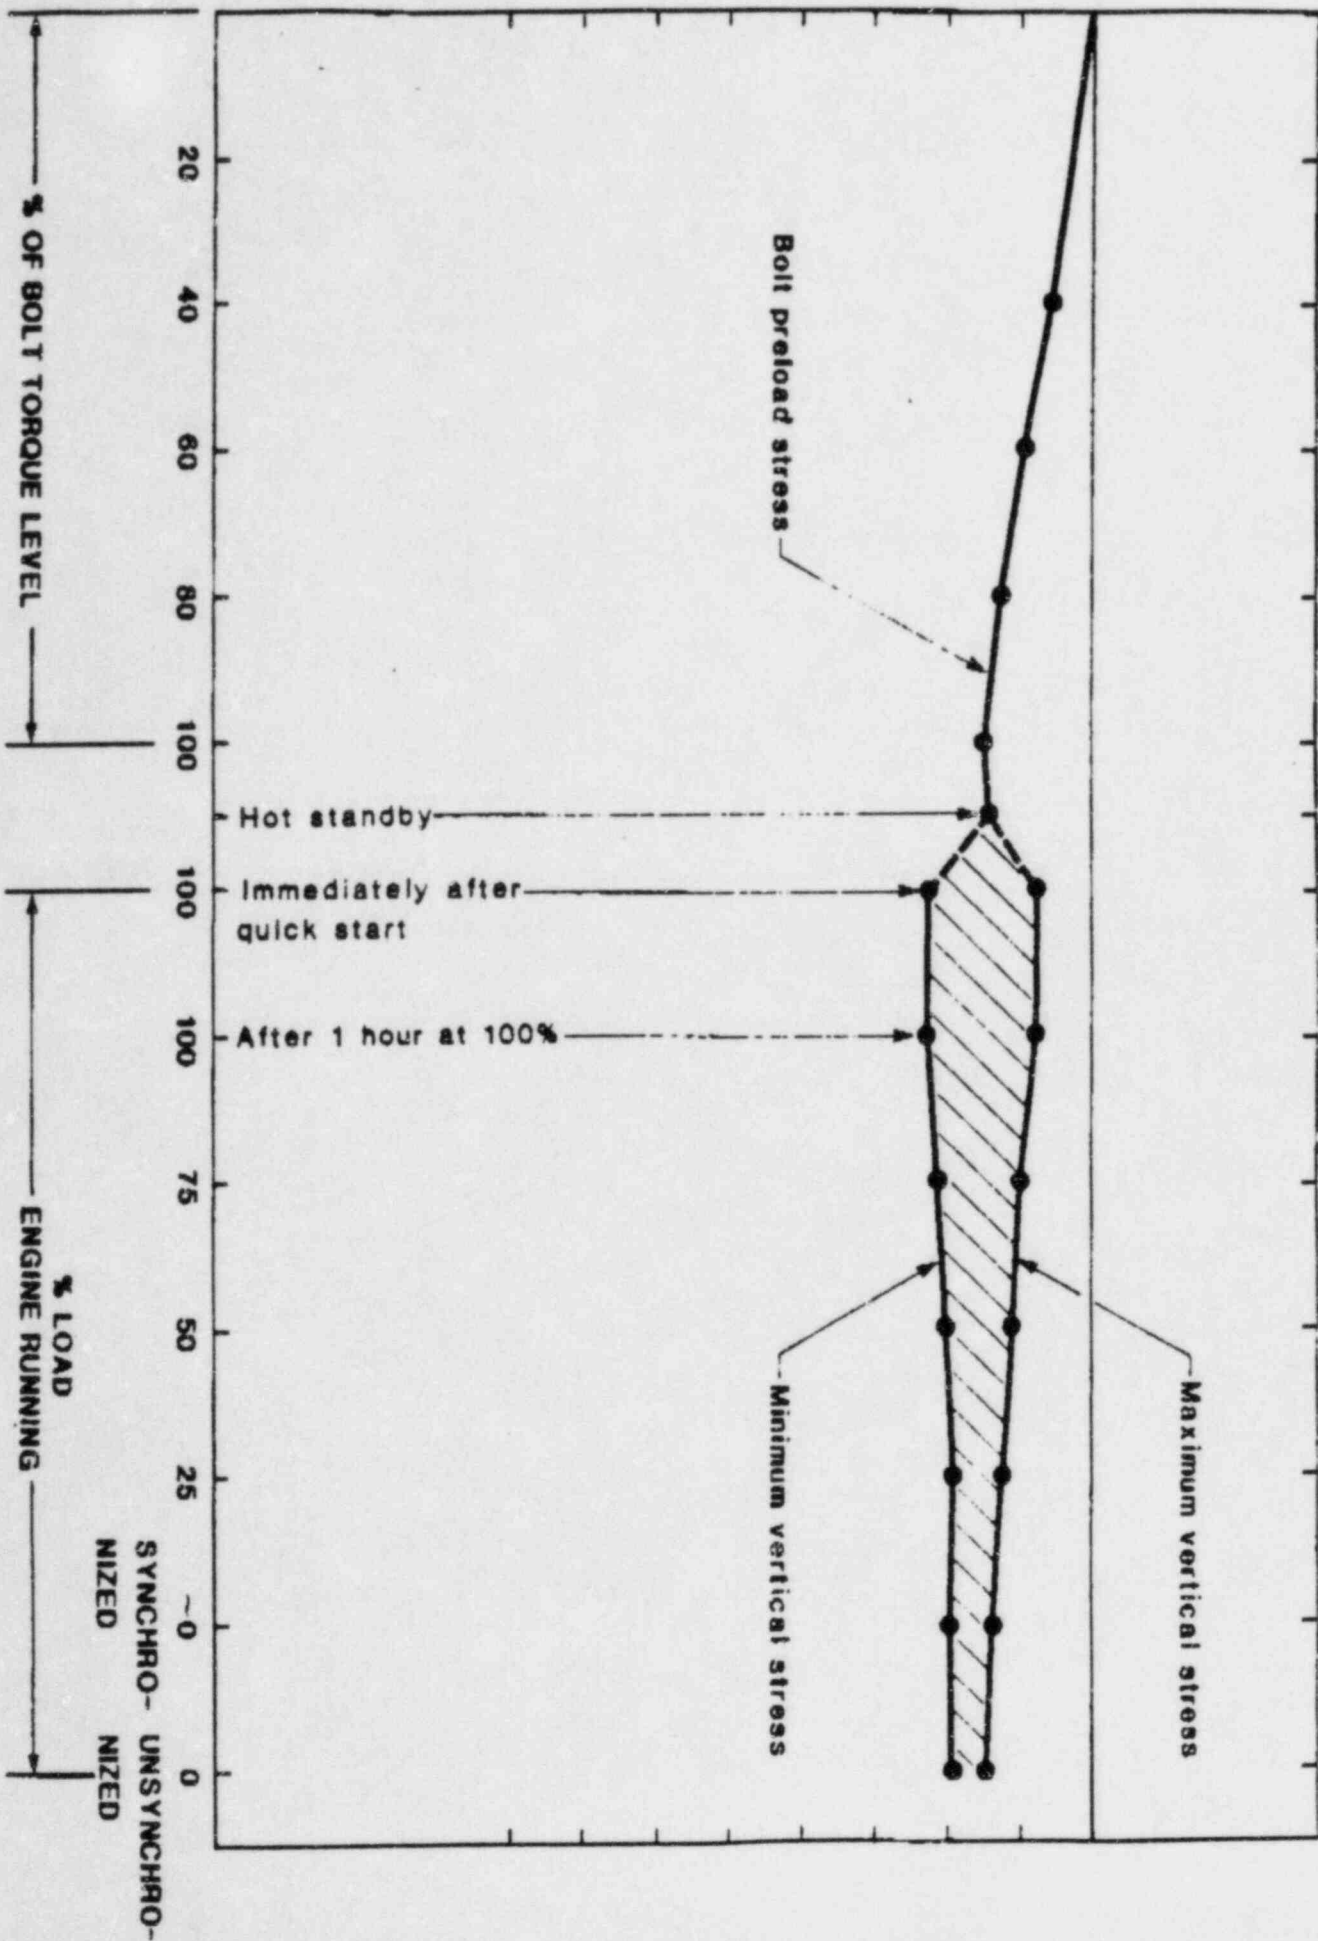
B-59-2

Left of Saddle #8
Gage #1

SHOREHAM DG-103 REPLACEMENT BLOCK
CAM GALLERY STRAIN GAGE TEST

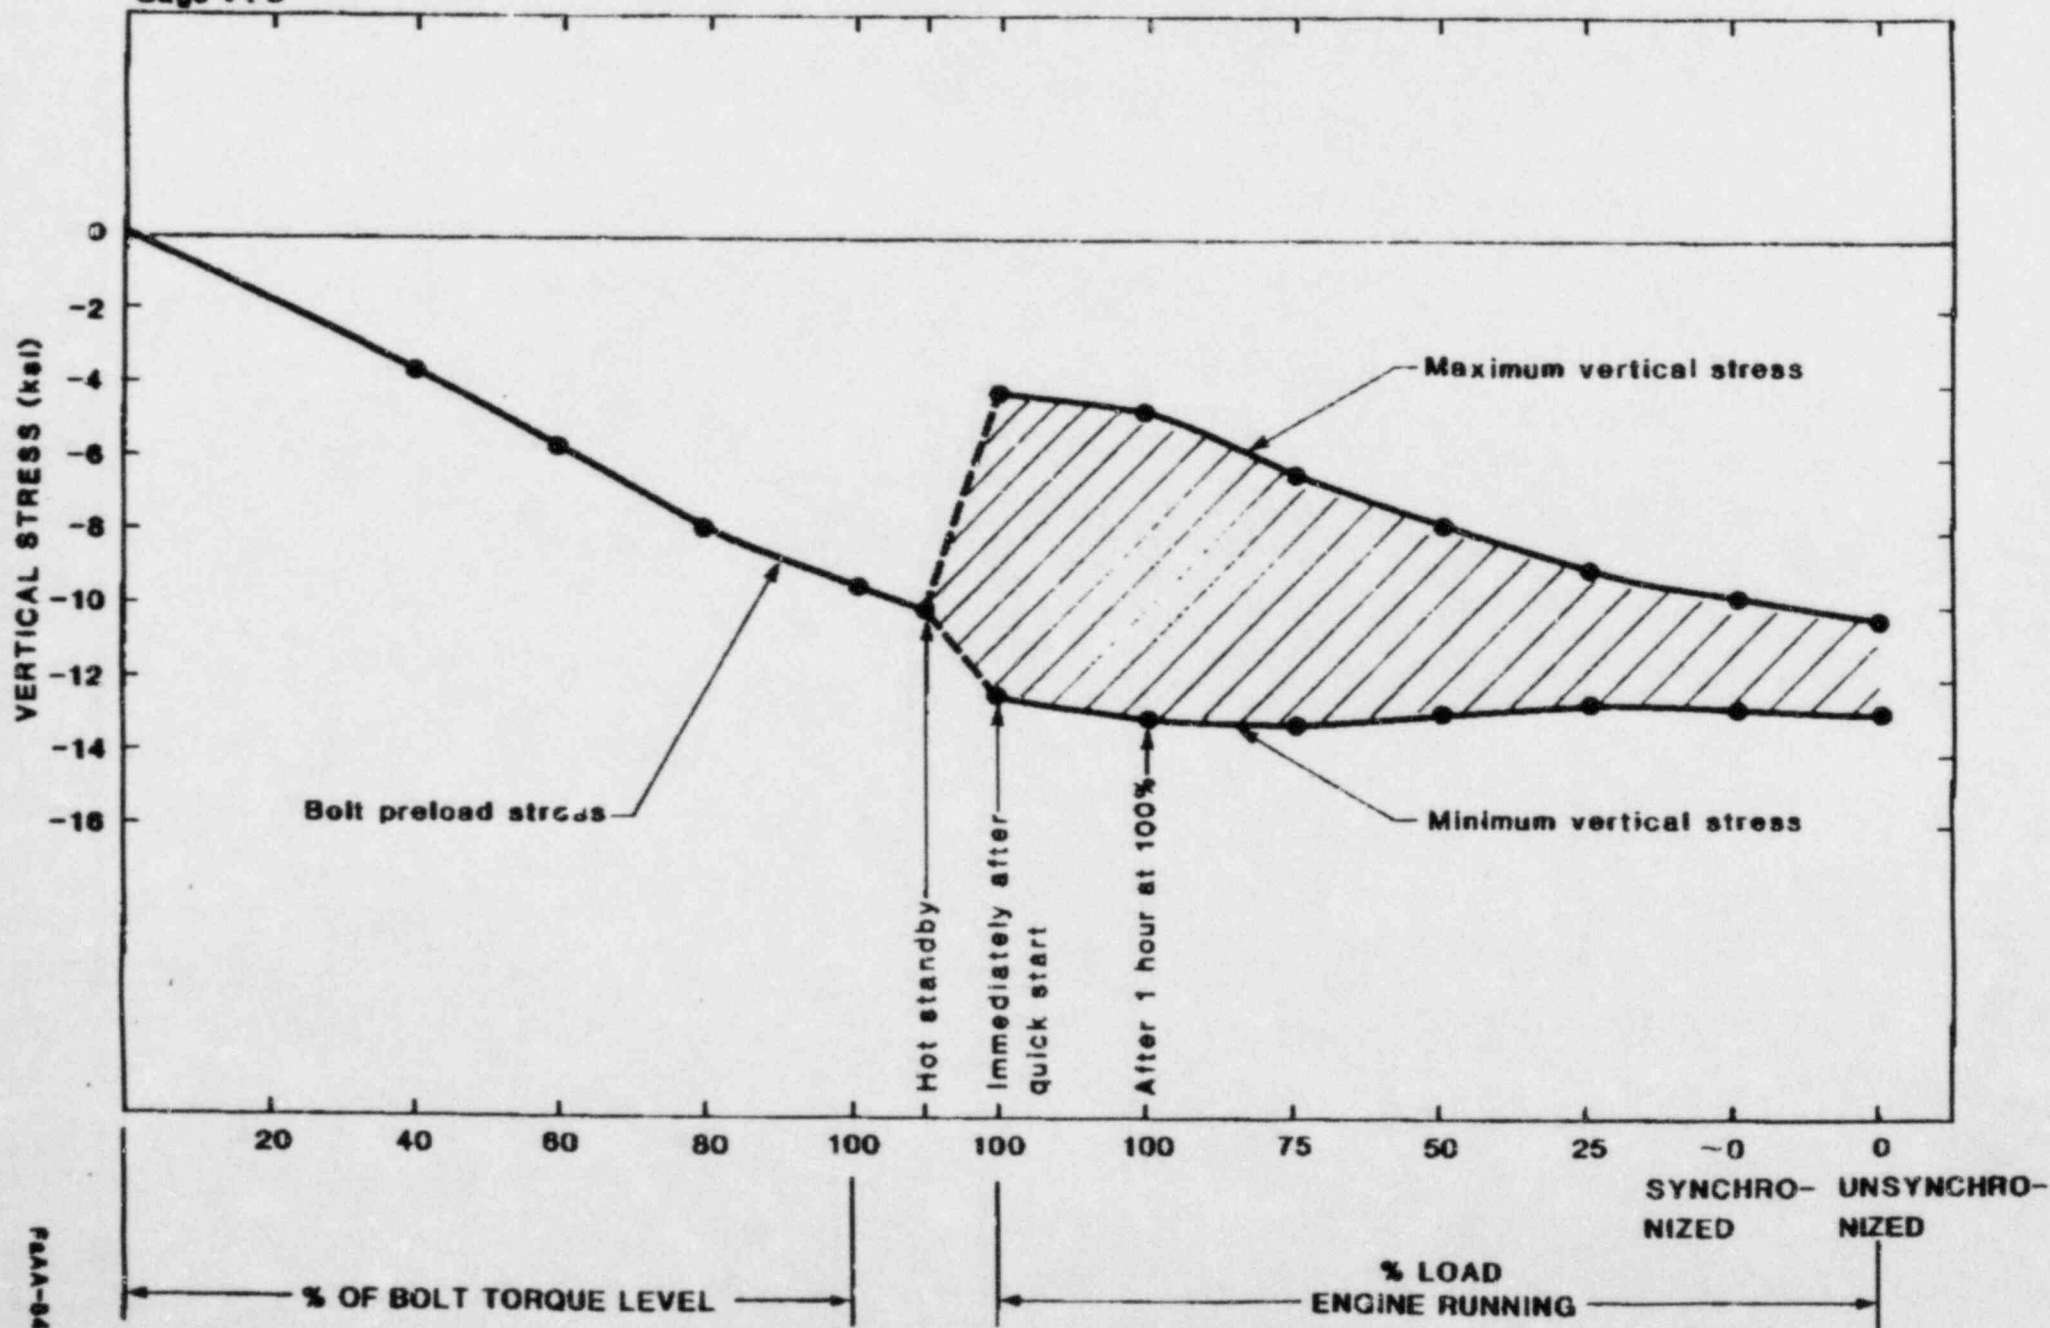
B-59-3

On Saddle #8
Gage #2B

SHOREHAM DG-103 REPLACEMENT BLOCK CAM GALLERY STRAIN GAGE TEST

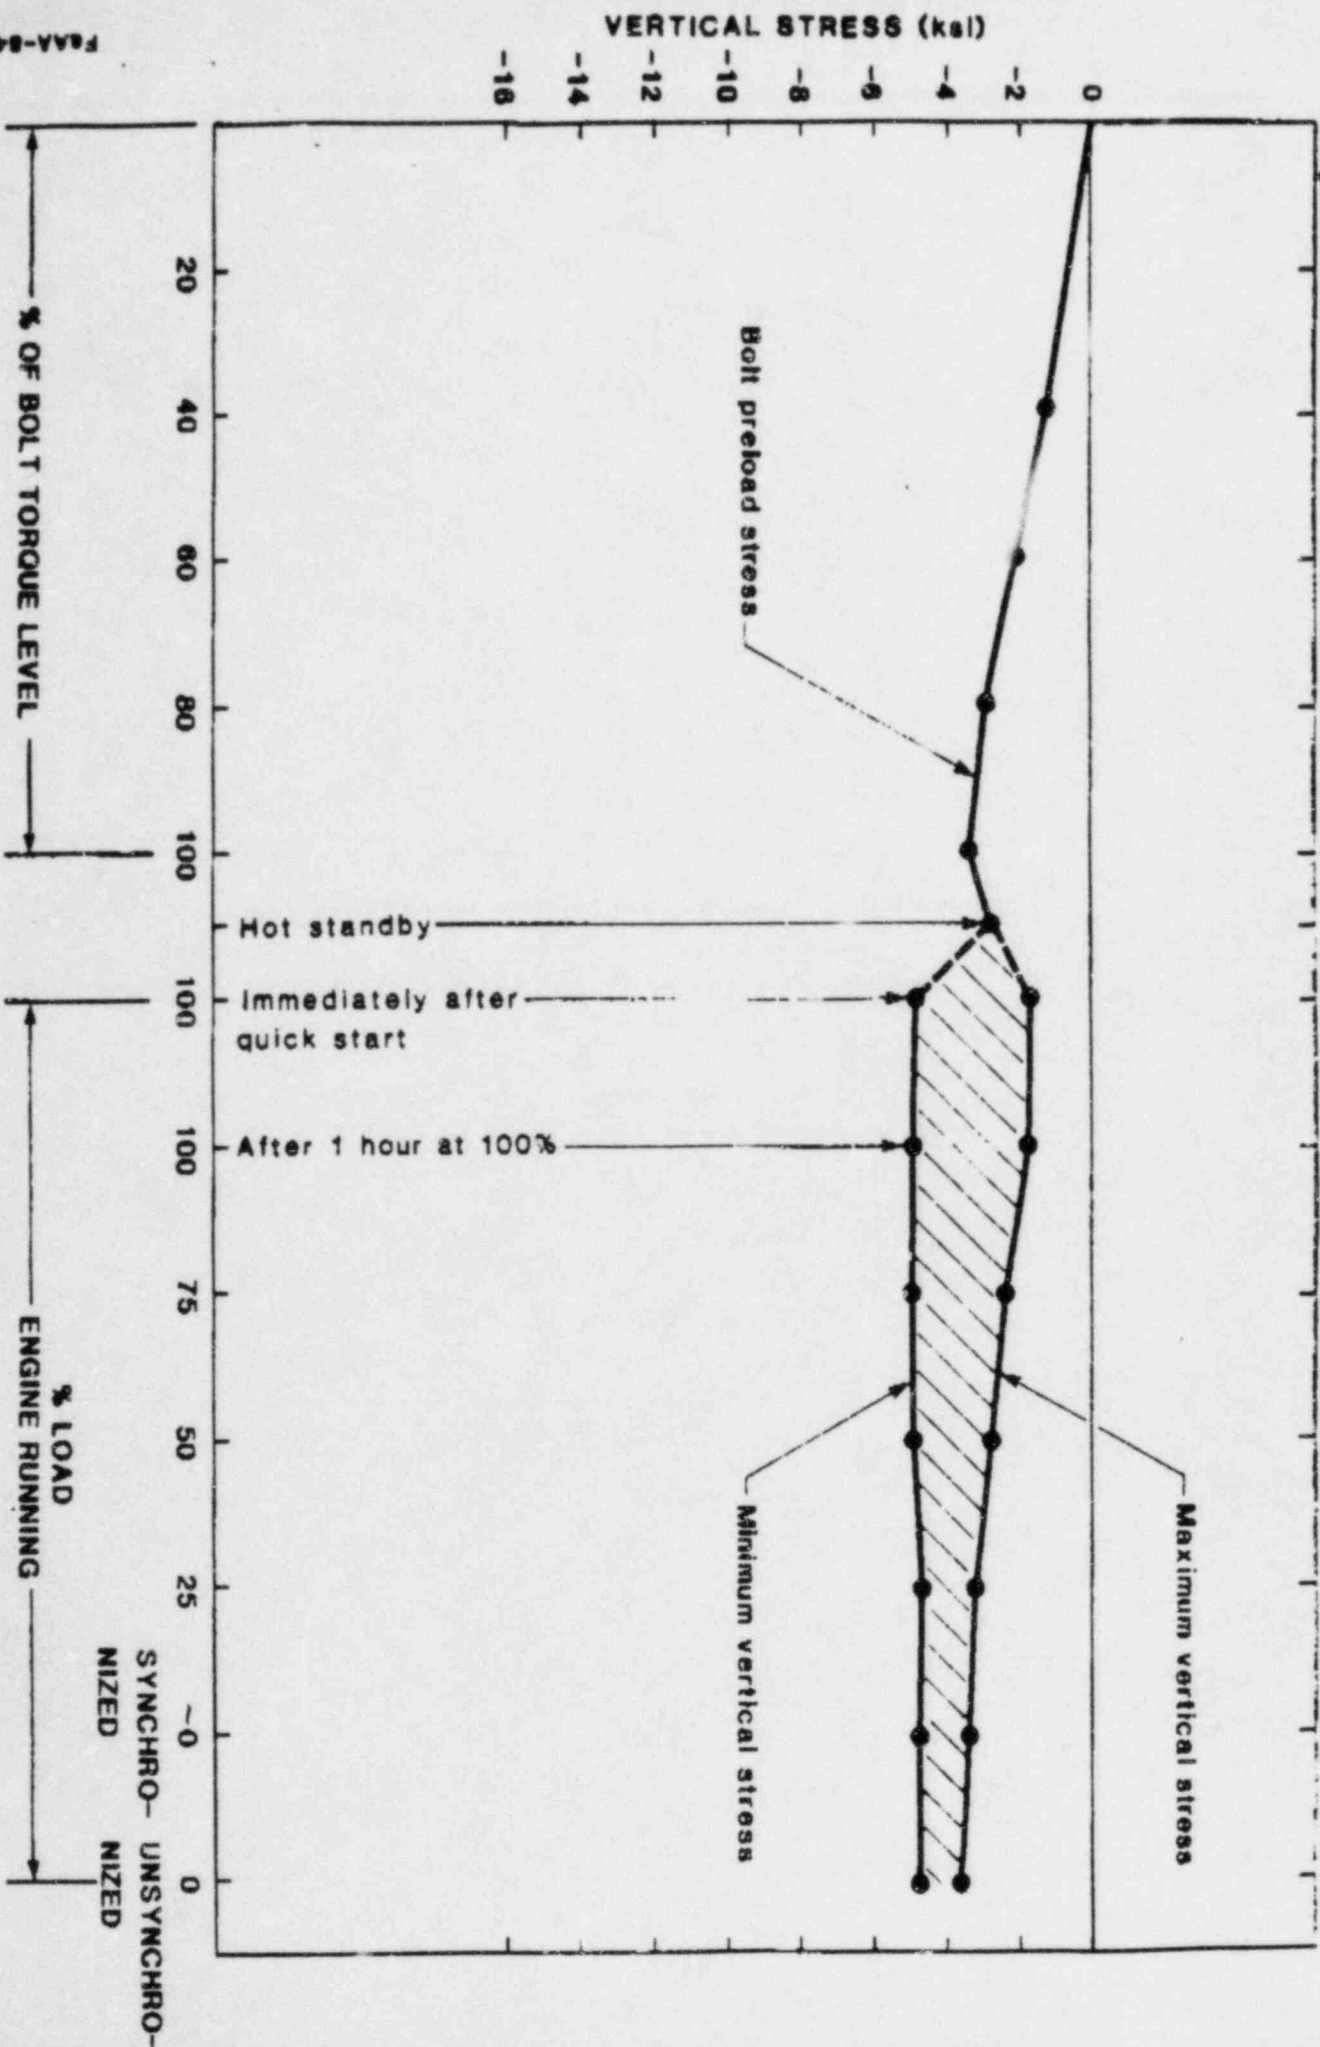
B-59-4

Right of Saddle #8
Gage #3

SHOREHAM DG-103 REPLACEMENT BLOCK
CAM GALLERY STRAIN GAGE TEST

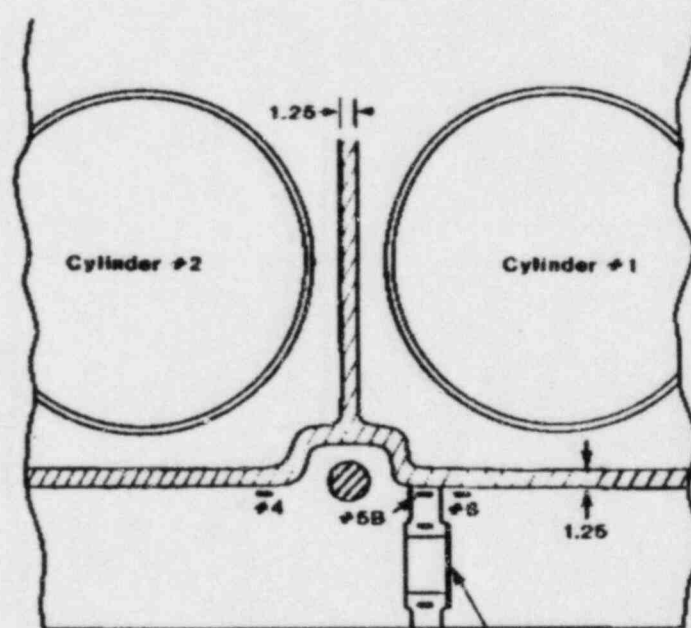
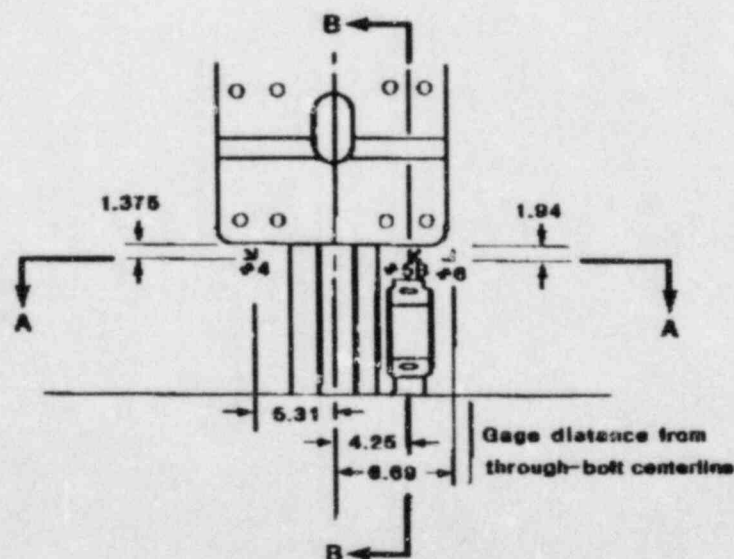
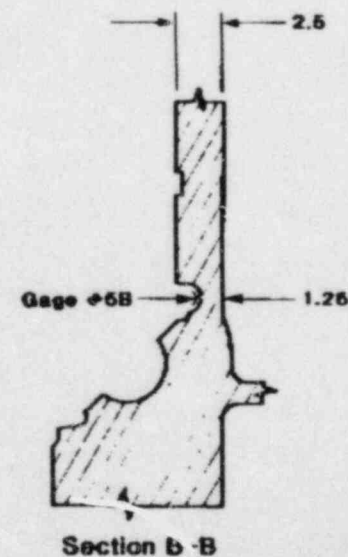
B-59-5

Gages

#4, 5B Rosettes (vertical, 45°, horizontal)

#6 Biaxial (vertical, horizontal)

SCHEMATIC OF SHOREHAM EDG-103
CAM GALLERY
CAM SADDLE #2 STRAIN GAGE LOCATIONS

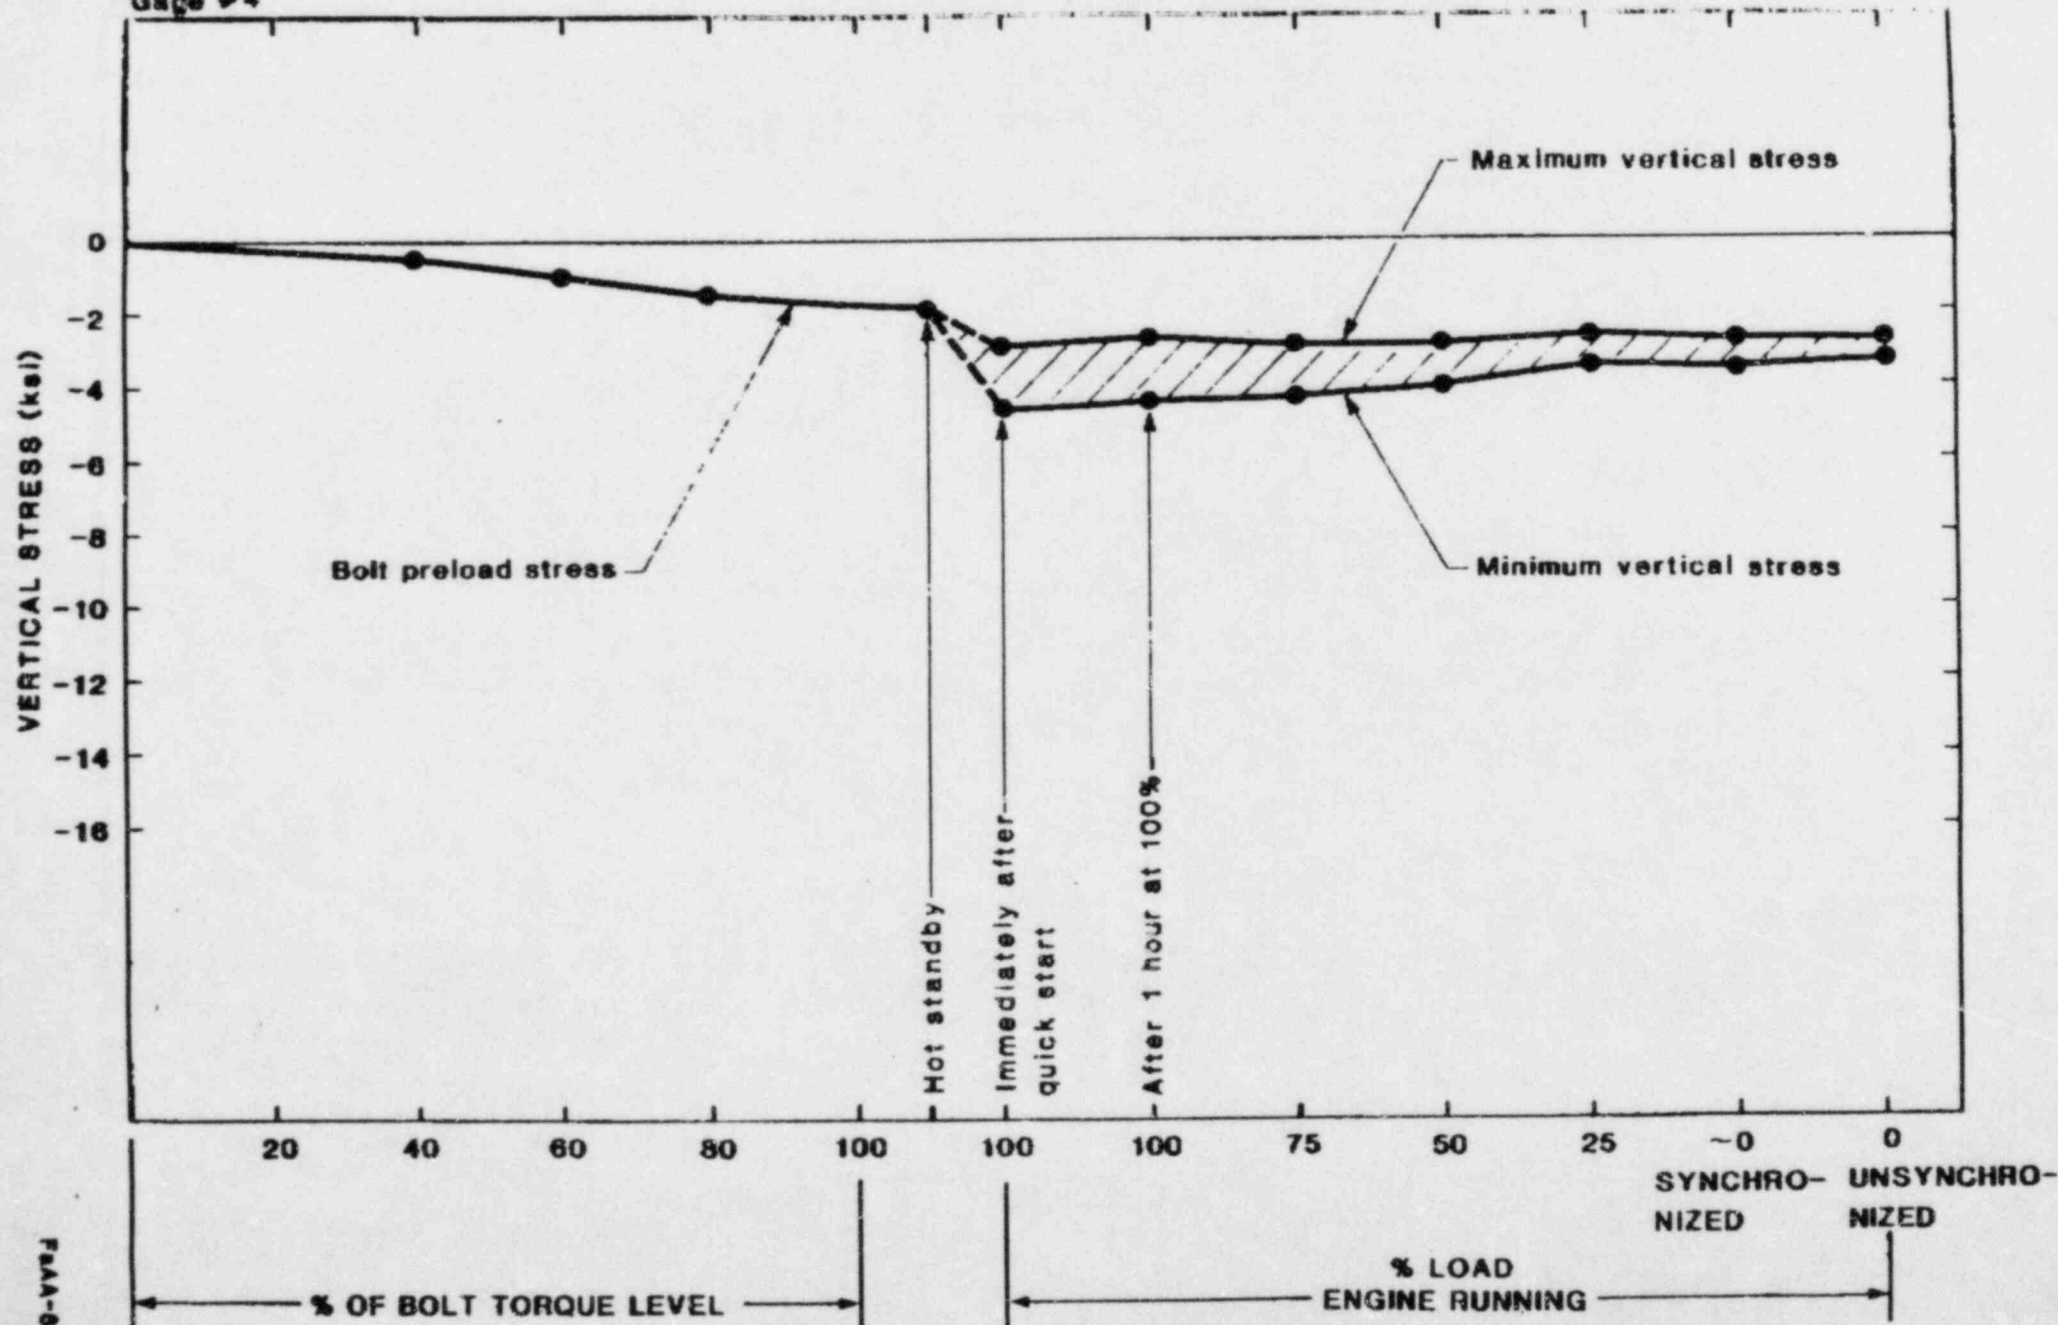
B-59-6

Left of Saddle #2

SHOREHAM DG-103 REPLACEMENT BLOCK CAM GALLERY STRAIN GAGE TEST

Gage #4

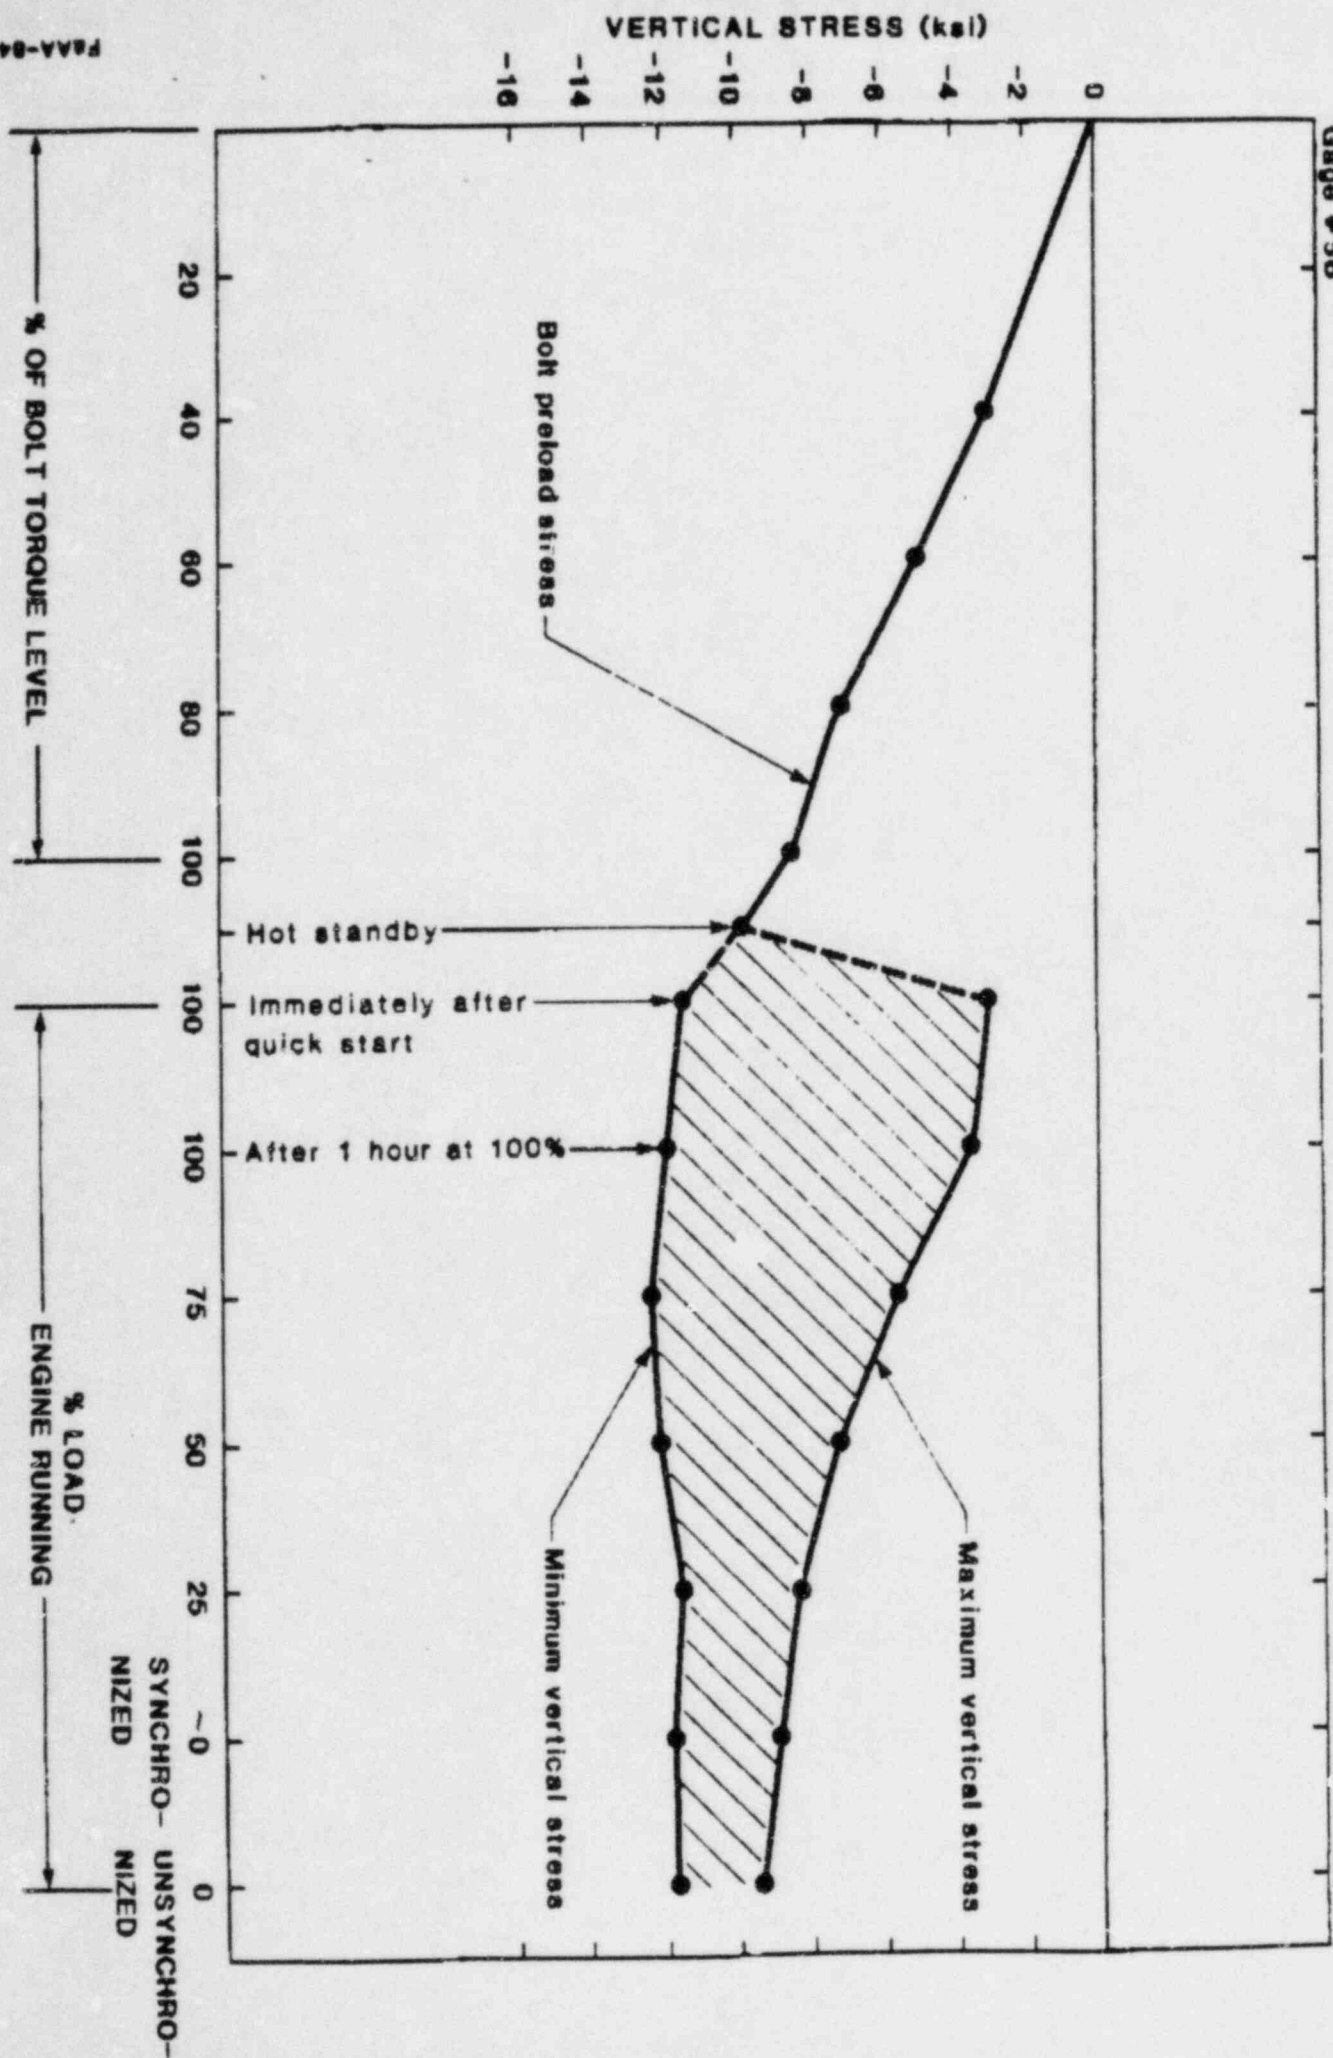
B-59-7

On Saddle #2
Gage #5B

SHOREHAM DG-103 REPLACEMENT BLOCK
CAM GALLERY STRAIN GAGE TEST

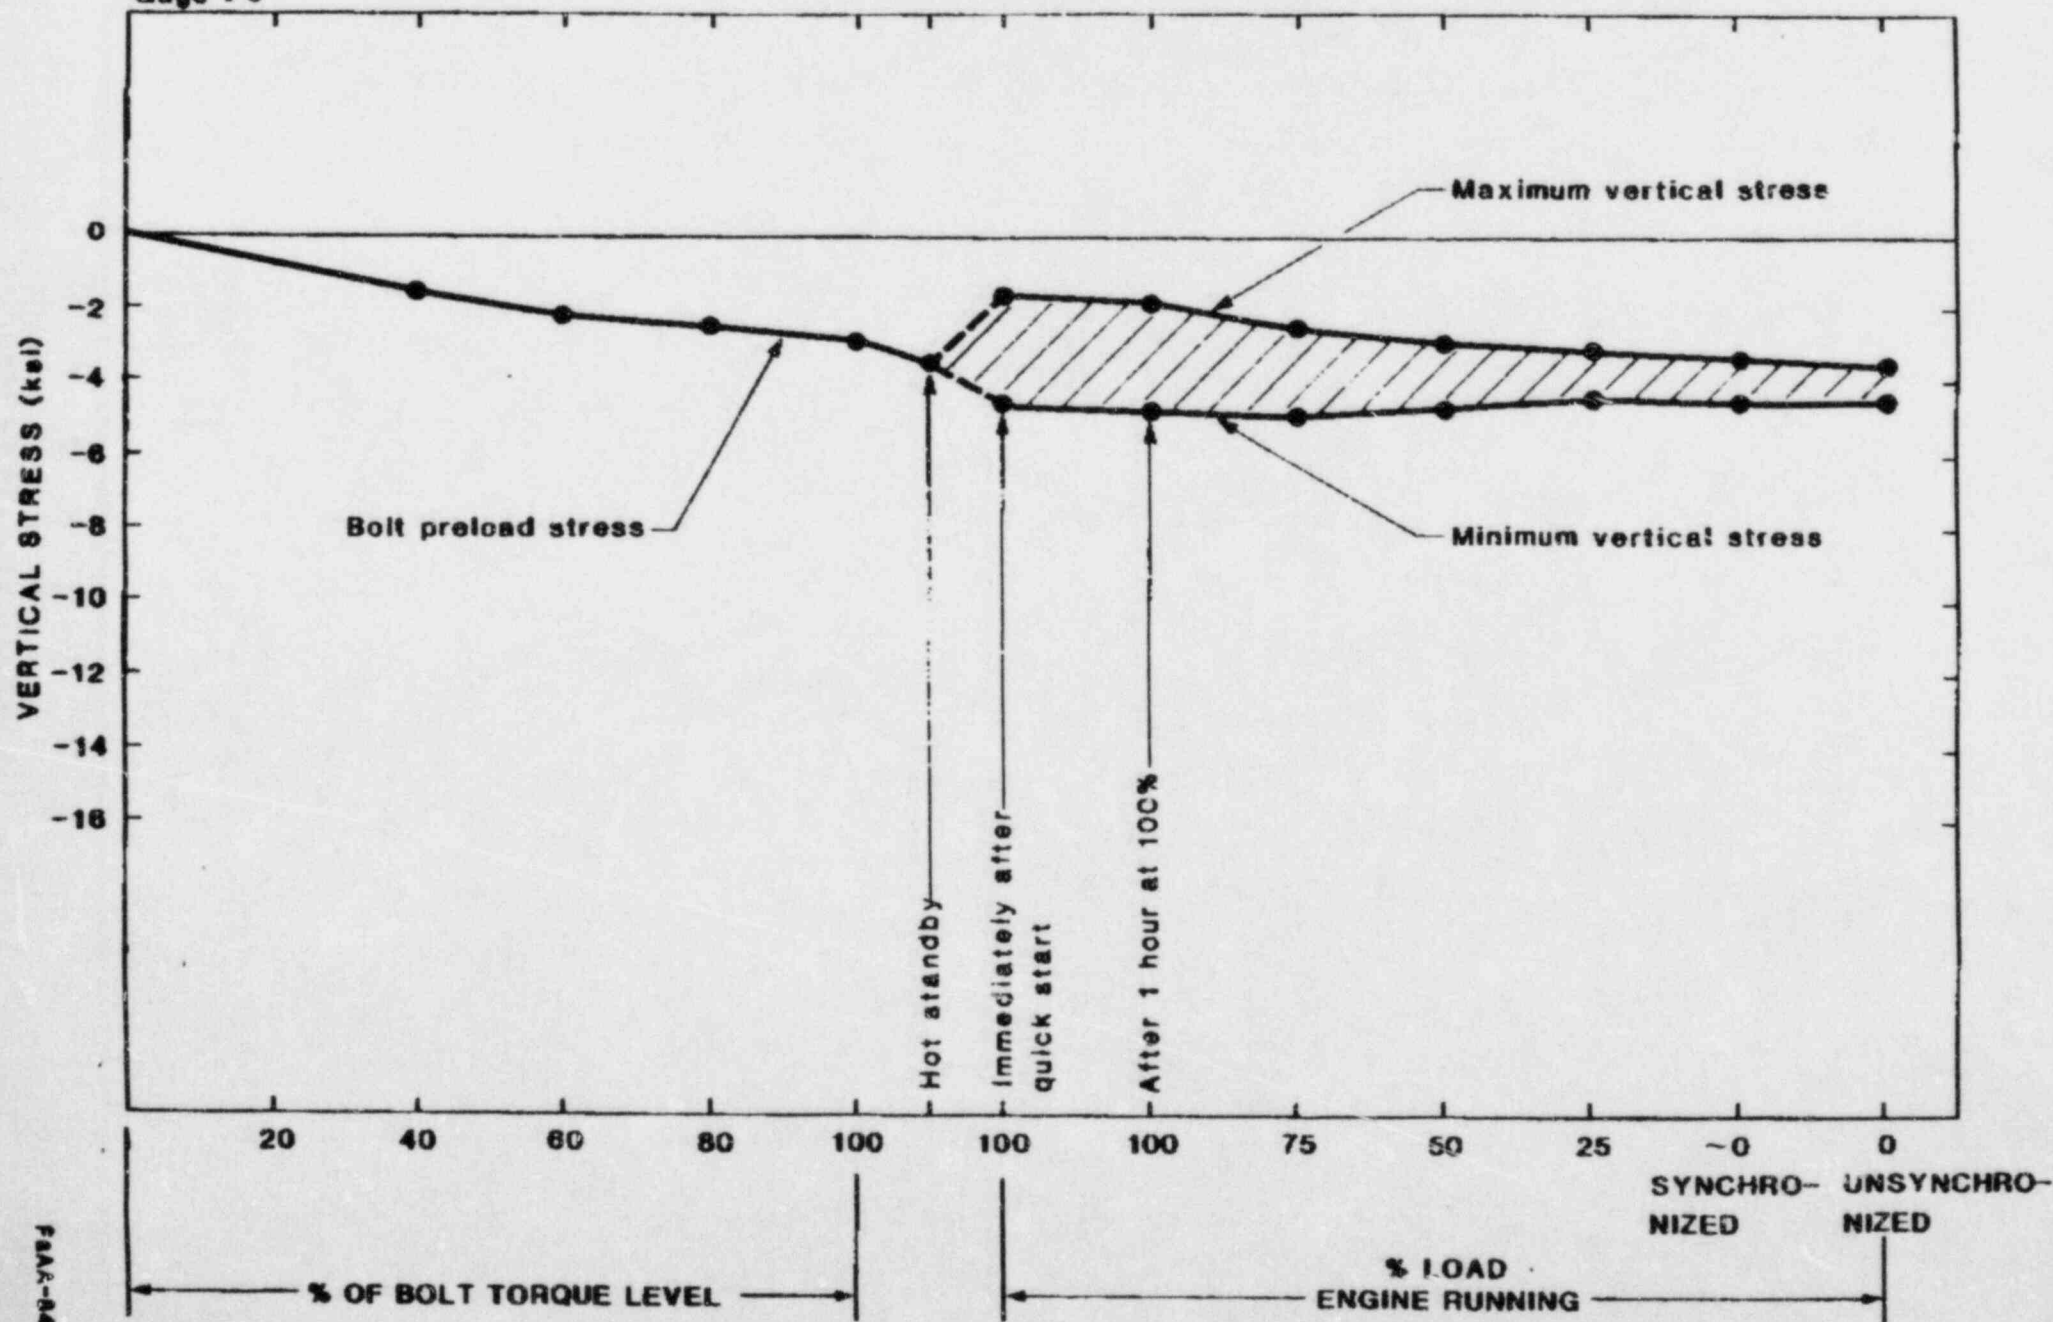
B-69-8

Right of Saddle #2
Gage #8

SHOREHAM DG-103 REPLACEMENT BLOCK
CAM GALLERY STRAIN GAGE TEST
