LICENSEE EVENT REPORT (LER)

FACILITY NAME (1) Calvert Cliffs Unit 1										DOCKET NUMBER (2) 0 5 0 0 0 3 1 7					PAGE (3) 1 OF 013								
TITLE (4) Loss of Circulating Water Caused by Sea Nettle Impingement																							
EVENT DATE (5)			LER NUMBER (6)				REPORT DATE (7)			OTHER FACILITIES INVOLVED (8)													
MONTH	DAY	YEAR	YEAR	SEQUENTIAL NUMBER	REVISION NUMBER	MONTH	DAY	YEAR	FACILITY NAMES N/A				DOCKET NUMBER(S) 0 5 0 0 0										
1	0	0	2	8	4	8	4	0	1	3	0	0	1	0	2	6	8	4	0	5	0	0	0
OPERATING MODE (9) 1		THIS REPORT IS SUBMITTED PURSUANT TO THE REQUIREMENTS OF 10 CFR 8: (Check one or more of the following) (11)																					
POWER LEVEL (10) 0 9 2		20.402(b)				20.406(c)				X 50.73(a)(2)(iv)				73.71(b)

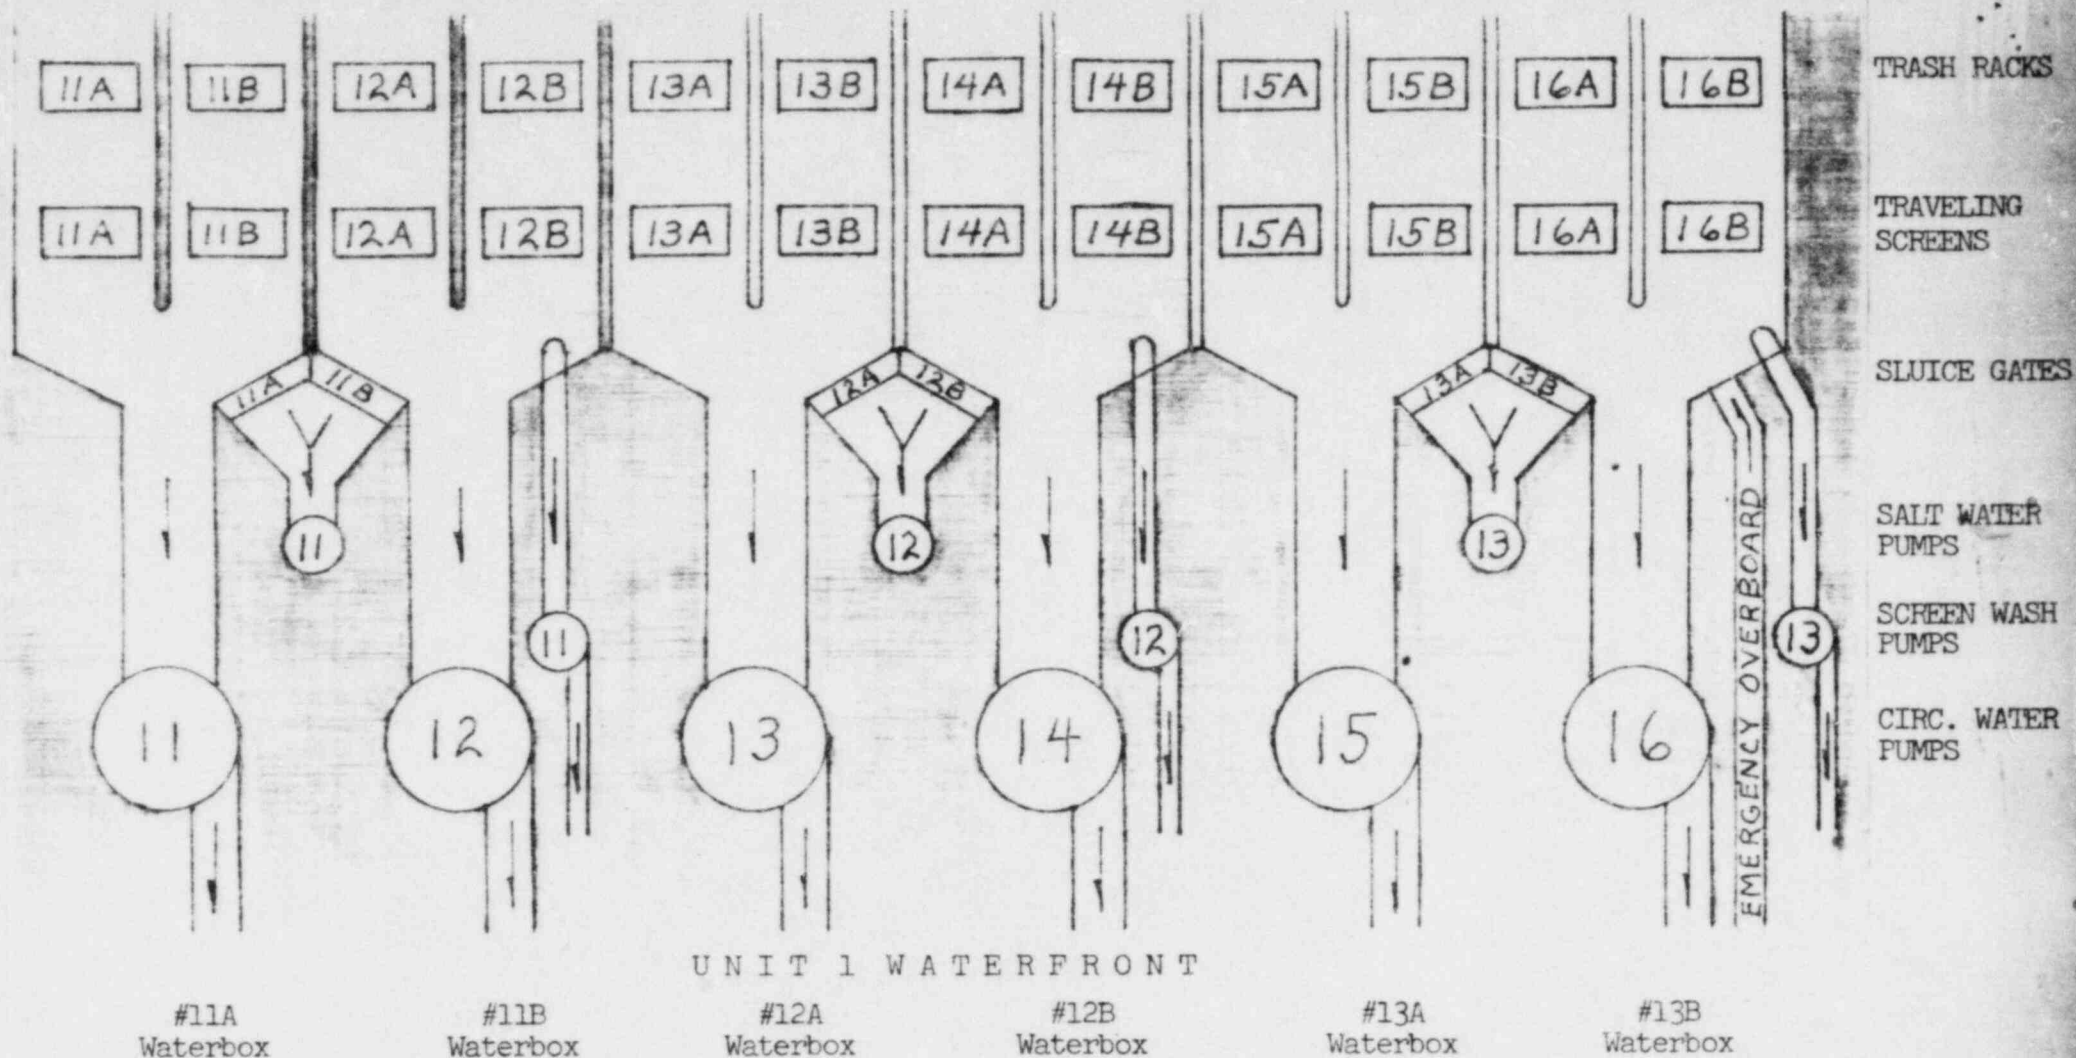
UNIT 1 WATERFRONT

Attachment 1 is provided as a description of the Unit 1 intake structure. Each salt water pump takes suction on either of two adjacent circulating water pump wells. There are three salt water pumps, six circulating water pumps, and twelve traveling water screens for each unit.
