GE Nuclear Energy

GENE-523-A110-1095

October 1995

A STRUCTURAL MARGIN EVALUATION FOR HATCH 2 INTERNAL CORE SPRAY LINES

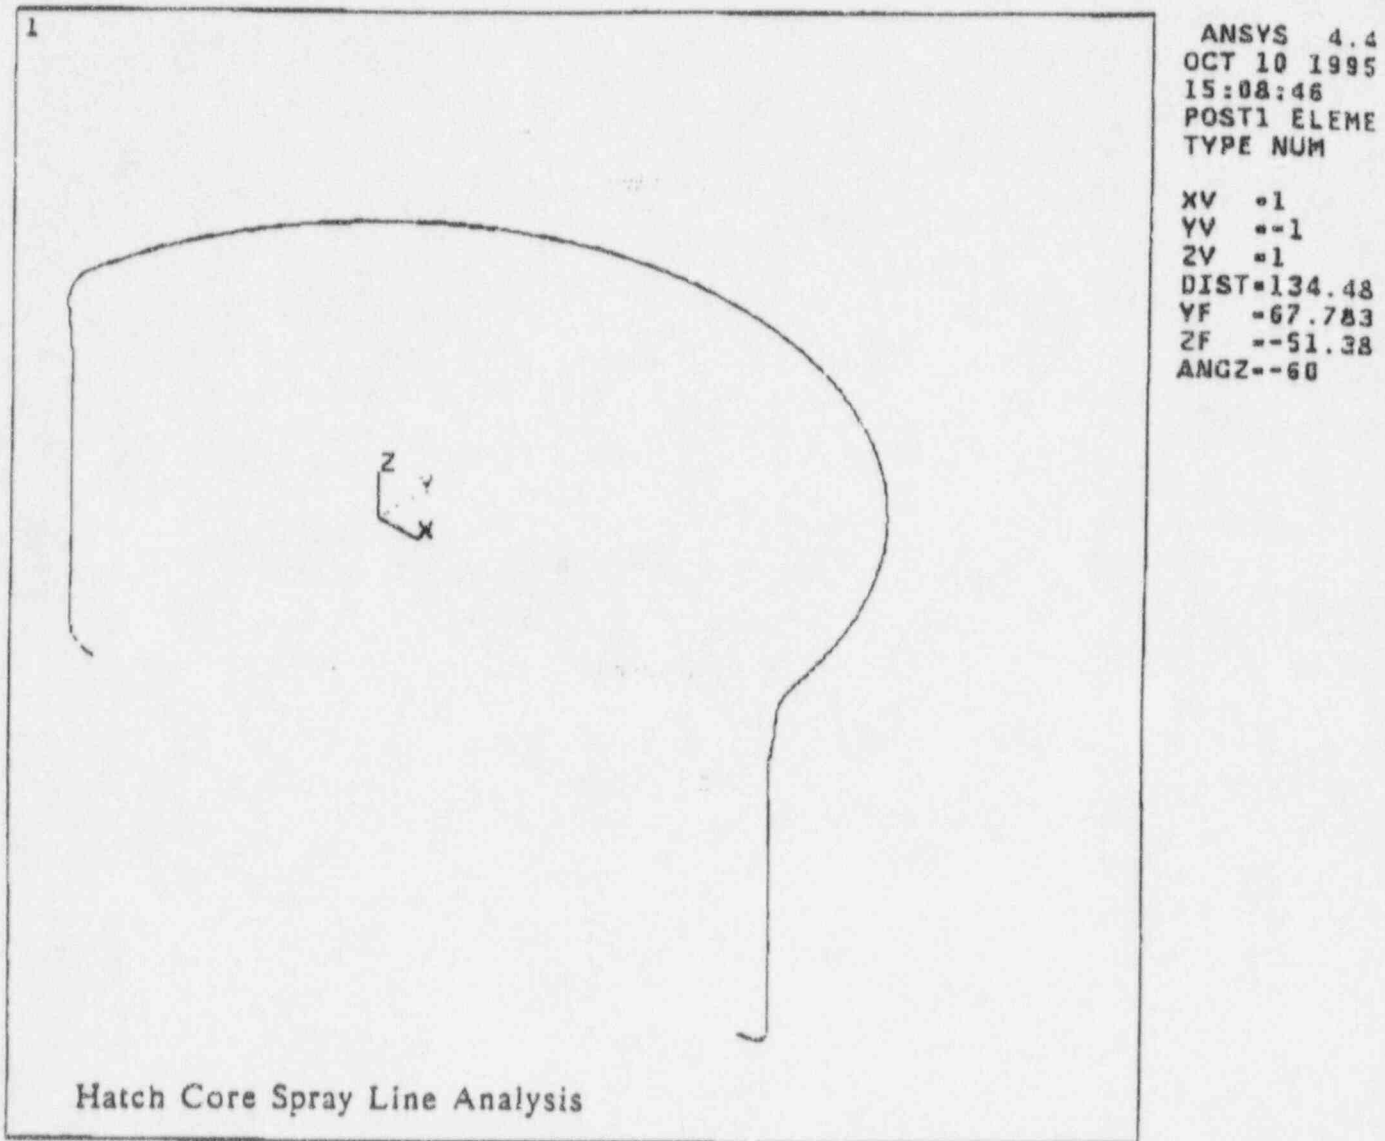
Figure 1 Finite Element Model of Core Spray System

A finite element model was constructed using the geometry of a core spray line very similar to that of Hatch 2. Figure 1 shows the geometry of the model. The stress analysis was conducted using ANSYS computer code (Reference 3). Loads due to the weight of the pipe (including captured water in the pipe) were applied to the model along with vertical and horizontal seismic loads and reactor vessel downcomer flow impingement loads. The largest resulting stresses were used from the finite element model results. These stresses were then combined with the stresses due to pressure and core spray flow loads. The resulting total stresses are shown in Table 1 on the next page as noted above, the loads due to thermal mismatch of the core spray line and reactor vessel need not be included as they are secondary in nature.

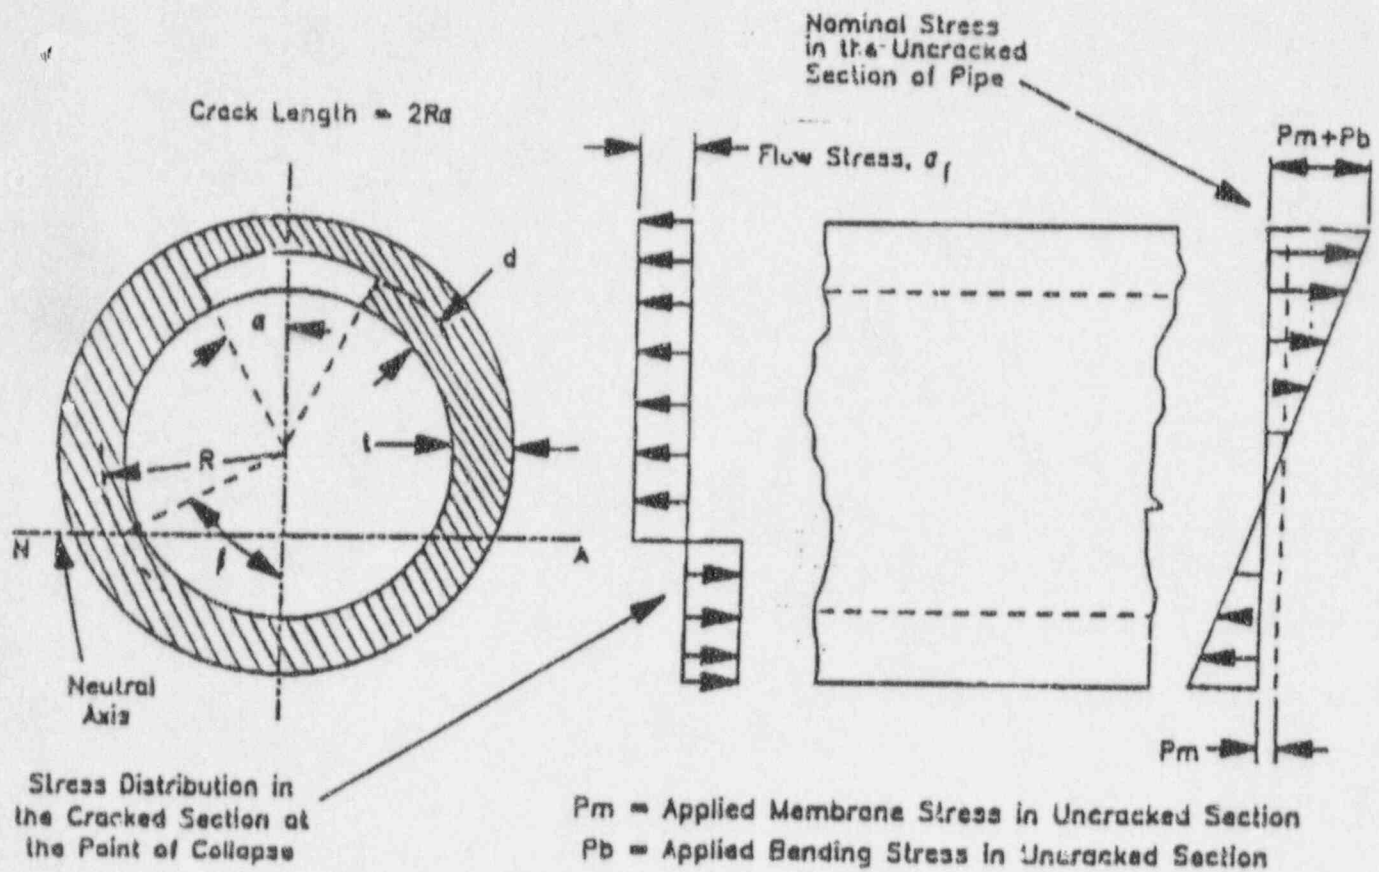
Figure 2 Stress Distribution in a Cracked Pipe at the Point of Collapse

Consider a circumferential crack of length, $l = 2R\alpha$, and constant depth, d , located as shown in Figure 2. In order to determine the point at which collapse occurs, it is necessary to apply the equations of equilibrium assuming that the cracked section behaves like a hinge. For this condition, the assumed stress state at the cracked section is as shown in Figure 2 where the maximum stress is the flow stress of the material, σ_f . Equilibrium of longitudinal forces and moments about the axis gives the following equations:

Using the stresses of Table 1 and a d/t ratio of 1.0 (through-wall flaw), the allowable through-wall crack for which failure by collapse might occur is 263°.
