LICENSEE EVENT REPORT (LER)

FACILITY NAME (1) CRYSTAL RIVER UNIT 3										DOCKET NUMBER (2) 0 5 0 0 0 3 0 2										PAGE (3) 1 OF 0 3																													
TITLE (4) AUXILIARY BUILDING EXHAUST FANS OUT OF SERVICE FOR MAINTENANCE																																																	
EVENT DATE (5)										LER NUMBER (6)										REPORT DATE (7)										OTHER FACILITIES INVOLVED (8)																			
MONTH			DAY			YEAR			YEAR			SEQUENTIAL NUMBER			REVISION NUMBER			MONTH			DAY			YEAR			FACILITY NAMES N/A										DOCKET NUMBER(S) 0 5 0 0 0												
0 6			2 5			8 4			8 4			0 1			4			0 0			0 7			2 5			8 4			N/A										0 5 0 0 0									
OPERATING MODE (9) 1										THIS REPORT IS SUBMITTED PURSUANT TO THE REQUIREMENTS OF 10 CFR § (Check one or more of the following) (11)																																							
POWER LEVEL (10) 0 9 9										20.402(b)										20.405(c)										50.73(a)(2)(iv)										73.71(b)

AUXILIARY BUILDING
EXHAUST VENTILATION SYSTEM

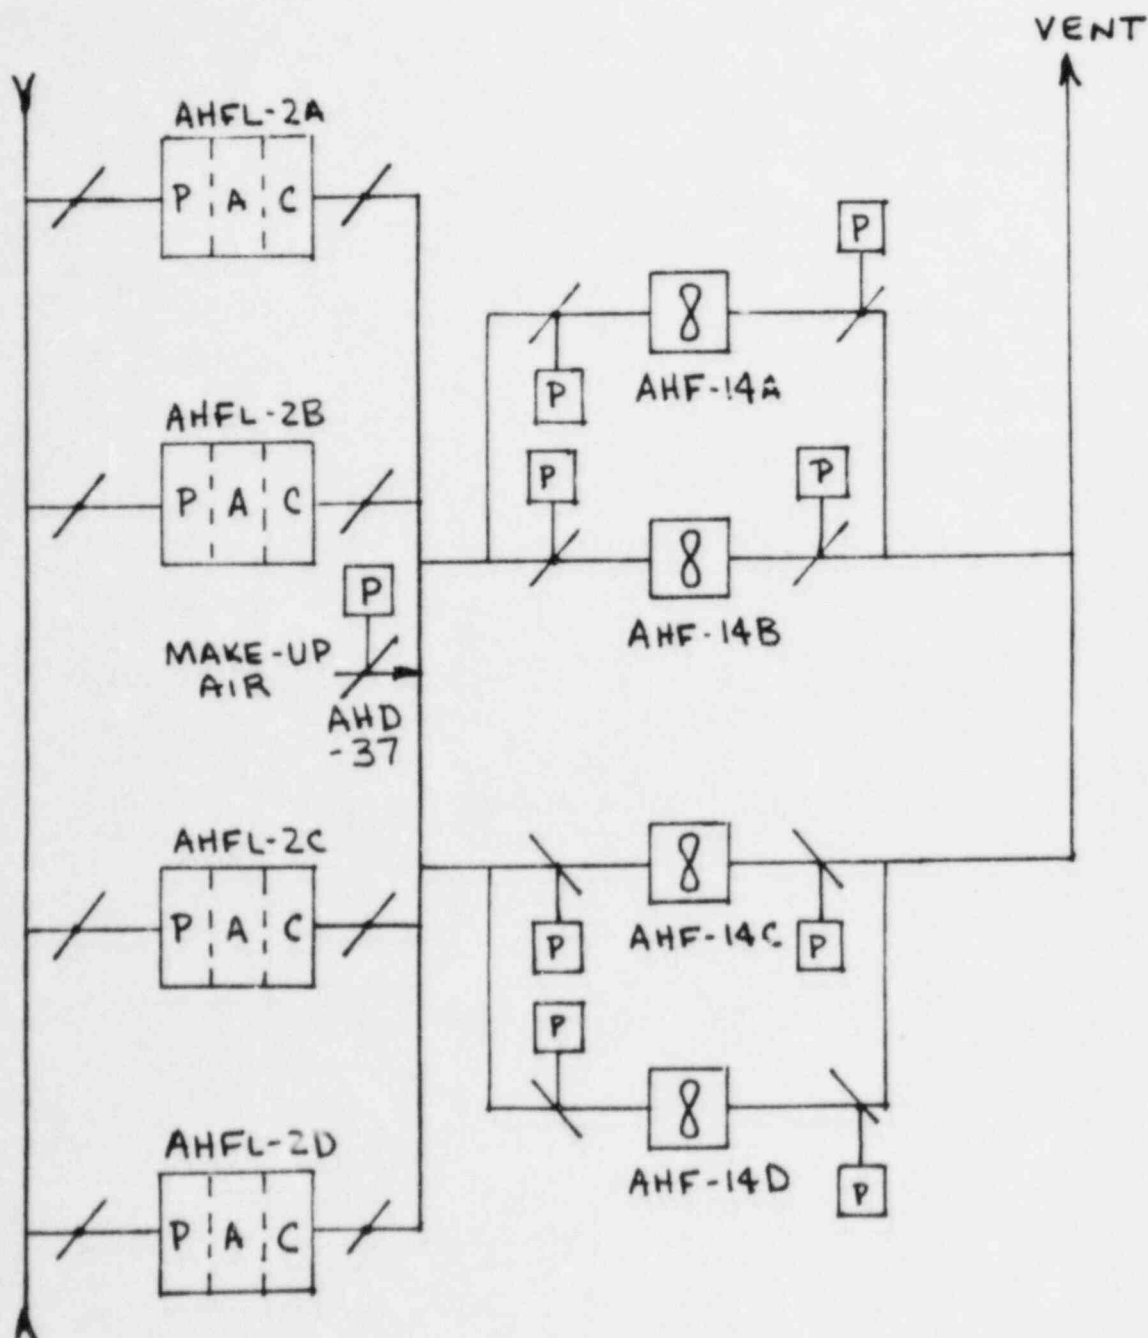
FIGURE 1

1. On March 22, 1984, during a planned shutdown, at 0330 the Auxiliary Building Exhaust Fans (AHF-14 A, B, C, D) (VF, FAN) were taken out of service in order to install a blank-off plate (FB) on makeup air damper AHD-37 (VF, DMP) (Figure 1). The purpose of the blank-off plate was to allow the ventilation system to be operated while damper AHD-37 was replaced. The blank-off plate was installed, and a pair of exhaust fans restarted at 0550 on 3/22/84.
2. On June 25, 1984, at 0445 the Auxiliary Building Exhaust Fans were taken out of service in order to install a blank-off plate on the exhaust duct for filter bank AHFL-2B (VF, FLT). The purpose of the blank-off plate was to allow the exhaust damper for the filter bank to be replaced. The blank-off plate was installed and the exhaust fans restarted at 0530 on 6/25/84.
