Crystal River Unit 3

Subject: Licensee Event Report (LER) 95-019-00

FACILITY NAME (1) CRYSTAL RIVER UNIT 3 (CR-3)										DOCKET NUMBER (2) 0 5 0 0 0 3 0 2					PAGE (3) 1 OF 0 7								
TITLE (4) Service Water System Review Discovers Leak Instrumentation Unable to Perform its Function Resulting in Operation Outside the Design Basis of thte Plant.																							
EVENT DATE (5)			LER NUMBER (6)				REPORT DATE (7)			OTHER FACILITIES INVOLVED (8)													
MONTH	DAY	YEAR	YEAR	SEQUENTIAL NUMBER	REVISION NUMBER	MONTH	DAY	YEAR	FACILITY NAMES N/A				DOCKET NUMBER(S) 0 5 0 0 0										
0	9	2	9	5	9	5	0	1	9	0	0	1	0	2	6	9	5	N/A	0	5	0	0	0
OPERATING MODE (9)		THIS REPORT IS SUBMITTED PURSUANT TO THE REQUIREMENTS OF 10 CFR §: (CHECK ONE OR MORE OF THE FOLLOWING) (11)																					
POWER LEVEL (10)		0 9 7

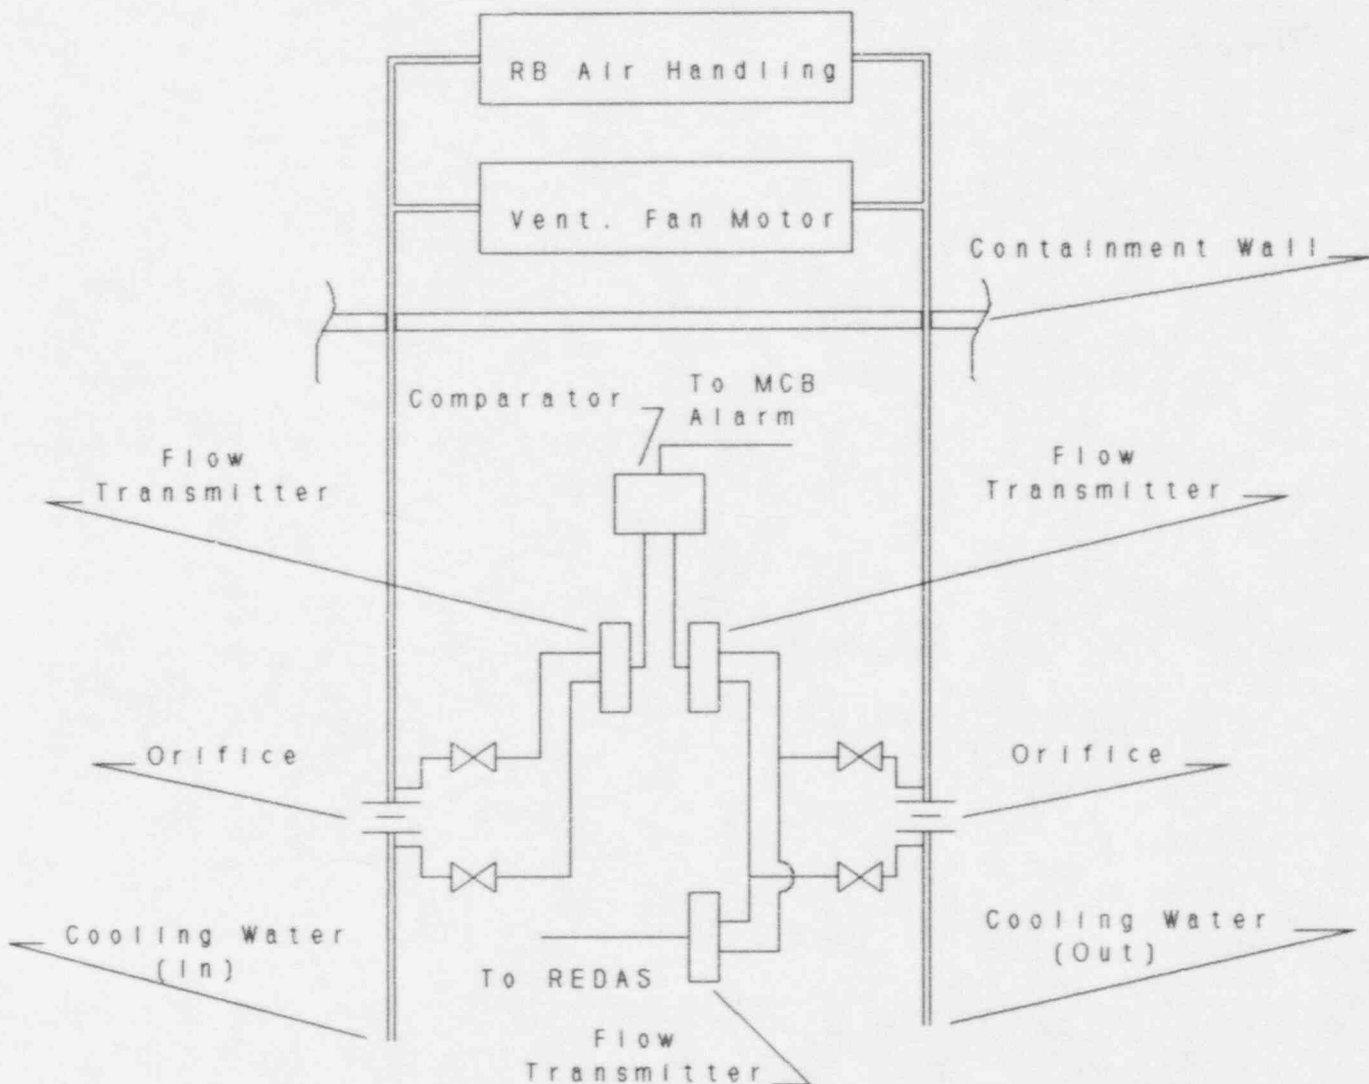
Attachment 1 - RB COOLER LEAK DETECTION

One of the safety functions of the SW system is to provide a redundant RB cooling function to the RB Spray System [BE], through the RBCUs, for the purpose of removing heat released inside the containment following a gross leakage of primary coolant or main steam. The SW system can provide cooling water to each of three RBCUs. Only two are in operation after an ES actuation. SW flow is isolated to the idle RBCU. The flow through a typical RBCU is illustrated in Figure 1 - RB Cooler Leak Detection. The SW flow to each RBCU is currently in excess of 1940 gpm.

If cooling water supply or return lines rupture, the leaking coil, or pipe, as well as any other component of the SW System inside containment, will initiate an alarm from differential FTs on the cooling water supply and return lines. The operator at the control board will then remotely close the isolation valves on the affected line. The remaining unit will operate in conjunction with the building spray system to provide heat removal capability in accordance with the plant design.

The high flow differential alarm sounds in the control room if there is a 90 gpm or greater difference between the inlet and return SW coolant flow lines. The installed instrumentation has a range of 0 to 150 inches (in.) of water which equates to 0 to 1943 gpm. The instrumentation is presently calibrated for a range of 0 to 35 in. of water, corresponding to 0 to approximately 930 gpm. Since SW flow can be in excess 1940 gpm with two of the three RBCUs in operation, the leak detection instrumentation is offscale high and is not capable of identifying a 90 gpm leak as required by the design basis.

A review of past calibration data sheets by engineering personnel indicates that the calibration range for the FTs was changed from 0 to 150 in. to 0 to 35 in. of water in 1976. Although this range is acceptable for CI system cooling, it is inadequate when the RBCUs are aligned to SW. The basis for this change has not been determined nor has the documentation been located. This deficiency appears to have been in place since the original plant construction, prior to power operation.

An evaluation of the calibration spans for the applicable flow transmitters will be performed. The evaluation will include a review of the need for this instrumentation, flow rates in effect for both SW and CI cooling, and an evaluation of the flow switch setpoints. This evaluation will be completed by January 1, 1997, and may produce additional corrective actions.
