ILLINOIS POWER

Subject: Clinton Power Station - Unit 1
Licensee Event Report No. 90-016-00

LICENSEE EVENT REPORT (LER)

| TITLE (4) Breach of Secondary Containment Integrity During CORE ALTERATIONS Due to Unknown Personnel Blocking Open a Secondary Containment Access | | | | | | | | | | | | | | | | | | | | | | | | | |

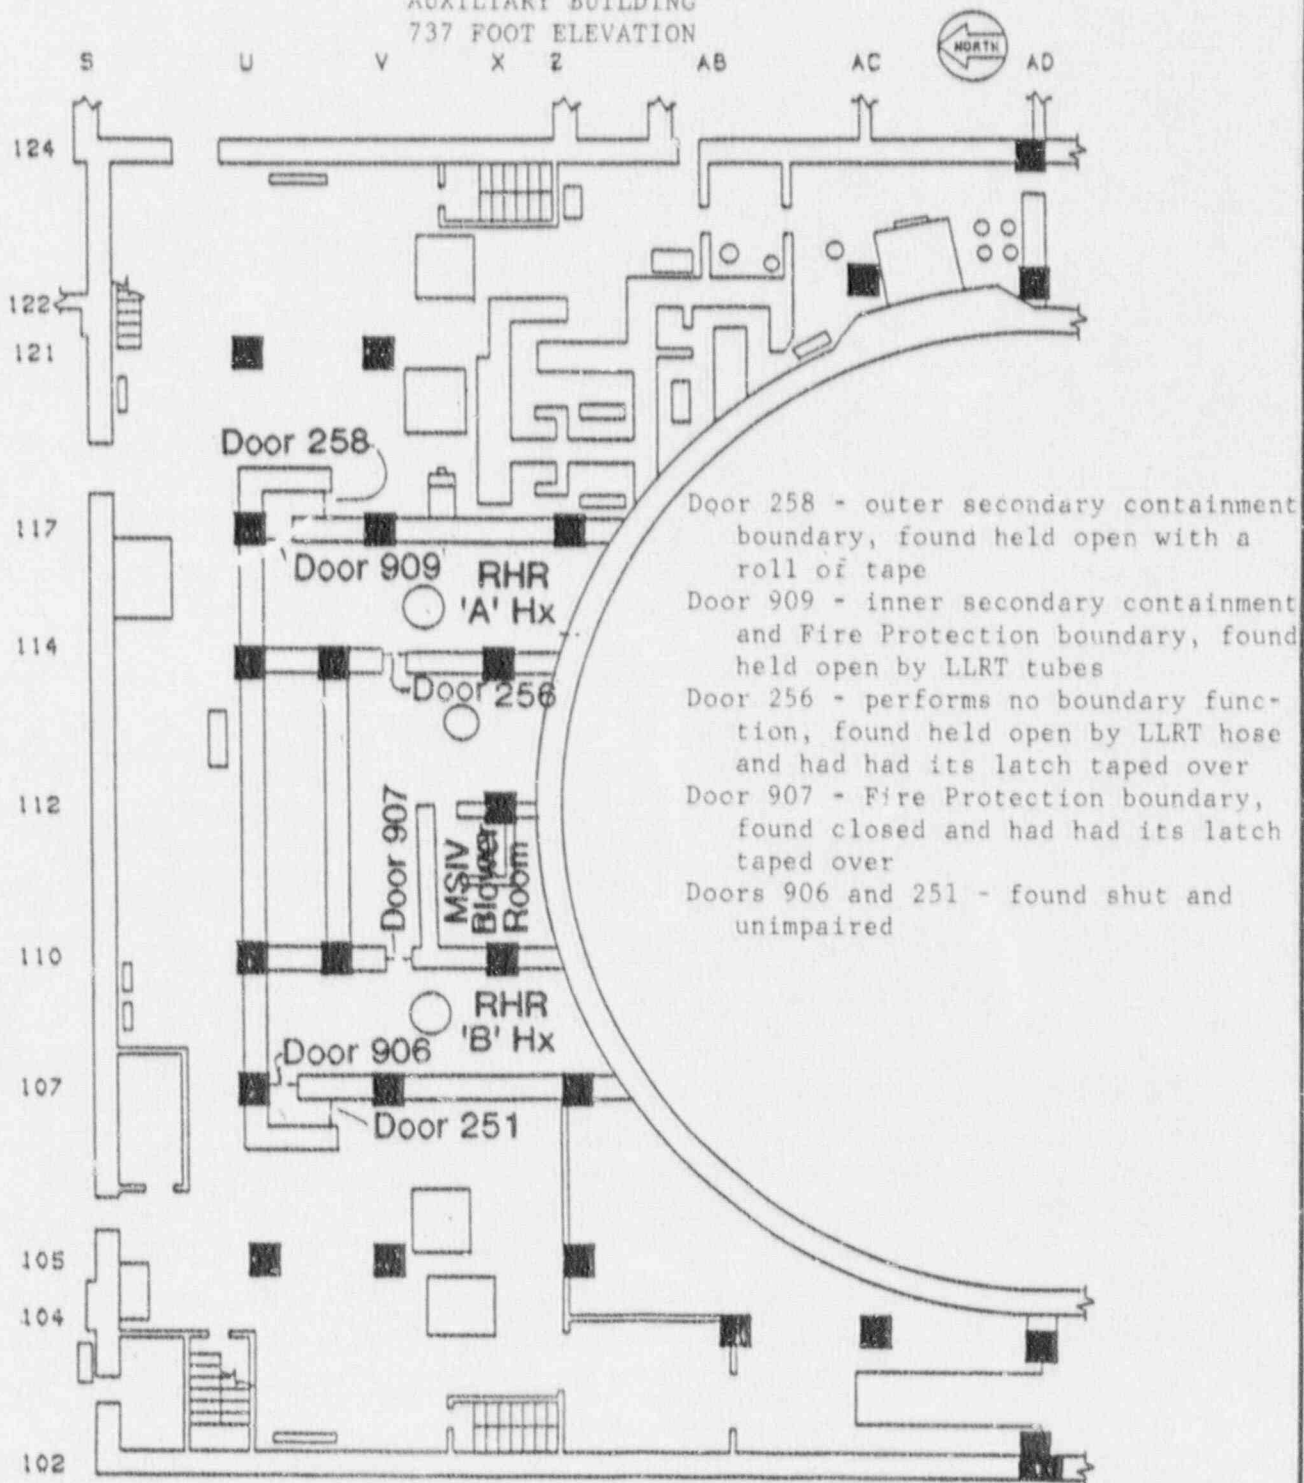
FIGURE 1

- ° The RHR 'A' HX room outer interlock [IEL] door, door 258, was held open with a roll of yellow tape between the door and door frame. Door 258 is a High Radiation and secondary containment integrity boundary normally locked shut (see Figure 1, on page 6). The Shift Supervisor (SS) and Radiation Protection Shift Supervisor (RPSS) maintain administrative control of the keys to unlock it.

- ° The RHR 'A' HX room inner interlock door, door 909, was held open approximately three inches by two three-eighths inch sleeved Local Leak Rate Test (LLRT) tubes [TBG] running under the door. Door 909, normally shut, latched and interlocked to door 258, is a Fire Protection and secondary containment integrity boundary (see Figure 1, page 6). The secondary containment electrical airlock interlock had been defeated.

- ° Door 256, between the RHR 'A' HX room and Main Steam [SB] Isolation Valve (MSIV) Leakage Control System (LCS) [BD] room, was found held open approximately three inches by an LLRT hose running under the door, and had had its latch taped over to prevent the door from latching (see Figure 1, on page 6). Door 256 does not perform any controlled boundary function except as a ventilation barrier during normal plant operations.

- ° Door 907, between the RHR 'B' HX room and MSIV Blower room, was found closed, but had had its latch taped over to prevent the door from latching (see Figure 1, on page 6). Door 907, normally shut and latched, is a Fire Protection boundary.

Investigation into this event determined secondary containment integrity was breached sometime after 1545 hours, on November 29, 1990, until the condition was discovered and corrected at approximately 2100 hours, on November 29, 1990. During this time, fifty-five fuel moves had been made and a one-quarter inch water gauge negative pressure was maintained by the Fuel Building Heating, Ventilation, and Air Conditioning System (VF) [VG]. On November 27, 1990, Plant Staff - Technical had completed an LLRT of LMC-061 penetration, and left the three-eighths inch sleeved LLRT tubing running beneath door 907 into the RHR 'A' HX room. At that time, the LLRT tubing was not preventing door 907 from being shut. The investigation could not determine how long doors 256 and 907 had been impaired with tape over their latches, preventing them from latching, or how long the secondary containment electrical airlock interlock had been defeated.

Illinois Power Company's (IP) investigation into this event included interviews of appropriate personnel with access under an approved Radiation Work Permit (RWP) into the RHR HX rooms on November 29, 1990. This investigation could not determine the cause of this event, since no person or persons can be identified who impaired the specified doors; however, the most probable cause is the lack of respect or knowledge by person or persons for the requirements of secondary containment integrity, High Radiation, and Fire Protection boundary doors.

The RP technician took the following immediate action upon discovery of the above condition: 1) removed the roll of tape, and shut and locked door 258, 2) removed the LLRT tubes from under the door and shut door 909, 3) removed tape over the latch of door 256, but left the LLRT hose in place, and 4) removed the tape over the latch and shut door 907.

The secondary containment electrical airlock interlock for doors 258 and 909 was placed back into operation on December 20, 1990.

All personnel with access to the Protected Area were informed that no door is to be taped, blocked, or otherwise impaired without permission from the appropriate supervision.
