FACILITY NAME (1)	DOCKET NUMBER (2)	LER NUMBER (6)			PAGE (3)
		Year	Sequential Number	Revision Number	
Quad Cities Unit Two	0 5 0 0 0 2 6 5	9 5	- 0 0 7	- 0 0	2 OF 0 6

General Electric - Boiling Water Reactor - 2511 MWt rated core thermal power.

EVENT IDENTIFICATION: Failure to start of the HPCI Turning Gear Motor due to unknown cause.

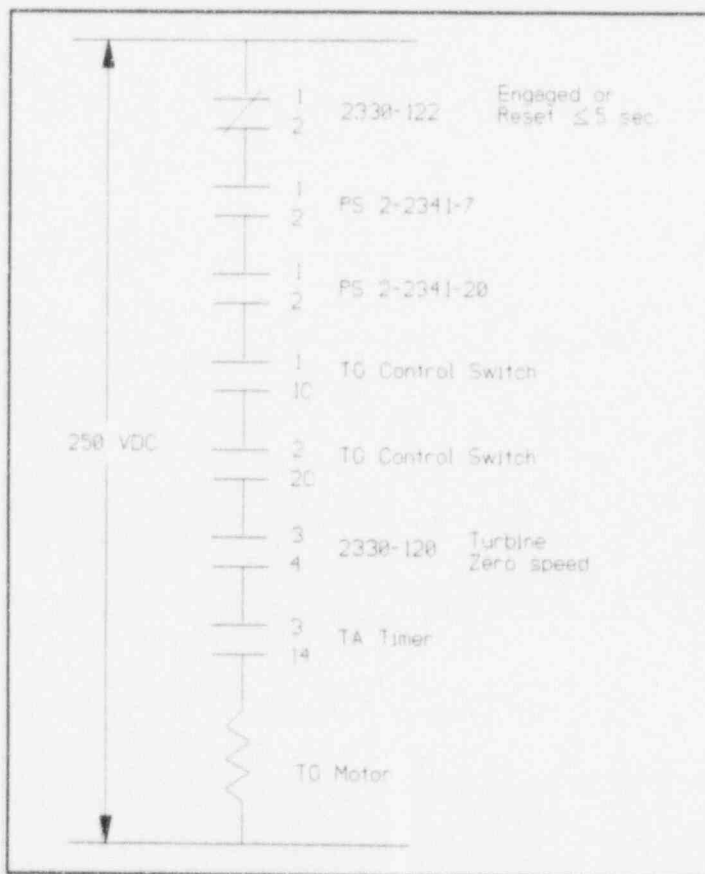
The actual root cause of this event is unknown. Troubleshooting indicates the most probable cause of the turning gear motor failure to start was associated with the turning gear motor logic. One of the contacts may not have changed state, thus creating an open circuit and not providing power to the turning gear motor. This was based on the following reasons:

Under normal operating conditions, power to the turning gear motor requires the following: (1) the 1-2 contacts of relay 2330-122 to be closed ('B' contacts needing relay 2330-122 de-energized); (2) the auxiliary oil pump running in order to pick up contacts 1-2 from pressures switches 2-2341-7 and 2-2341-20; (3) the turning gear motor control switch in "Normal, Start, or Engage" positions picking up switch contacts 1-1C and 2-2C; (4) the turbine at zero speed picking up contacts 3-4 on relay 2330-120 and; (5) the turning gear timer relay "TA" energized picking up contacts 3-14. The attached figure shows a simplified schematic of the interlocks that are required for the start of the turning gear motor.
