LICENSEE EVENT REPORT (LER)

FACILITY NAME (1)
Oyster Creek, Unit 1DOCKET NUMBER (2)
0 5 0 0 0 2 1 9 1 OF 1 1

Inadvertent Repositioning of Primary Containment Isolation Valves

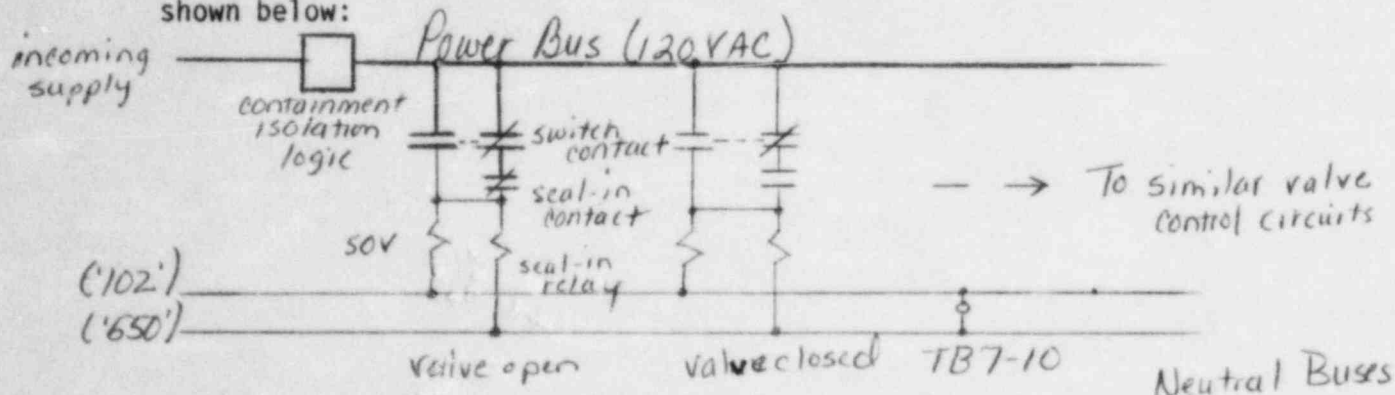
- a. The neutral side of the seal-in relays for the affected solenoid operated valves are connected together in a neutral string with a single wire supplying this string (in panel 10F) from panel 11F. Interruption of this neutral cross-tie causes the neutral string in panel 10F to develop a potential with respect to the 11F neutral.
- b. Improper de-energization of the electrical circuit of concern. The procedure used for the computer termination should have required either:
 1. The use of a temporary jumper to maintain the neutral in panel 10F.
 2. De-energization of all power sources connected to the neutral involved in this event, rather than just the one from fuse 6F8.

The computer tie-in previously discussed required that the neutral feed from panel 11F to panel 10F be interrupted due to the lifting of the '102' lead (11F neutral) from contact 10 of Terminal Board '7' (TB7-10) in panel 11F. The other contact on TB7-10 remained connected to the 10F neutral bus (referred to as the '550' neutral string). Since the '550' neutral string was disconnected from the panel 11F neutral, it was now possible for a voltage potential to develop between the two neutrals. As a result of a containment isolation switch relay modification conducted in 1981, the basic valve control circuit consisted of an SOV connected to the 11F neutral ('102') in parallel with a seal-in relay connected to the 10F neutral ('550'), as shown below:

The immediate corrective action was to re-install the lifted neutral lead. A functional test was performed on July 13, 1984 to demonstrate that insertion of a primary containment isolation signal while the 10F/11F neutral tie is interrupted will cause all CIVs to shut, and that interrupting the neutral tie while a primary containment isolation signal is present will not result in valve repositioning (assuming only one valve is in the 'bypass' mode). Future solutions to be implemented prior to restart include:

- A check of all plant safety circuits to determine if similar neutral wiring deficiencies exist elsewhere.
- Incorporation of specific cautions for lifting neutral leads into station administrative procedures.

- c. Modification of the current 10F/11F neutral circuit configuration to prevent this event from occurring in the future.
- d. An outside contractor will independently analyze the circuit of concern.
- e. Another test will be performed and will include the following:
 - i. Detailed analysis of the voltage and current steady state and transient values in the control circuitry when the 10F/11F neutral tie of concern is interrupted and restored.
 - ii. Opening the five SOVs with the 'bypass' feature to determine if the remaining 13 SOVs will open with a containment isolation signal still present.
 - iii. Sequentially attempt to open the CIVs while a containment signal is still inserted with the five (5) SOVs in 'bypass' to ensure that this action does not cause any CIVs to automatically open.

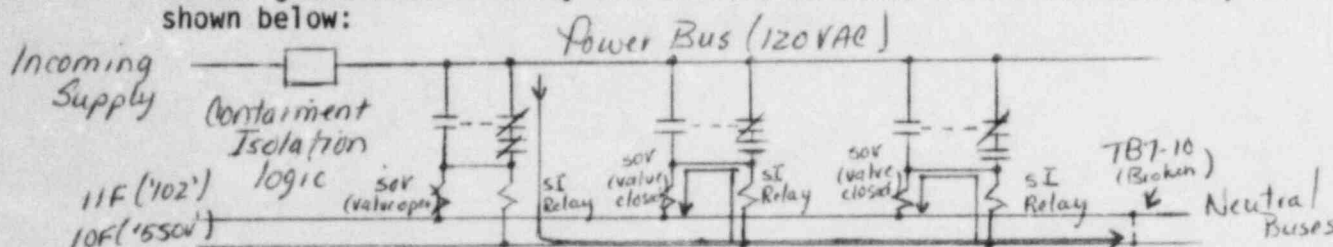
A total of 18 containment isolation valves (including MSIVs) have seal-in relays connected to the '550' neutral string. During normal operation with the valve open, the seal-in relay and SOV are energized. The seal-in contact is held shut by the energized seal-in relay. When power is interrupted to the control circuit, the SOV and seal-in relay de-energize, and the valve closes. Since the seal-in contact is now open, restoration of power will not cause the valve to automatically re-open. (The operator must place valve control switch to the 'open' position.) This was the intent of the 1981 control circuit modification. There is only one connection between the '102' bus and the '550' neutral string. This occurs at TB7-10. If the connection at this point is interrupted, an abnormal current flowpath can result from an energized seal-in relay (valve open) through a de-energized seal-in relay and SOV (valve shut) to the 11F neutral, as shown below:

This occurs due to the fact that the '550' neutral is 'floating' with respect to the 11F neutral once the TB7-10 connection is broken, and the current flow seeks a neutral (11F) through a seal-in relay and SOV in series. If sufficient voltage drop occurs across the seal-in relay for a closed valve, (determined by the number of valves initially open) the seal-in relay will energize. This shuts the seal-in contact for the closed valve, which allows full bus voltage to be applied across the SOV, resulting in the opening of the valve. Since the seal-in relays for all 18 valves are connected to the '550' neutral, all valves will open when the threshold voltage drop across their seal-in relays is reached. This theory explains the phenomena which occurred during the computer point termination on the day of the event.
