## LICENSEE EVENT REPORT (LER)

FACILITY NAME (1) Fort St. Vrain, Unit No. 1										DOCKET NUMBER (2) 0 5 0 0 0 2 6 7										PAGE (3) 1 OF 08	
TITLE (4) Corrosion of PCRV Tendon Wires (Voluntary LER)																					
EVENT DATE (5)			LER NUMBER (6)			REPORT DATE (7)			OTHER FACILITIES INVOLVED (8)												
MONTH	DAY	YEAR	YEAR	SEQUENTIAL NUMBER	REVISION NUMBER	MONTH	DAY	YEAR	FACILITY NAMES N/A			DOCKET NUMBER(S) 0 5 0 0 0									
DETERMINED 0 3		2 7	8 4	8 4	0 0 5	0 1	0 7	2 7	8 4				0 5 0 0 0								
OPERATING MODE (9) N		THIS REPORT IS SUBMITTED PURSUANT TO THE REQUIREMENTS OF 10 CFR 5: (Check one or more of the following) (11)																			
POWER LEVEL (10) 0 0 0		20.402(b)			20.405(e)			80.73(a)(2)(iv)			73.71(b)

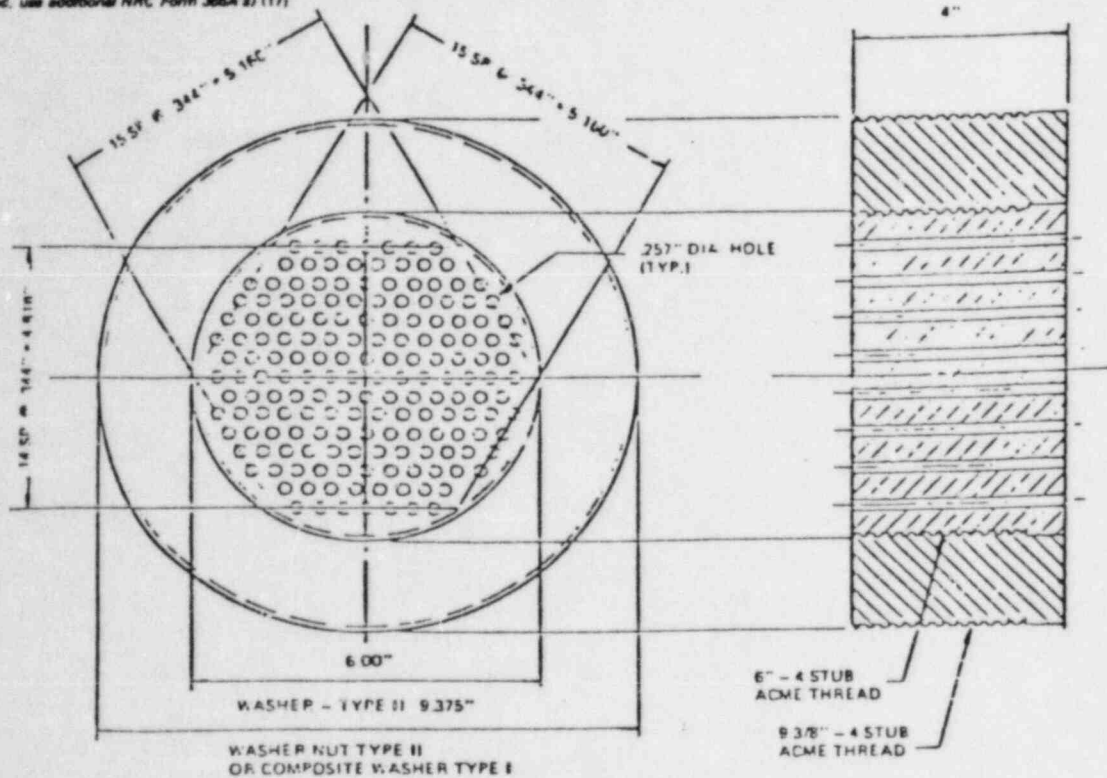
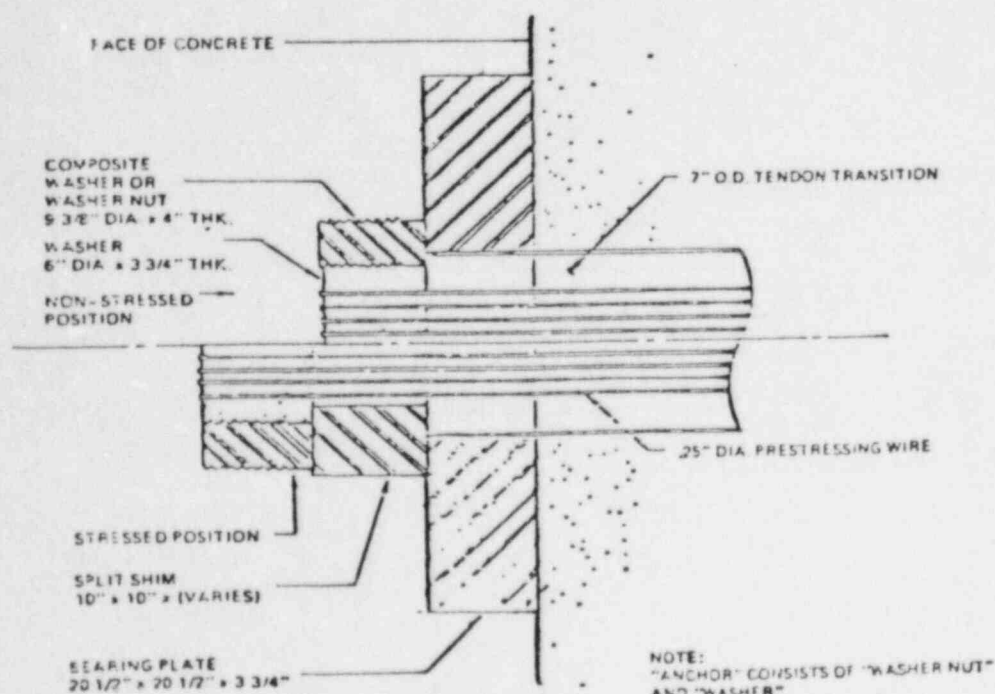
FIGURE 1

The Prestressed Concrete Reactor Vessel (PCRV) utilizes a system consisting of 448 prestressing tendons in two basic configurations consisting of 152 or 169 1/4 inch diameter wires. Each wire terminates at a buttonhead supported by an anchor (buttonhead) washer which seats through a split shim onto a bearing plate on the PCRV surface (see Figure 1). The tendons may be delineated into four different types according to the following table (also see Figure 2).

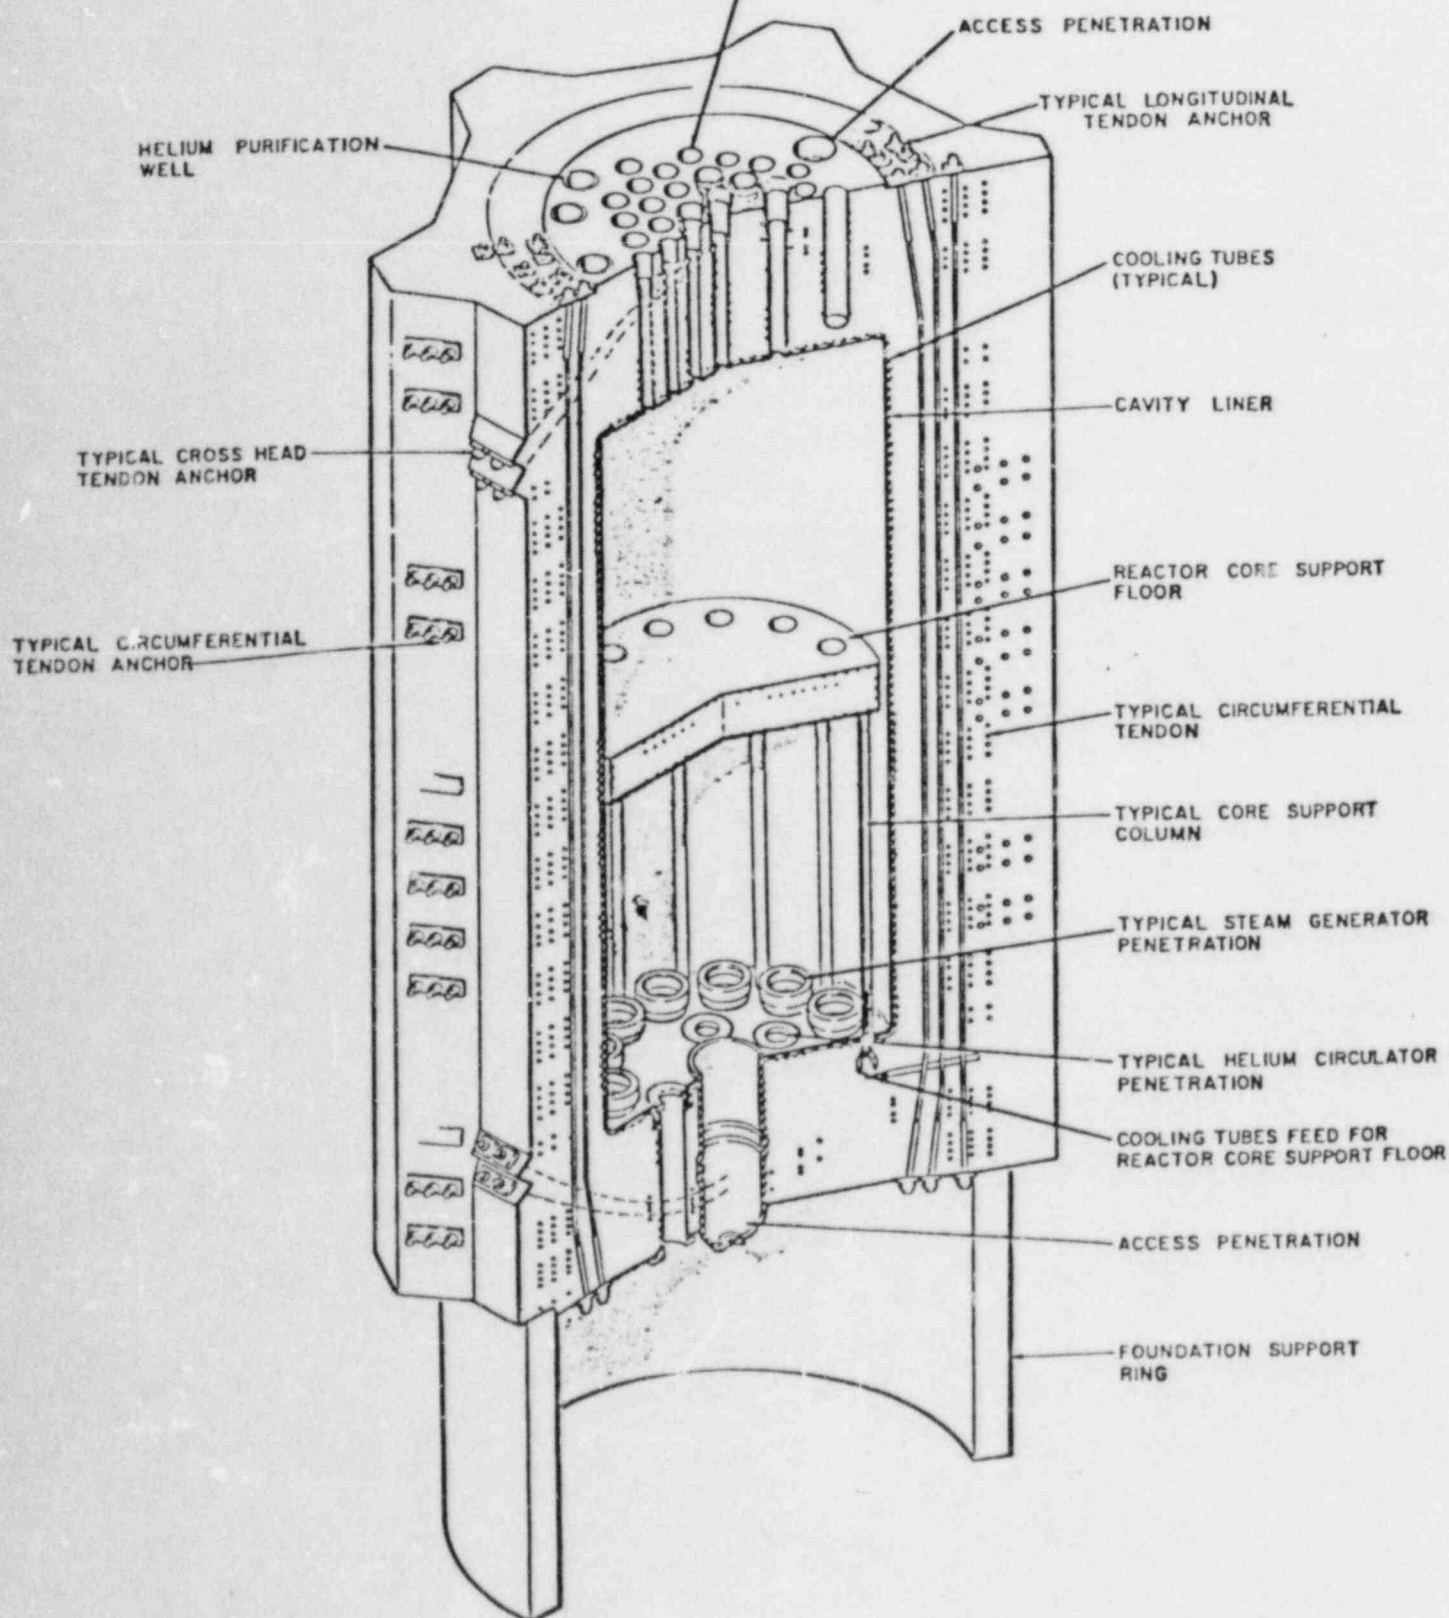
FIGURE 2

448 Tendons Total	27 Load Cells
310 Circumferential	17 Load Cells
90 Vertical	6 Load Cells
24 Top Cross Head	2 Load Cells
24 Bottom Cross Head	2 Load Cells
