Subject: Three Mile Island Nuclear Station, Unit 1 (TMI-1)
Operating License No. DPR-50
Docket No. 50-289
Additional Information in Response to Generic Letter (GL) 95-03
"Circumferential Cracking of Steam Generator Tubes"

GPU Nuclear Response to Generic Letter 95-03 Request for Additional Information

Three Mile Island Nuclear Station, Unit 1 (TMI-1)
Operating License No. DPR-50
Docket No. 50-289

Additional Information in Response to NRC Generic Letter 95-03

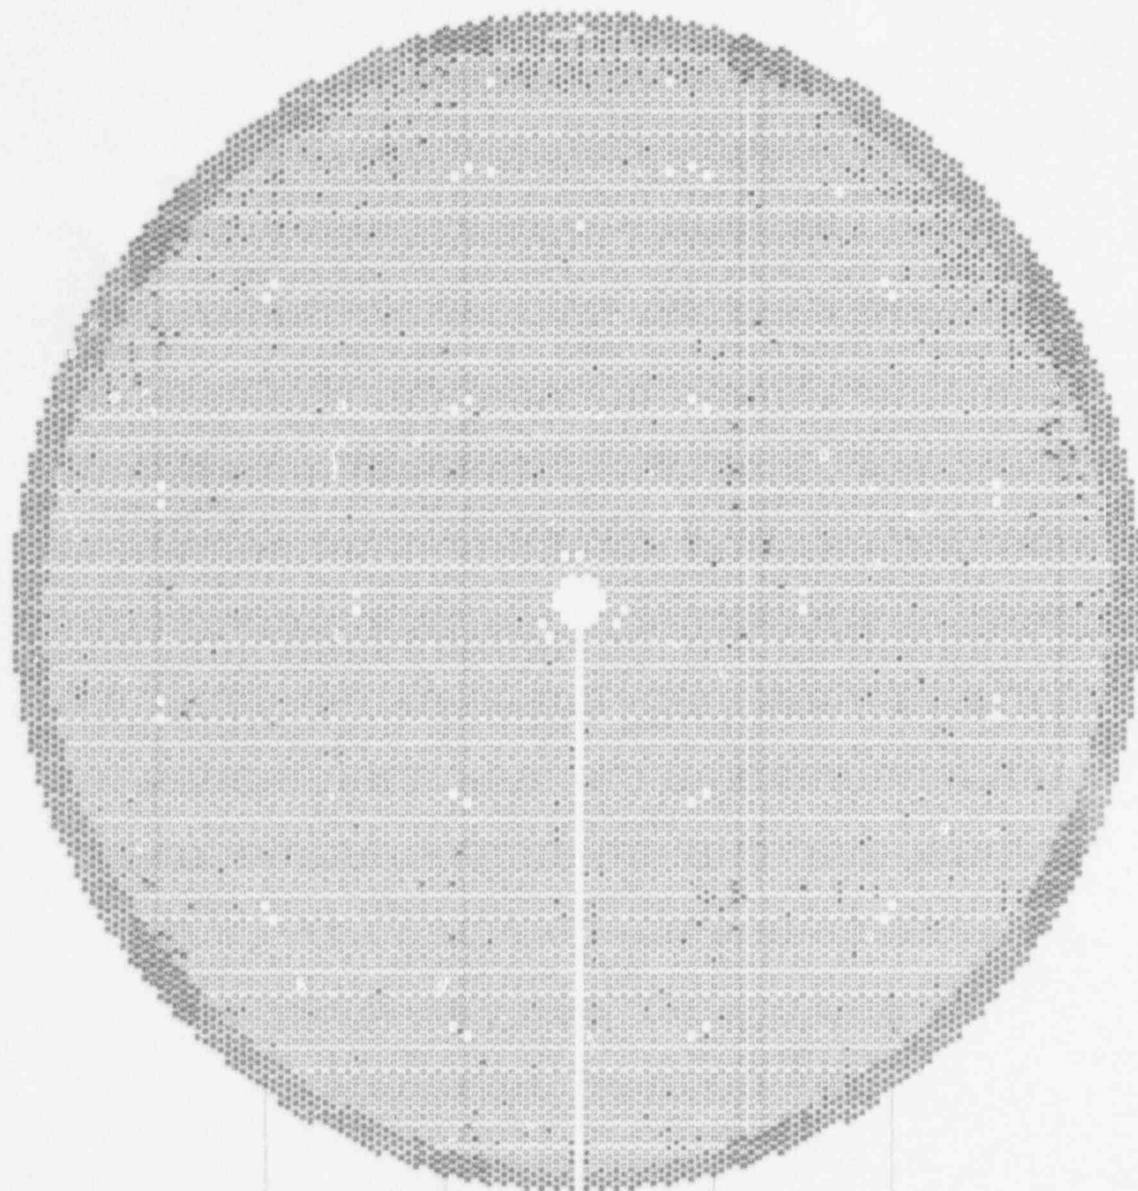
FIGURE 1

The outer tube locations in the 15th tube support plate (TSP) at all units are drilled to a .637" minimum / .646" maximum diameter. Approximately 1621 locations are typically drilled. At TMI-1 1626 locations are drilled in the 15th TSP as shown on Figure 1. All remaining locations at this support plate, and all locations at the other support plates, are broached as described in the GL 95-03 response.

As stated above in response to question #1, at TMI-1 all support plate holes are broached except for 1626 holes in the peripheral holes of the 15th TSP where the holes have been drilled only (See Figure 1).

1626: locations where 15th fep is drilled

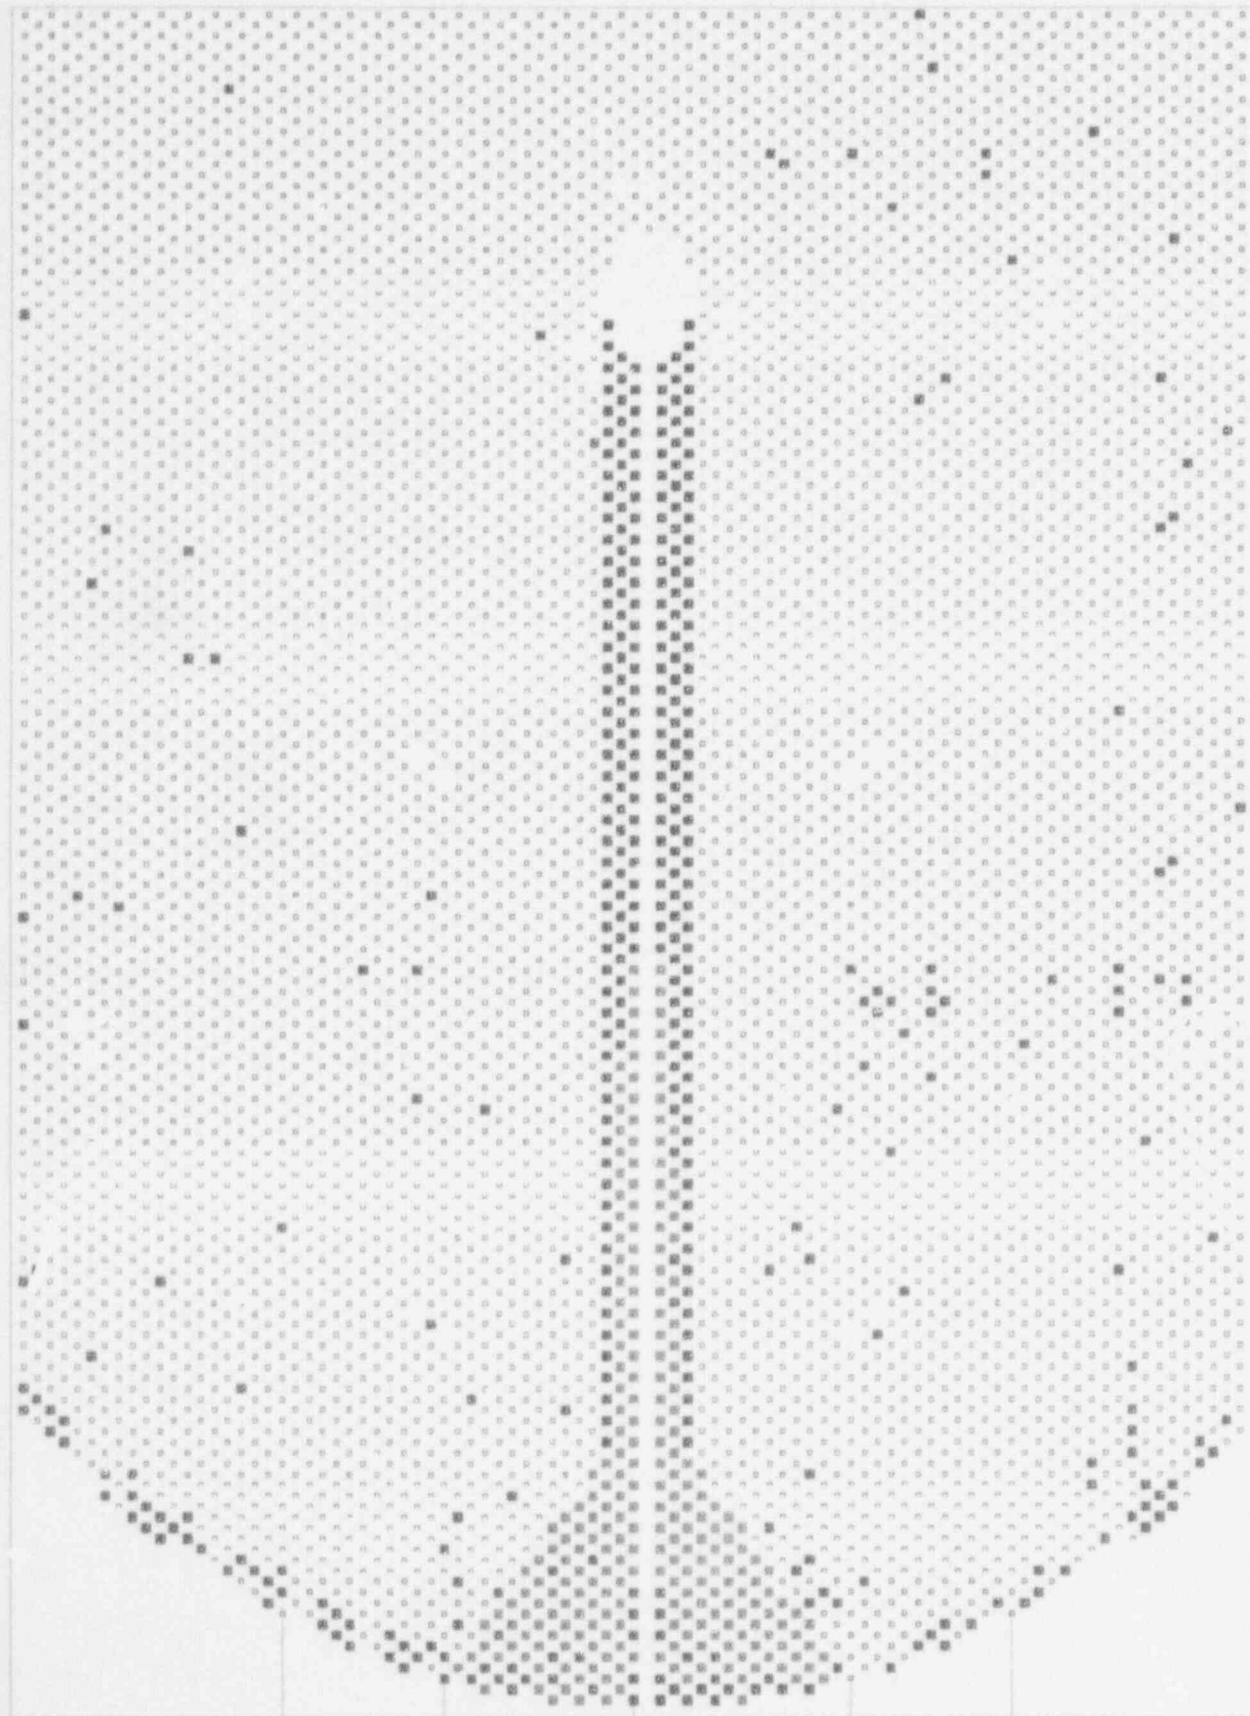
FIGURE 2A

Tubes along the inspection lane, including an area that fans out at the periphery, are referred to as the lane/wedge region. TMI-1 Tech Spec §4.19.2.a.4(1) defines a group of tubes in the lane/wedge region as "Group A-1," which, along with another group of tubes, may be excluded from the first random sample if all tubes in that group in both steam generators are inspected. Group A-1 is sometimes referred to as the "Tech Spec defined lane/wedge." Un-sleeved tubes in the TMI-1 Tech Spec defined lane/wedge areas of OTSG "A" and "B" are shown in red on Figures 2A and 2B respectively.

The "TMI-1 defined repair lane/wedge" is a region where engineering analysis and OTSG history review has determined that high cycle fatigue cracking is most likely to occur. All in service tubes in the "TMI-1 defined repair lane/wedge" have been sleeved. These tubes are shown in green on Figures 2A and 2B respectively.

216: unsleeved inspection lane/wedge

248: sleeved tubes inservice

228: currently plugged tubes

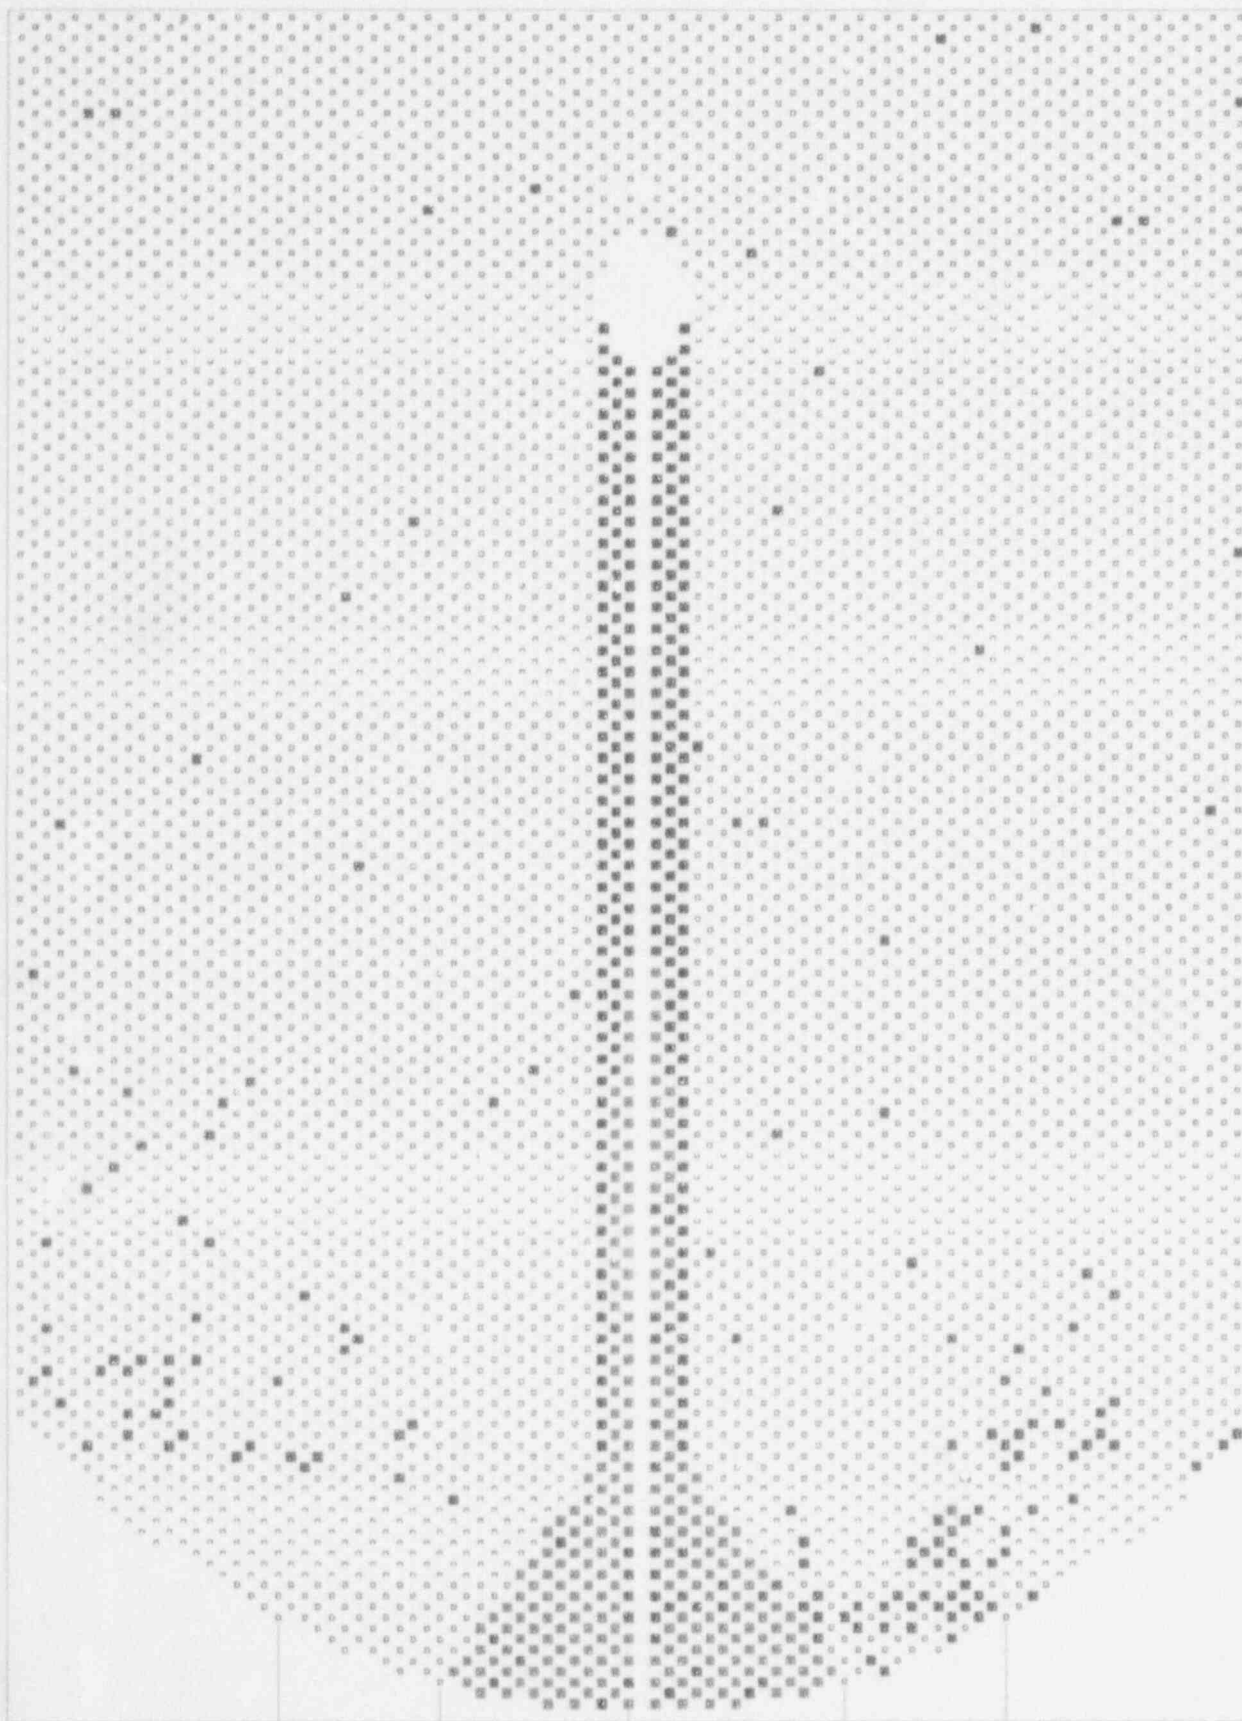
FIGURE 2B

217: unsleeved inspection lane/wedge tubes

253: sleeved tubes in service

197: currently plugged tubes

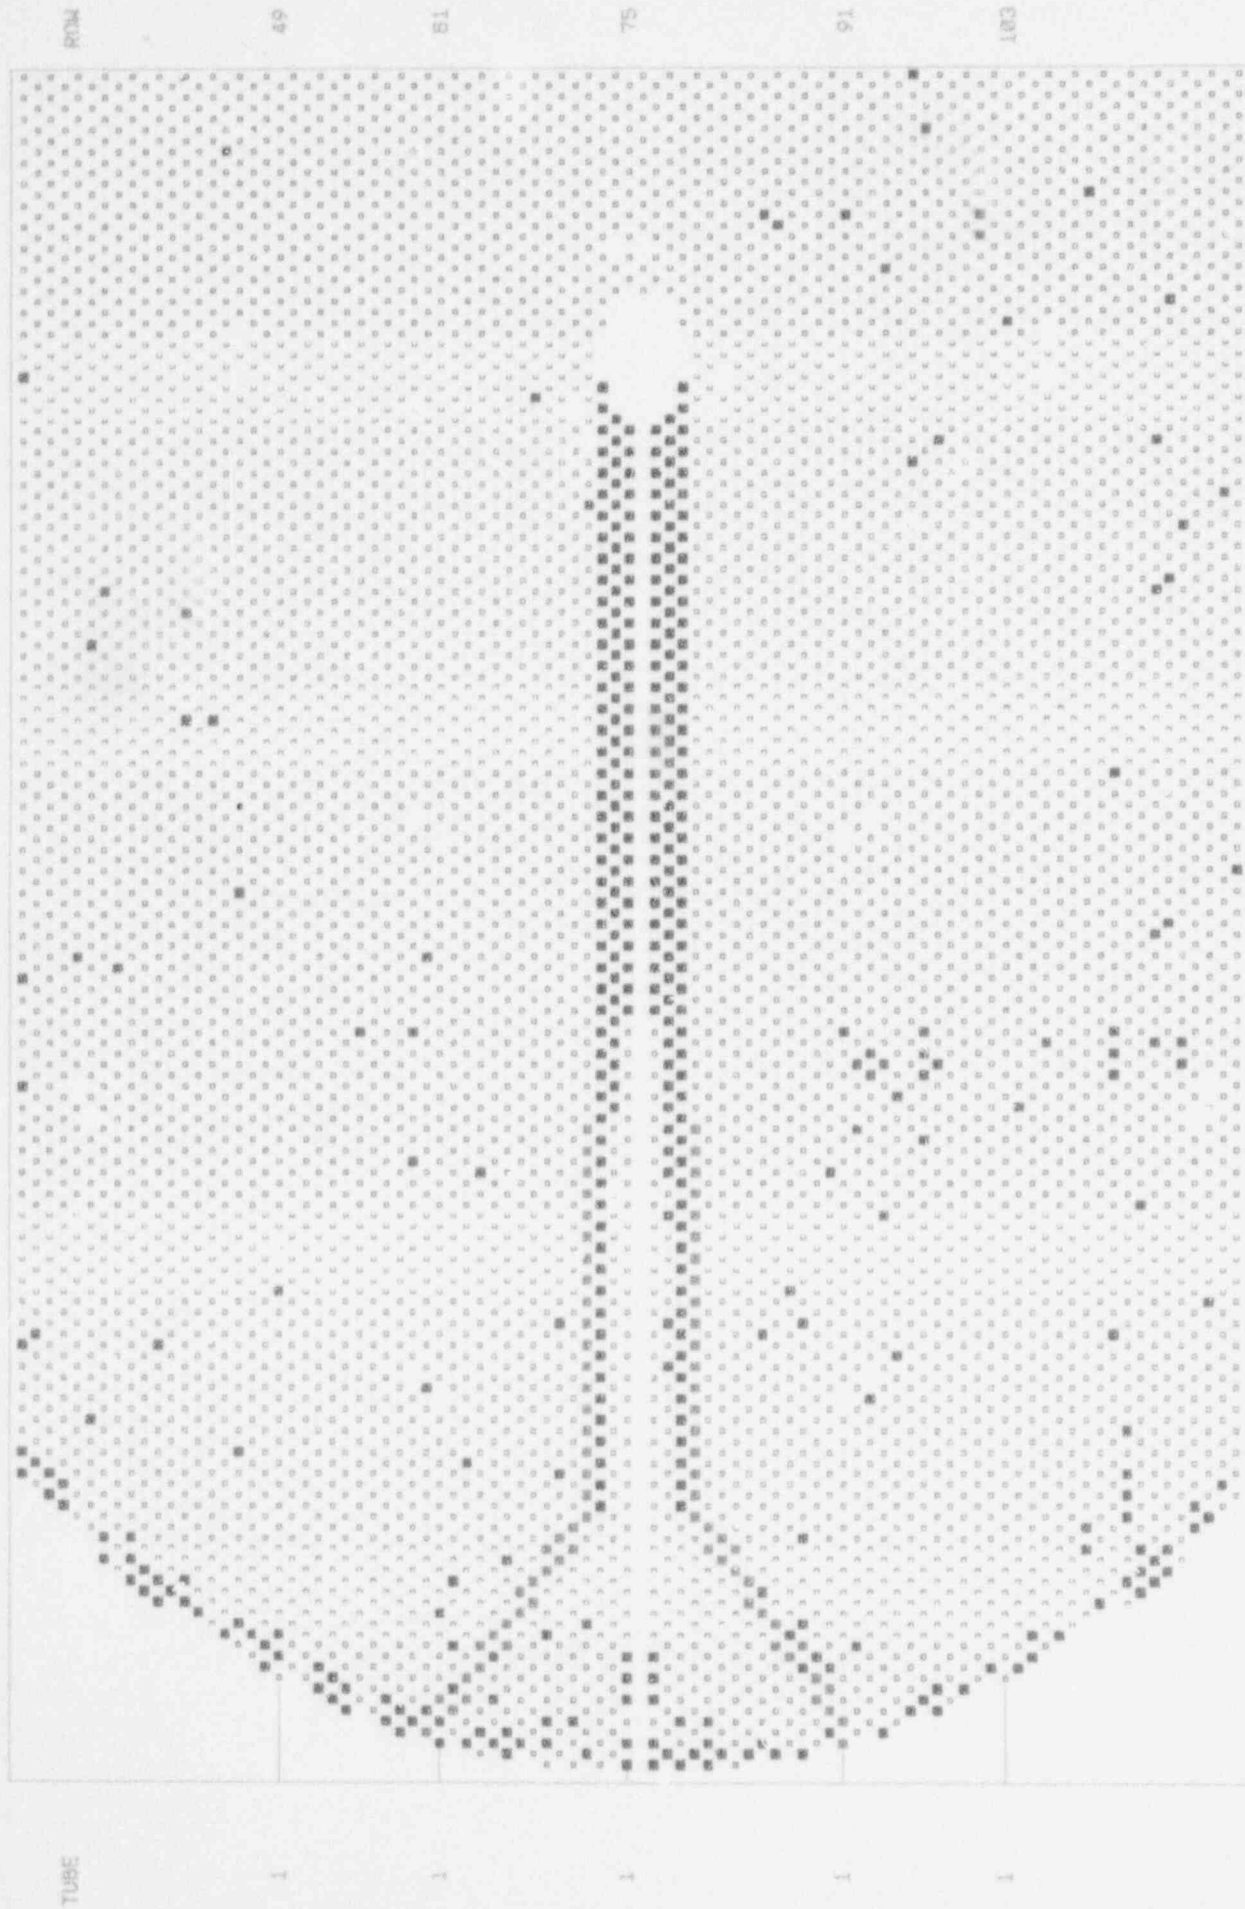
FIGURE 3A

Figures 3A and 3B show the 589 tubes where 3-coil MRPC examination of the kinetic expansion was performed during 11R. These tubes were chosen because they should be the first to exhibit high cycle fatigue cracking based on highest main steam cross flows and proximity to the previous historical OTSG high cycle fatigue failure locations.

Figures 3A and 3B show the lane/wedge tubes which were examined with the 3-coil MRPC technique during 11R. The 3-coil head contained 0.115" pancake, axial and circumferentially wound coils.

During 11R no cracks (or other defects) were detected in these tubes. If cracks were detected in this region the sample would have been expanded to bound the degraded region. Selection of the specific additional tubes to be inspected would be based on an engineering evaluation of the location of the degraded tube and the thermal/hydraulic conditions believed to be responsible for the fatigue failures. For example, detection of cracking in a tube near the periphery in the wedge region would be addressed by expanding the inspection in the wedge region on both sides of the lane. Detection of a crack along the lane further toward the center of the bundle would be addressed by extending the inspection toward the bundle center, and/or inspecting an additional row on either side of the lane.

216: lane/wedge tubes examined with arpc

77: sleeve border tubes examined with arpc

220: currently plugged tubes

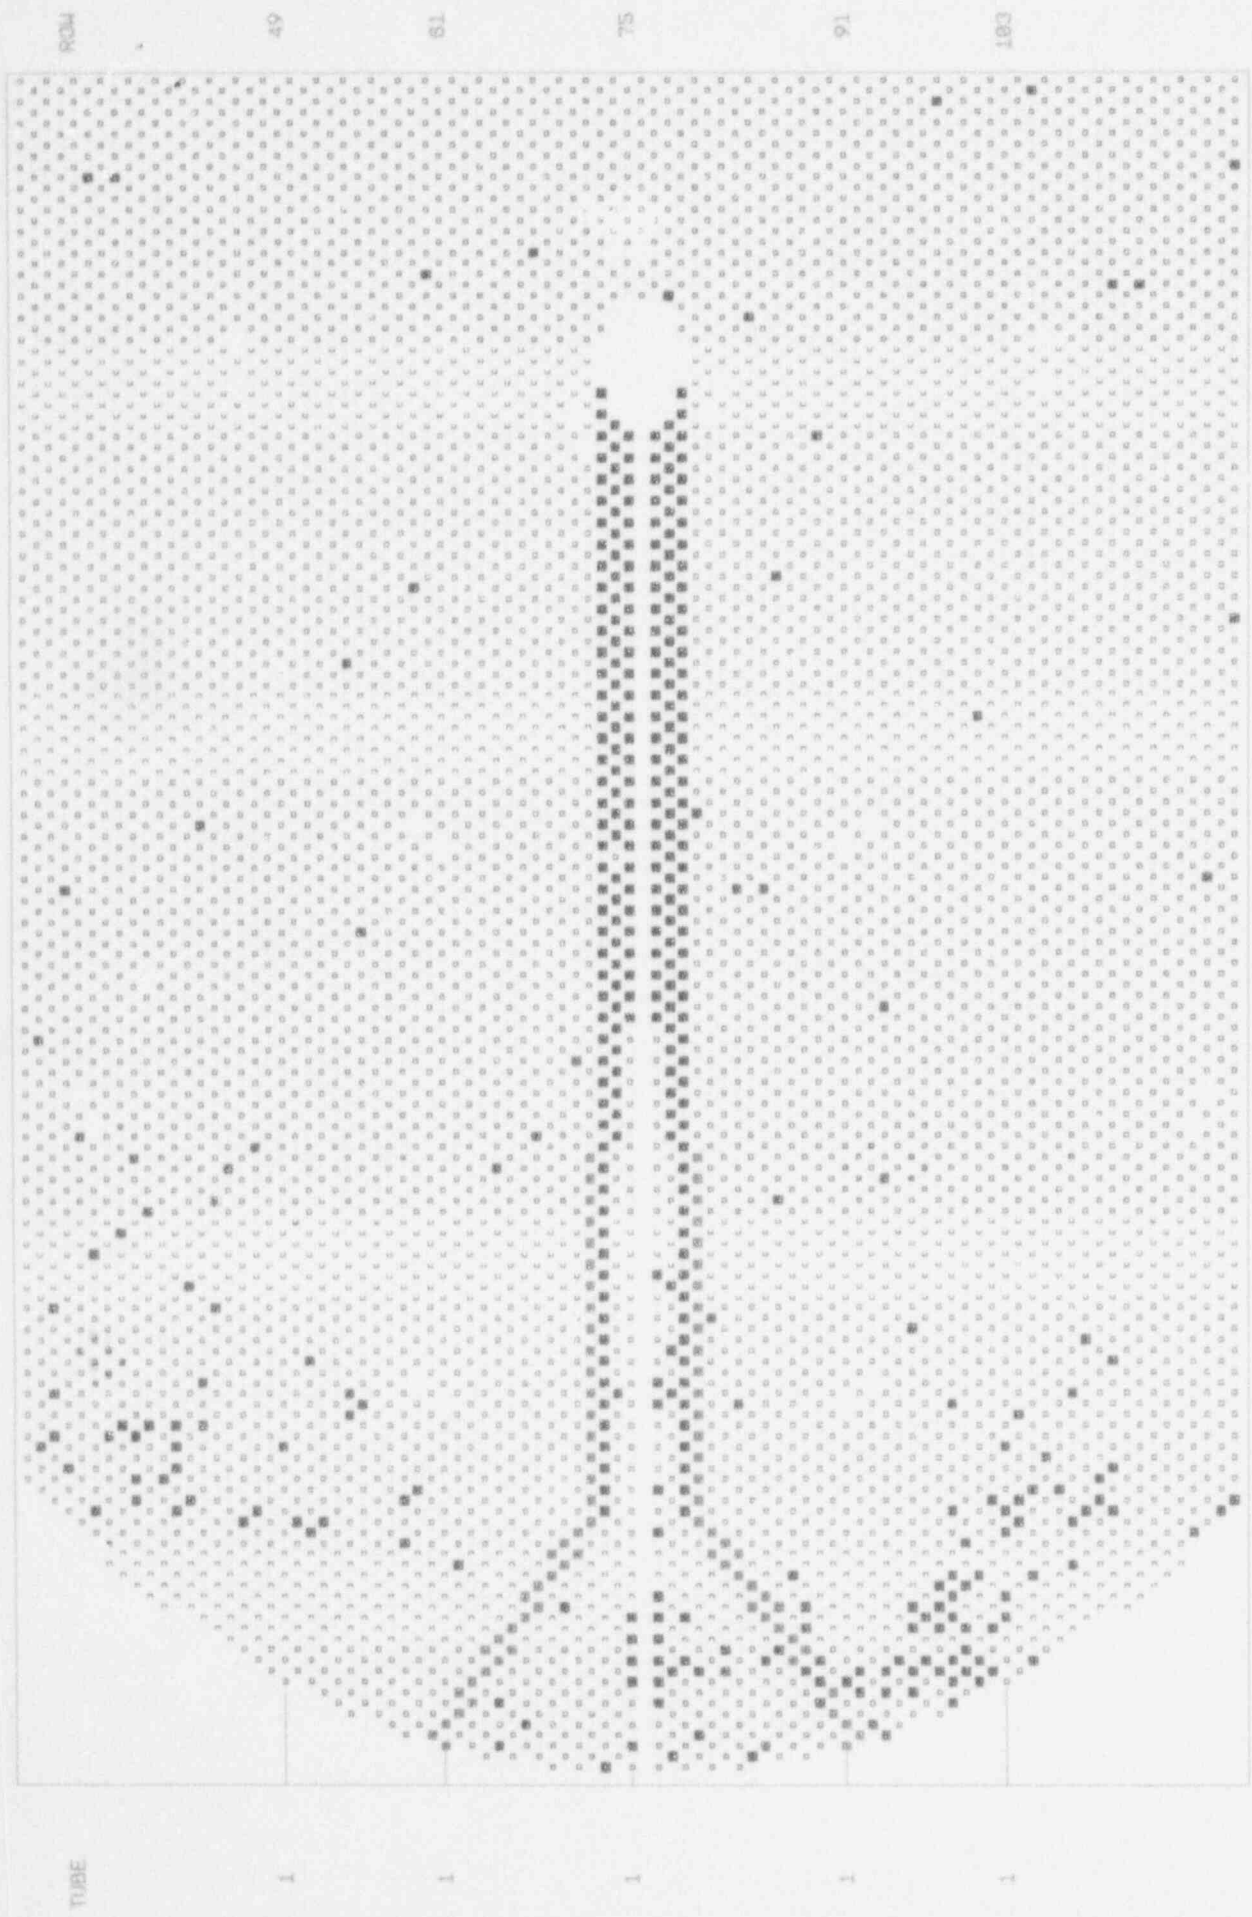
FIGURE 3B

217: lane/wedge tubes examined with mrpc
 79: sleeve border tubes examined with mrpc
 197: currently plugged tubes
