Reference: Facility Operating License No. DPR-65  
Docket No. 50-336  
Licensee Event Report 95-038-00

## LICENSEE EVENT REPORT (LER)

Millstone Nuclear Power Station Unit 2

Hydrogen Monitor Flowpath Design Deficiency

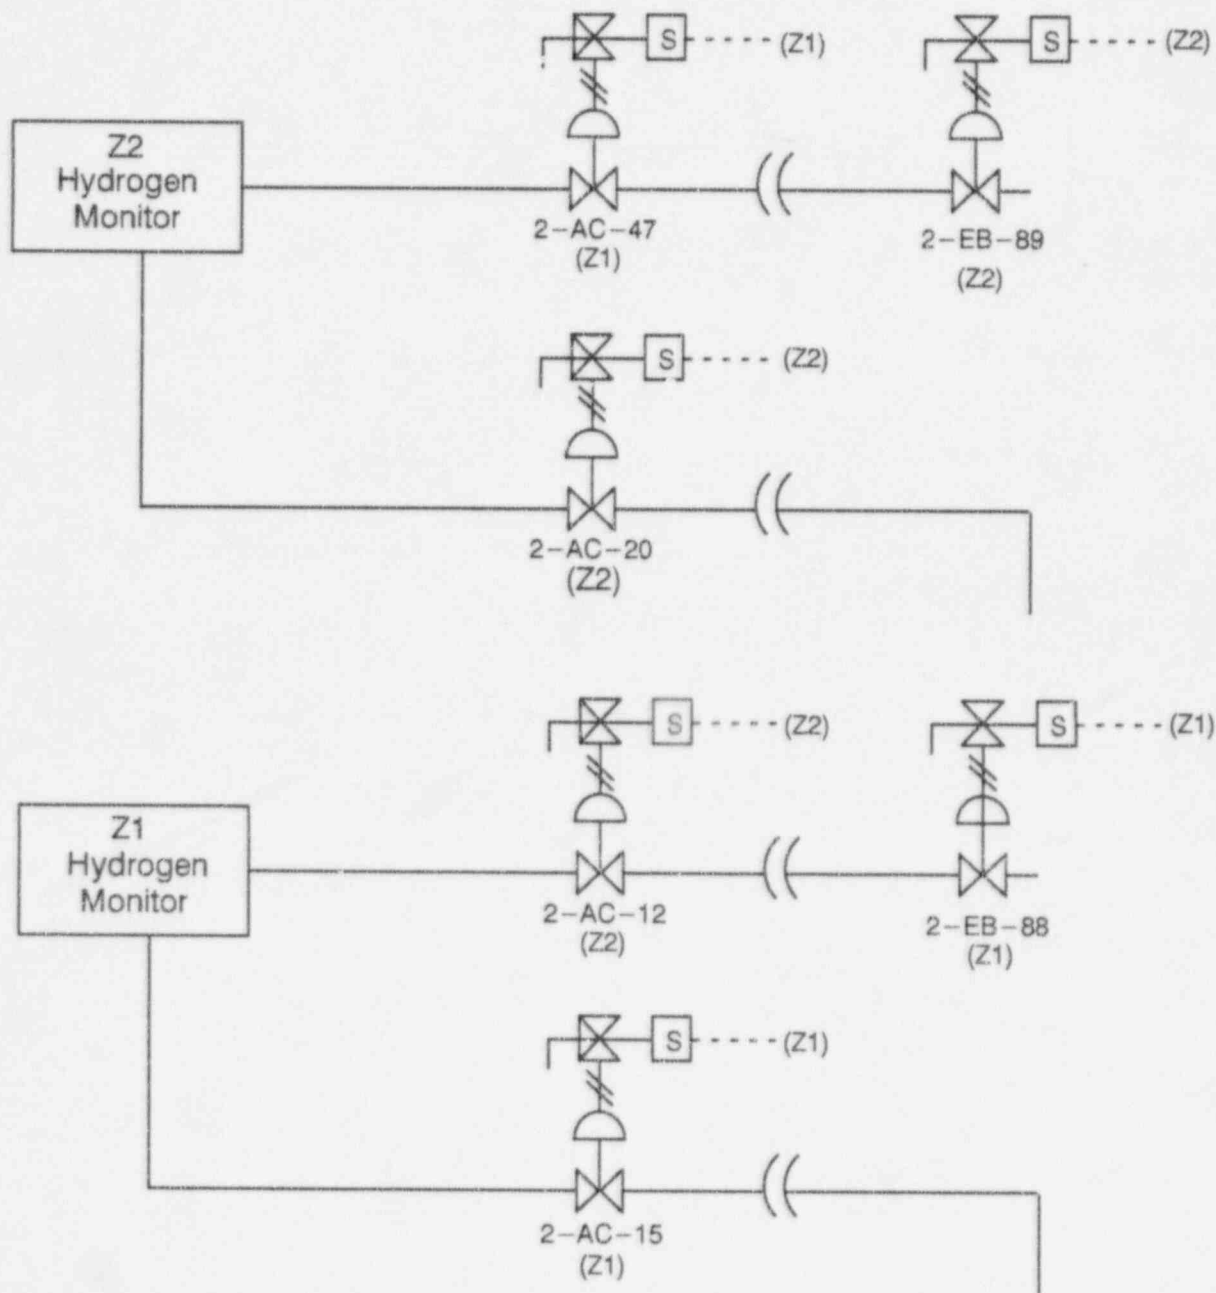
On October 6, 1995, at 1819 hours with the plant in mode 1 at 100% power, it was identified that following a Loss of Coolant Accident (LOCA) coincident with the loss of a DC Bus, a hydrogen monitoring flowpath could not be established due to the configuration of the power supply to the valves. The containment isolation function of these valves was operable and not affected by the identified problem.

Both hydrogen monitors have similar but separate flowpaths (see figure). The hydrogen monitoring system and PASS use the normal containment radiation monitor for the sampling flowpath post LOCA. The Facility 1 Hydrogen monitor has a Facility 1 suction line isolation valve inside containment and a Facility 1 return line isolation valve outside containment powered by Facility 1 DC power. The outside containment suction isolation valve is powered by Facility 2 DC power. The containment isolation signals are the same facility as the power to the valves. Therefore, following a LOCA that initiates a containment isolation signal coincident with the loss of the Facility 2 DC bus, the outside containment isolation valve cannot be opened to allow for hydrogen sampling when required by the Emergency Operating Procedures.

The above also applies to the Facility 2 Hydrogen monitoring system for DC power alignment.

The cause of this event is that the system was initially designed to meet the containment isolation single failure protection requirements. The subsequent hydrogen monitoring single failure protection feature in Reg. Guide 1.97 was not followed through in plant operating procedures.

The corrective action was to provide procedure guidance in an Operations Procedure that would provide electrical power to the respective outside containment isolation valve that would be de-energized due to a single DC bus failure. The Operations Procedure directs to the operators to align hydrogen monitoring in accordance with the Post Incident Hydrogen Control operations procedure. In this procedure, in the event of a loss of a vital DC bus, guidance was provided to install an electrical jumper for power to the de-energized valve. By providing direction in the procedure for installation of an electrical jumper to allow normal valve control opening of the containment isolation valves for Hydrogen monitoring post accident, (coincident with a loss of a DC Bus) there is no affect on any system performance because all actions can be performed inside the control room in a very short period of time. The Hydrogen monitoring system is credited for manual initiation within 12 hours following the accident.
