## Nuclear Information and Resource Service

### RE: Safety Evaluation of the Core Shroud Fix at Oyster Creek Nuclear Generating Station

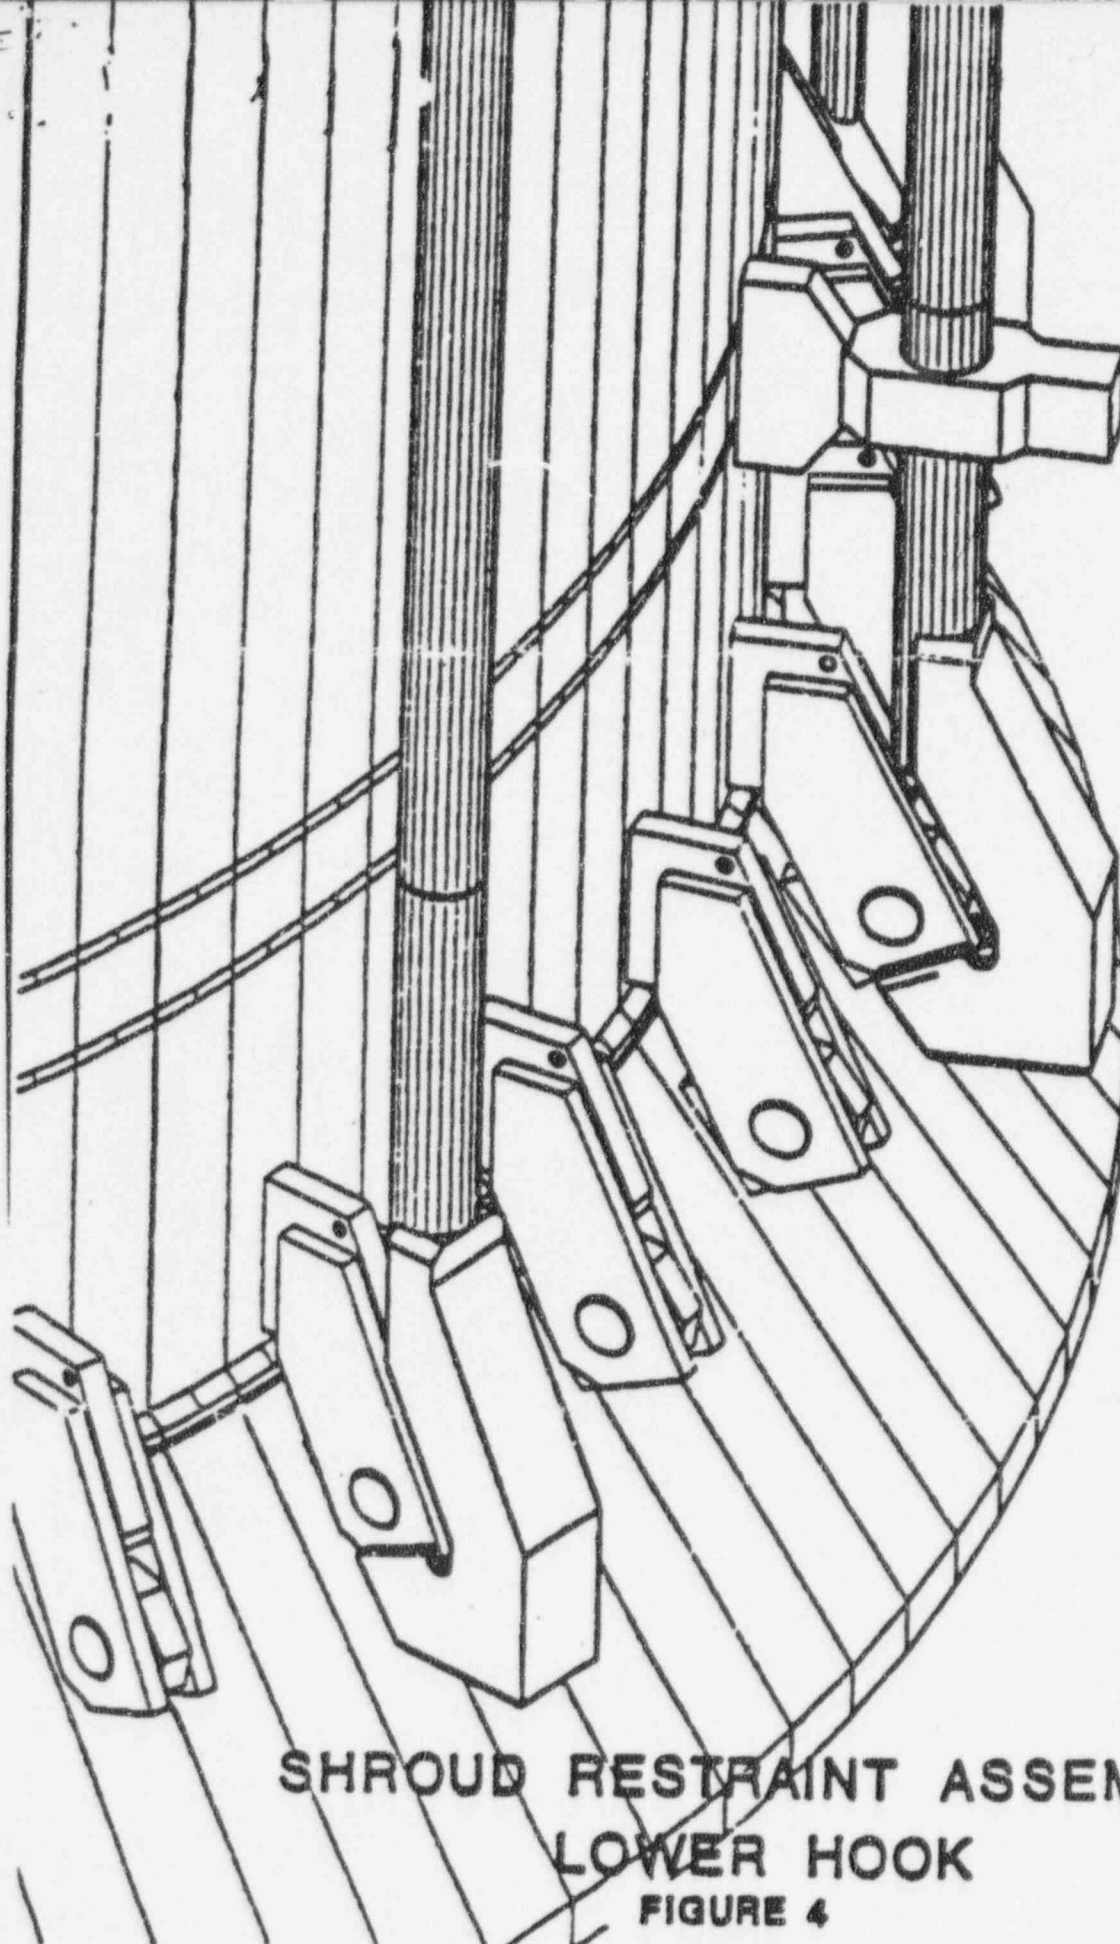
FIGURE 4

Specifically, NIRS concerns with the Oyster Creek's Core Shroud Repair focus on the Shroud Restraint Assembly Lower Hook depicted in Figure 4 of the NRC Safety Evaluation dated November 25, 1994. [Attached]

NIRS contends that the lower hooks for the restraint assemblies are dependent on the originally installed gussets, which in turn are composed of plates of Type 304 stainless steel and Inconel 600. NIRS contends that the anchor system utilized for the core shroud fix is dependent upon a susceptible material which has been subject to long-term exposure by the same harsh operational environment that incubated cracking of the core shroud. These conditions are identified in NUREG/CR-5754 "Boiling Water Reactor Internals Aging Degradation Study."

NIRS contends that both the NRC and the licensee ignored information contained within NUREG/CR-5754 which warns that it is "essential to control or eliminate stressors" (emphasis added). To the contrary, GPUN incorporated "a susceptible material" in the fabrication of the anchor system for the core shroud fix, namely, Type 304 stainless steel and Inconel 600 which have been subjected to aging conditions for 25 years during the reactor's operation.

SHROUD RESTRAINT ASSEMBLY  
LOWER HOOK
