# WOLF CREEK

Subject: Docket No. 50-482: Inservice Inspection Program  
Relief Requests

ISI RELIEF REQUEST IIR-23

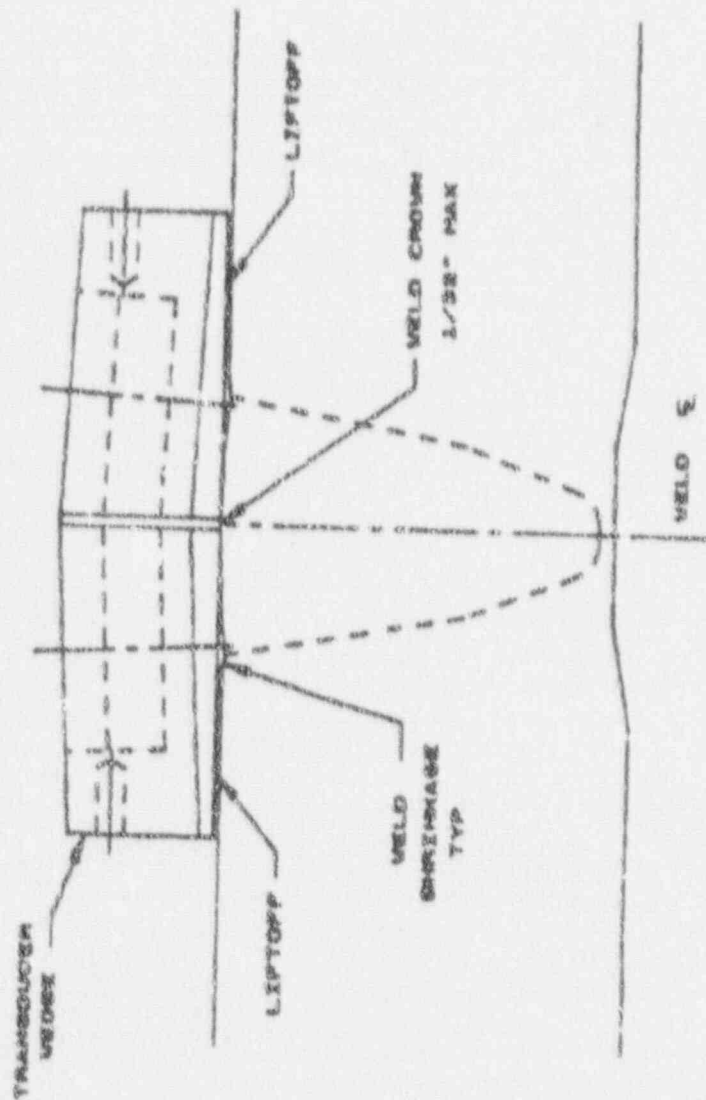
FIGURE 1

Basis for Relief: The transducers used to examine Cast Stainless Steel (CSS) were too large to maintain sufficient contact in the circumferential scanning mode (reference Figure 1). They did, however, maintain adequate contact when scanning perpendicular to the weld axis.

With welds F207, F307, F407, F305, F405 and F306, the weld crown and weld shrinkage causes transducer lift off. With welds F203 and F303, the weld taper causes transducer lift off.

Basis for Relief: The transducers used to examine Cast Stainless Steel (CSS) material were too large to maintain sufficient contact when running along the weld crown (circumferential examination). Thus, resulting with 0% inspection using the circumferential scan (reference Figure 1).

# TYPICAL CIRCUMFERENTIAL SCAN LIFTOFF

Alternate Examination: The code required volumetric examination will be completed perpendicular to the weld axis from two (2) directions.

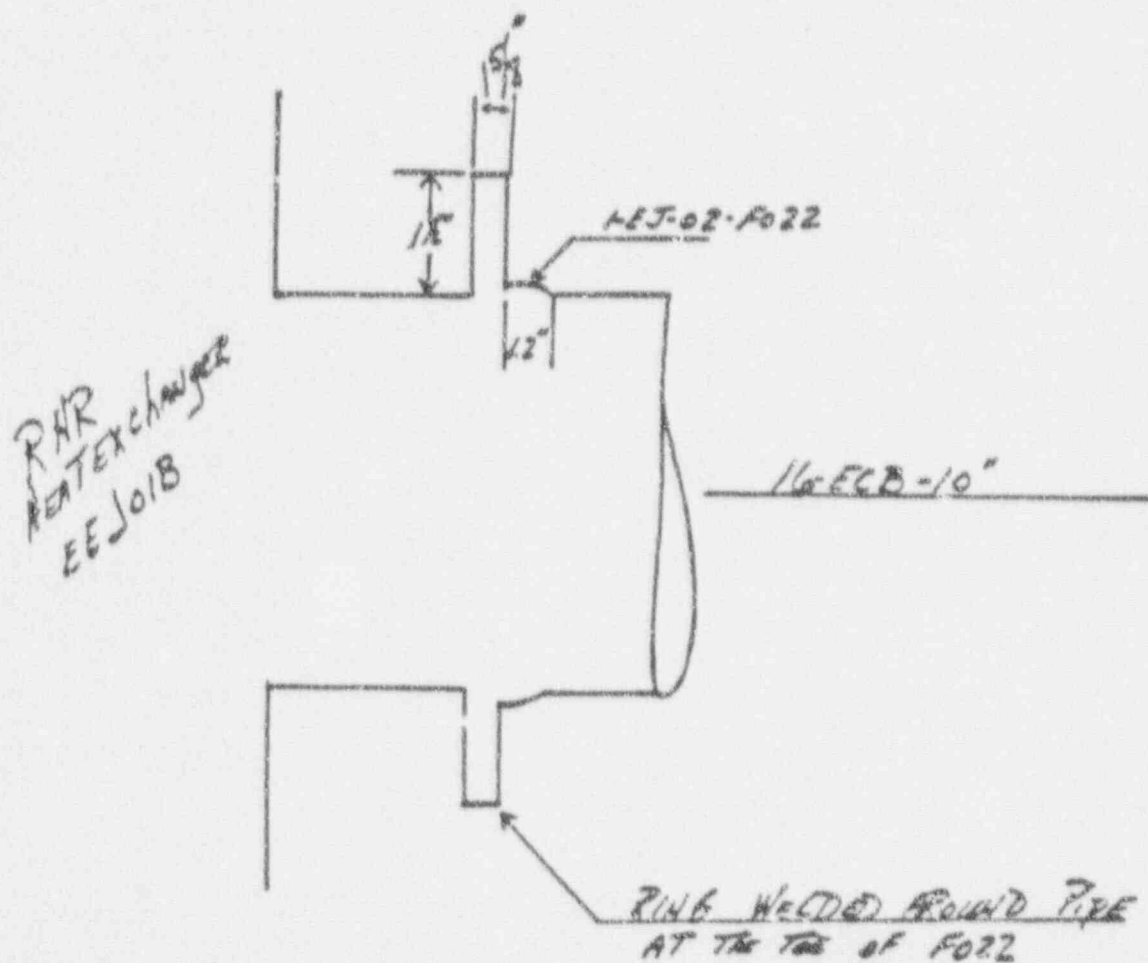
Figure 1

Basis for Relief: The surface examination of the subject weld is 39% obstructed by a 1 1/2" by 1 5/8" ring. The ring is welded over the downstream toe of the weld; therefore, making it impossible to get the required 1/2" coverage beyond the toe of the weld. To examine the obstructed area would require physically removing the welded ring (reference Figure 1).

Alternate Examination: None; the Code required surface examination will be completed to the maximum extent practical.

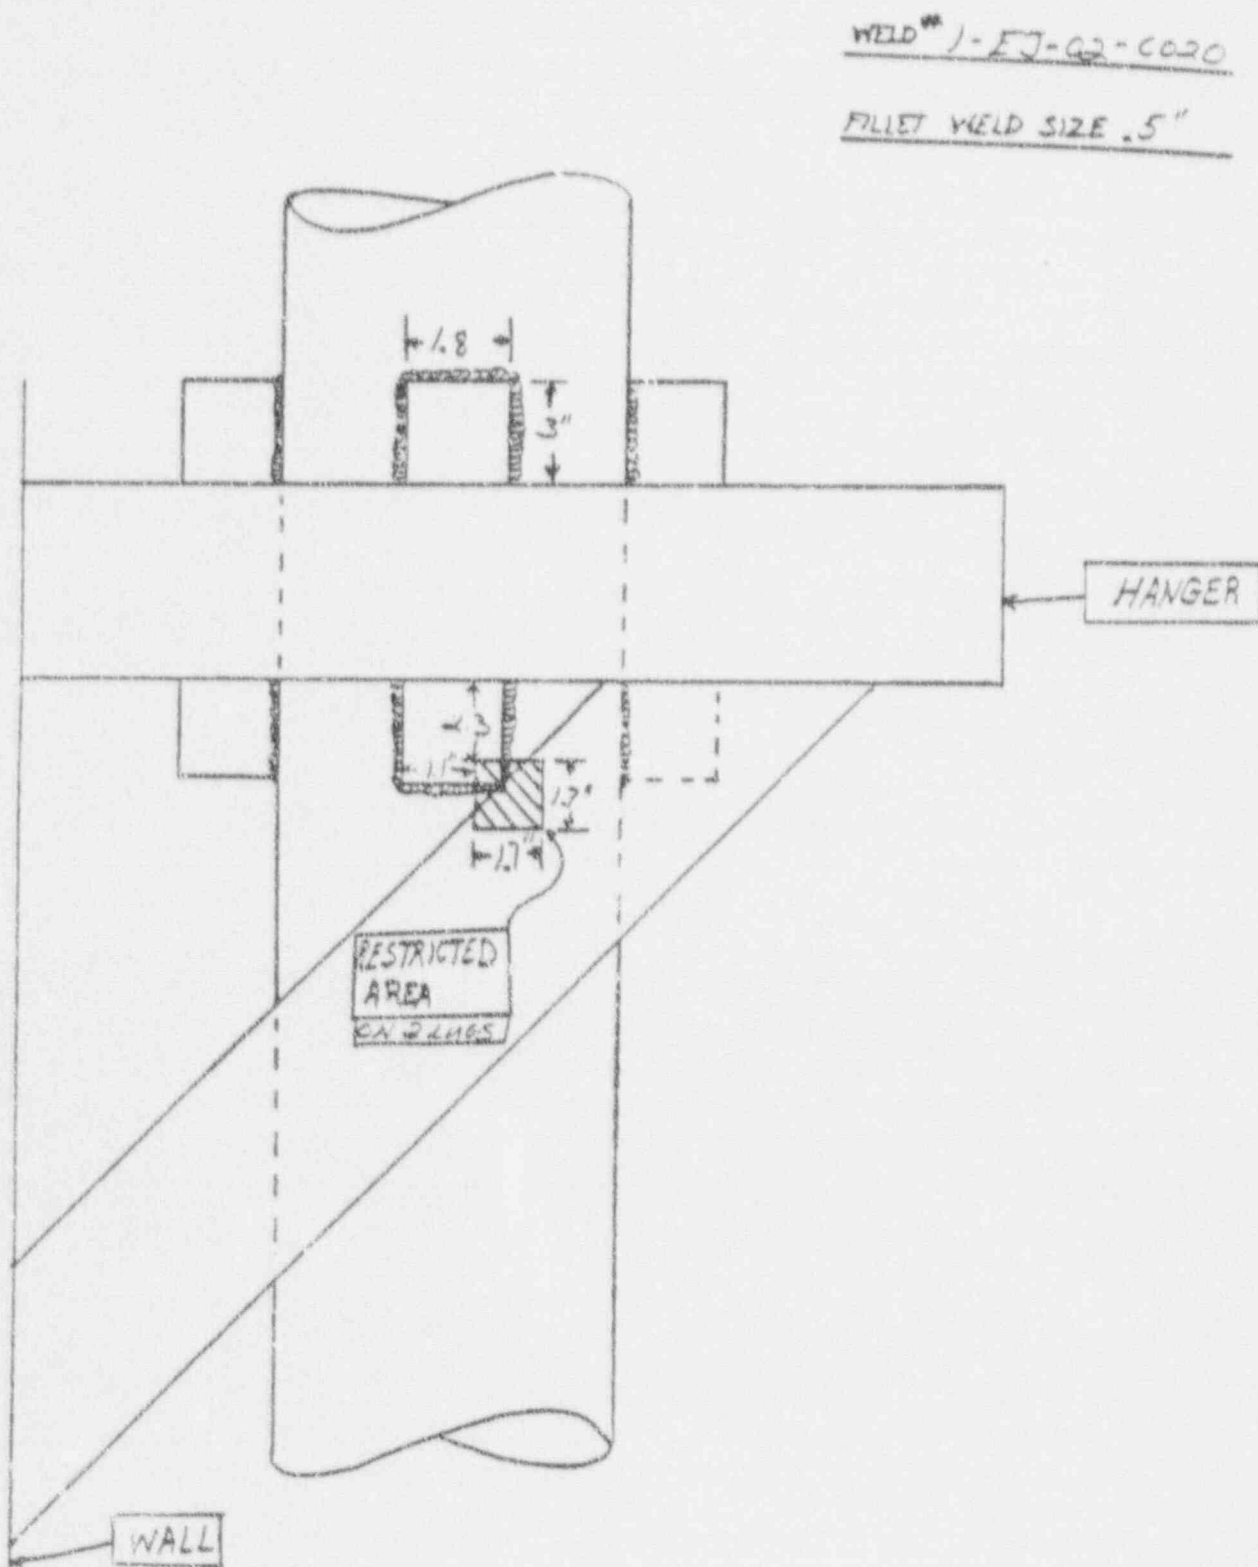
Figure 2

Basis for Relief: The surface examination of the subject integrally welded attachments (lugs) are 24% obstructed on two (2) of the lugs. The obstruction is a result of a permanent hanger that is used to support the Residual Heat Removal (RHR) piping. The diagonal supports of this hanger cross over the required inspection area on two of the lugs (reference Figure 2).

RESTRICTED DUE TO HANGER

Alternate Examination: None; the Code required surface examination will be completed to the maximum extent practical.

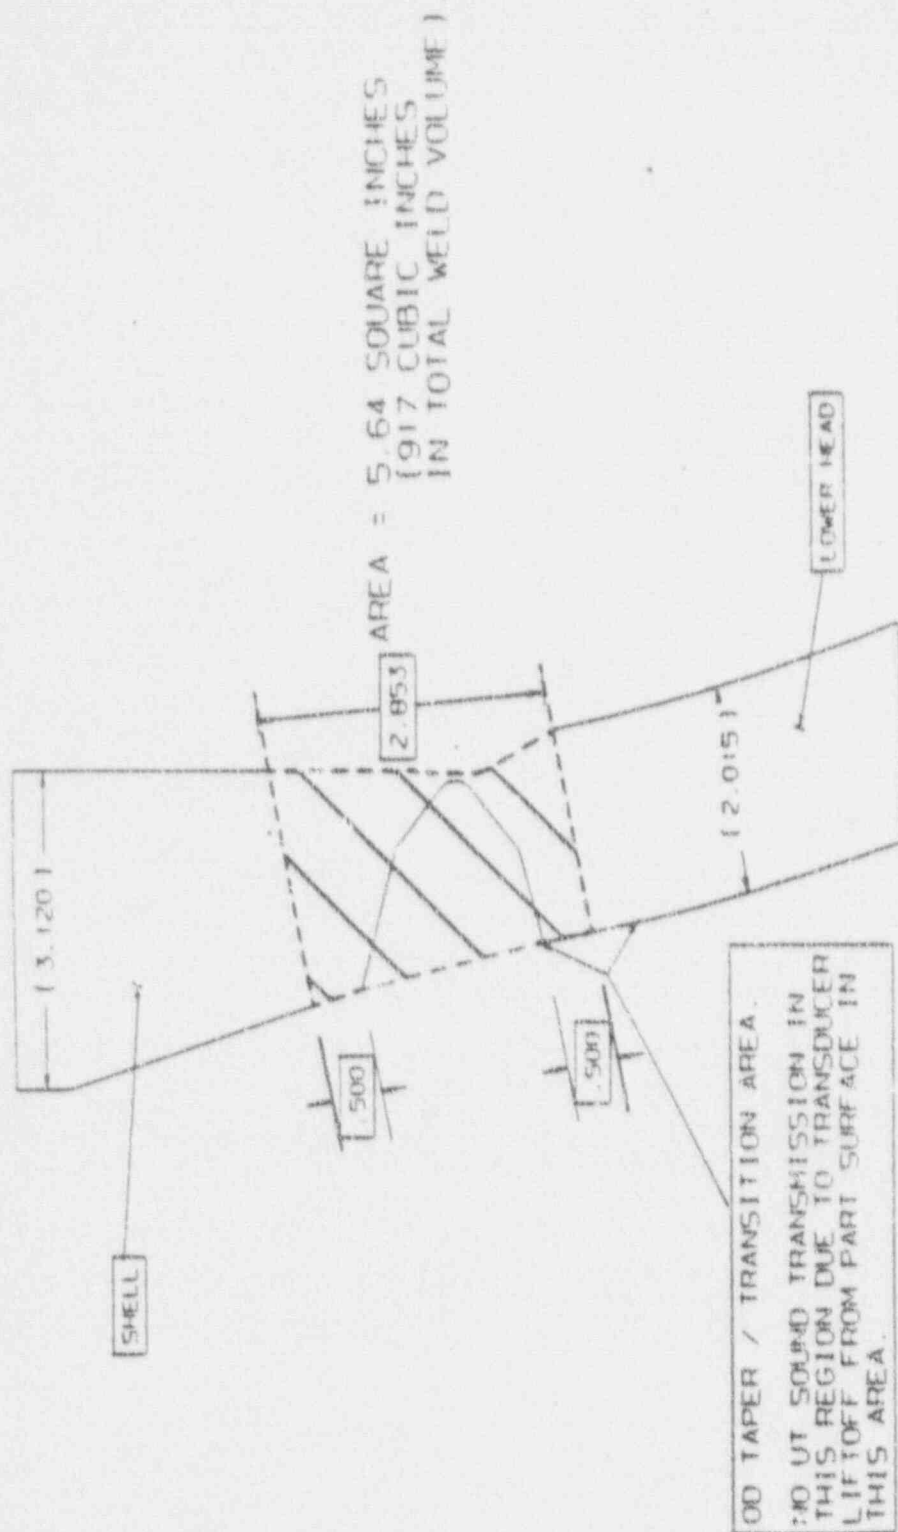
Figure 3A

The circumferential examination was 100% limited due to the weld configuration (reference Figures 3A through 3D for the percentage breakdown).

Alternate Examination: None; the Code required volumetric examination will be completed to the maximum extent possible.

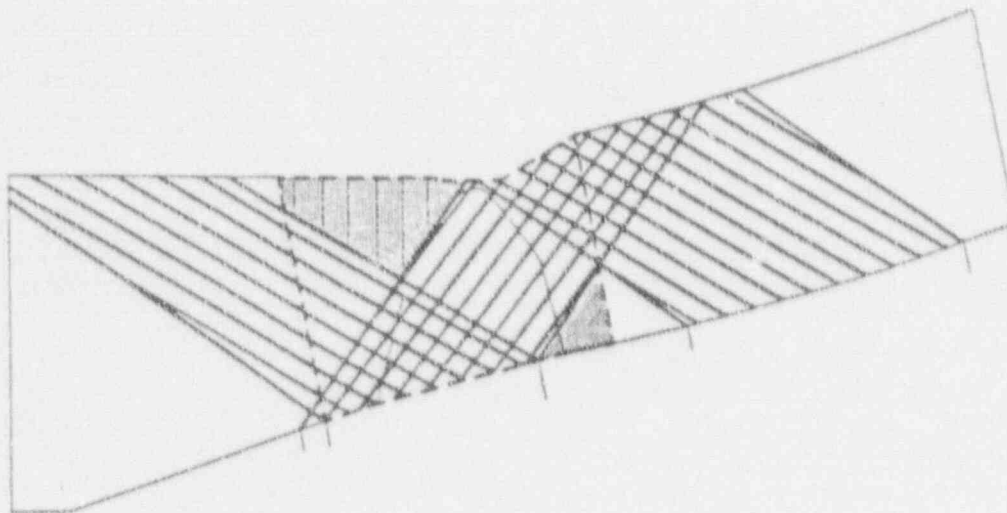
AREA COVERAGE  
 BEAM DIRECTION TOWARDS SHELL:  
 UPPER REGION - 2.06 SQUARE INCHES  
 236 CUBIC INCHES  
 36 PERCENT  
 LOWER REGION - 0.388 SQUARE INCHES  
 45 CUBIC INCHES  
 7 PERCENT  
 TOTAL:  
 PERCENTAGE OF WELD EXAMINED: 43  
 PERCENTAGE OF WELD NOT EXAMINED: 57  
 BEAM DIRECTION TOWARDS HEAD:  
 3.76 SQUARE INCHES  
 430 CUBIC INCHES  
 67 PERCENT  
 TOTALS:  
 PERCENTAGE OF WELD EXAMINED: 67  
 PERCENTAGE OF WELD NOT EXAMINED: 33

TOTAL WELD COVERAGE  
 WITHOUT EXTERNAL  
 RESTRICTIONS

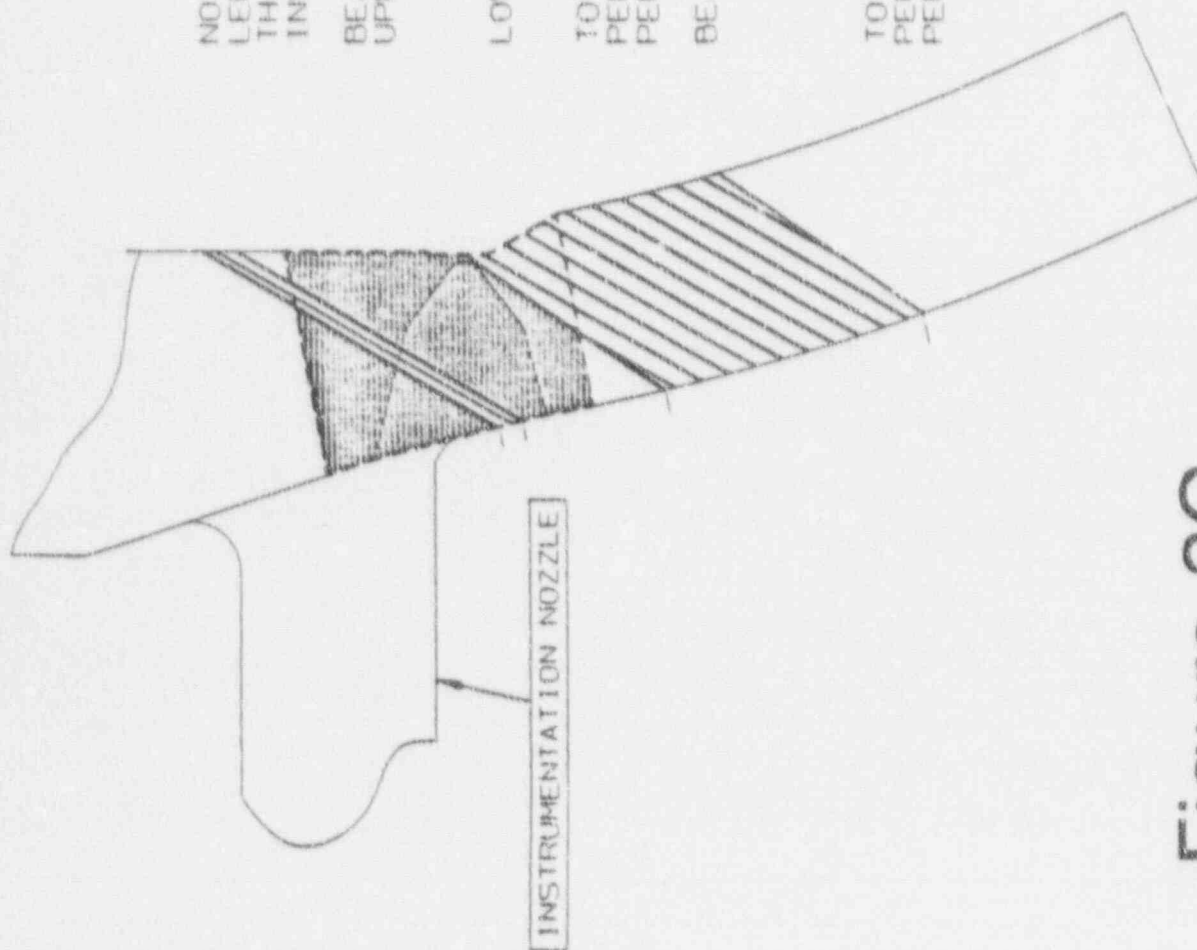
Figure 3C

NOTE:  
LENGTH OF RESTRICTION 4 INCHES @ 2 LOCATIONS  
THIS YIELDS 5.0% OF THE TOTAL WELD IS UNDER  
INSTRUMENTATION NOZZLE.

COVERAGE IN AREA WITH INSTRUMENTATION NOZZLE

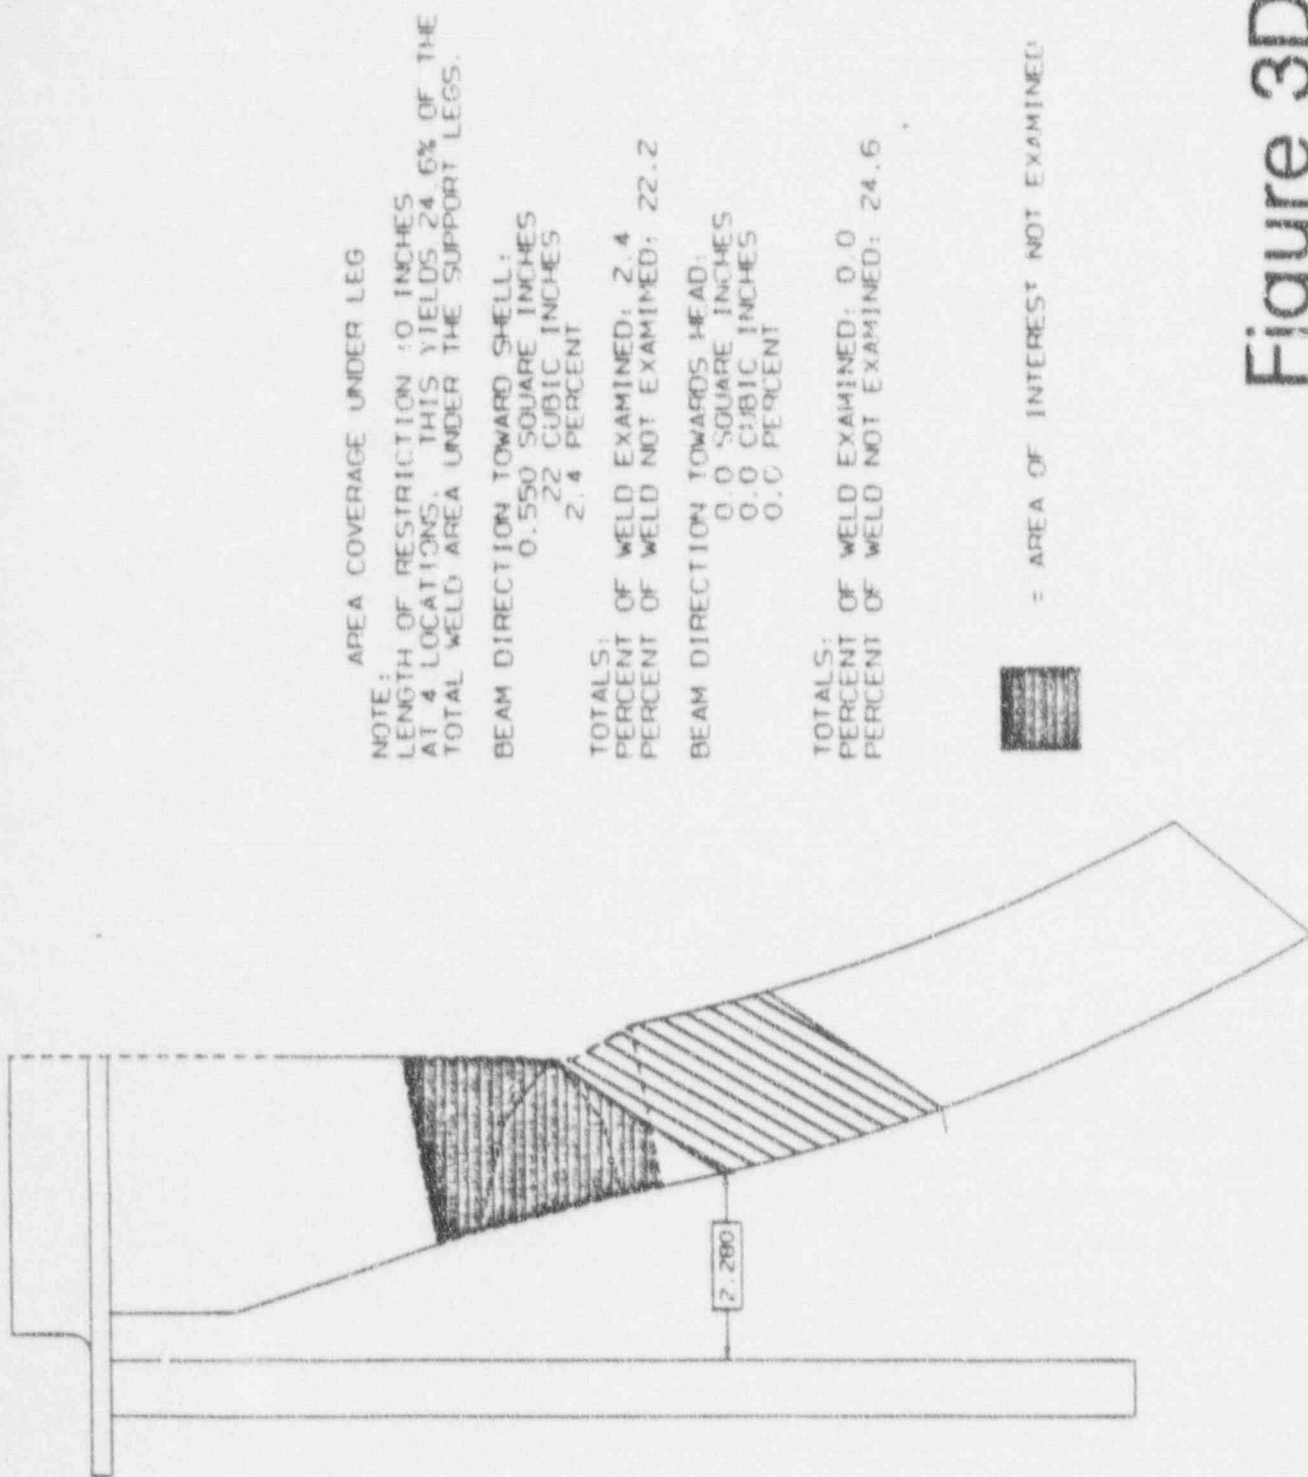
Figure 3D

COVERAGE IN AREA WITH BIT LEGS

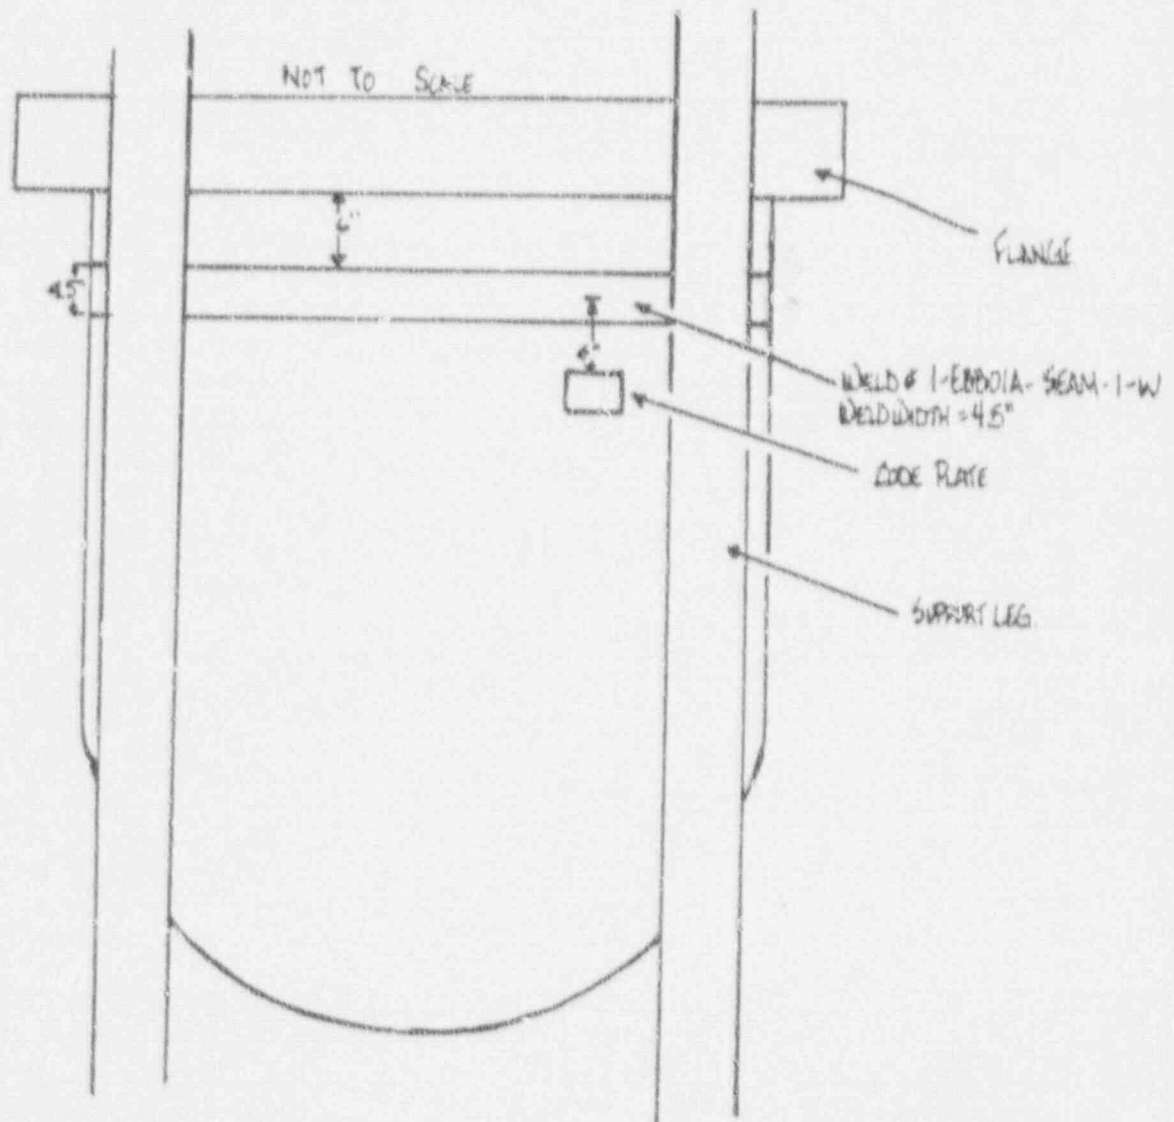
Basis for Relief: The volumetric examination of the subject weld is 22.4% obstructed by four (4) supports. The 60° axial scan on the tubesheet side is 20% obstructed by the support flange. The obstruction results from insufficient base metal between the weld and flange to complete this angle beam examination. There is approximately 1% obstruction due to weld taper and the code data plate. Reference Figure 4 for weld layout.

SUPPORT LEG LOCATIONS

39 1/4" to 63 1/4" CCW FROM DATUM X0, FULL SCAN AREA  
42 3/4" to 66 3/4" CW FROM DATUM X0, FULL SCAN AREA  
44" to 68" CCW FROM DATUM IV, FULL SCAN AREA  
38 1/2" to 62 1/2" CW FROM DATUM N, FULL SCAN AREA

CODE PLATE LOCATION

29 1/2" to 30 1/2" CW FROM DATUM X0  
4" to 8 1/4" BELOW WELD Q.

Alternate Examination: None; the Code required volumetric examination will be completed to the maximum extent practical.

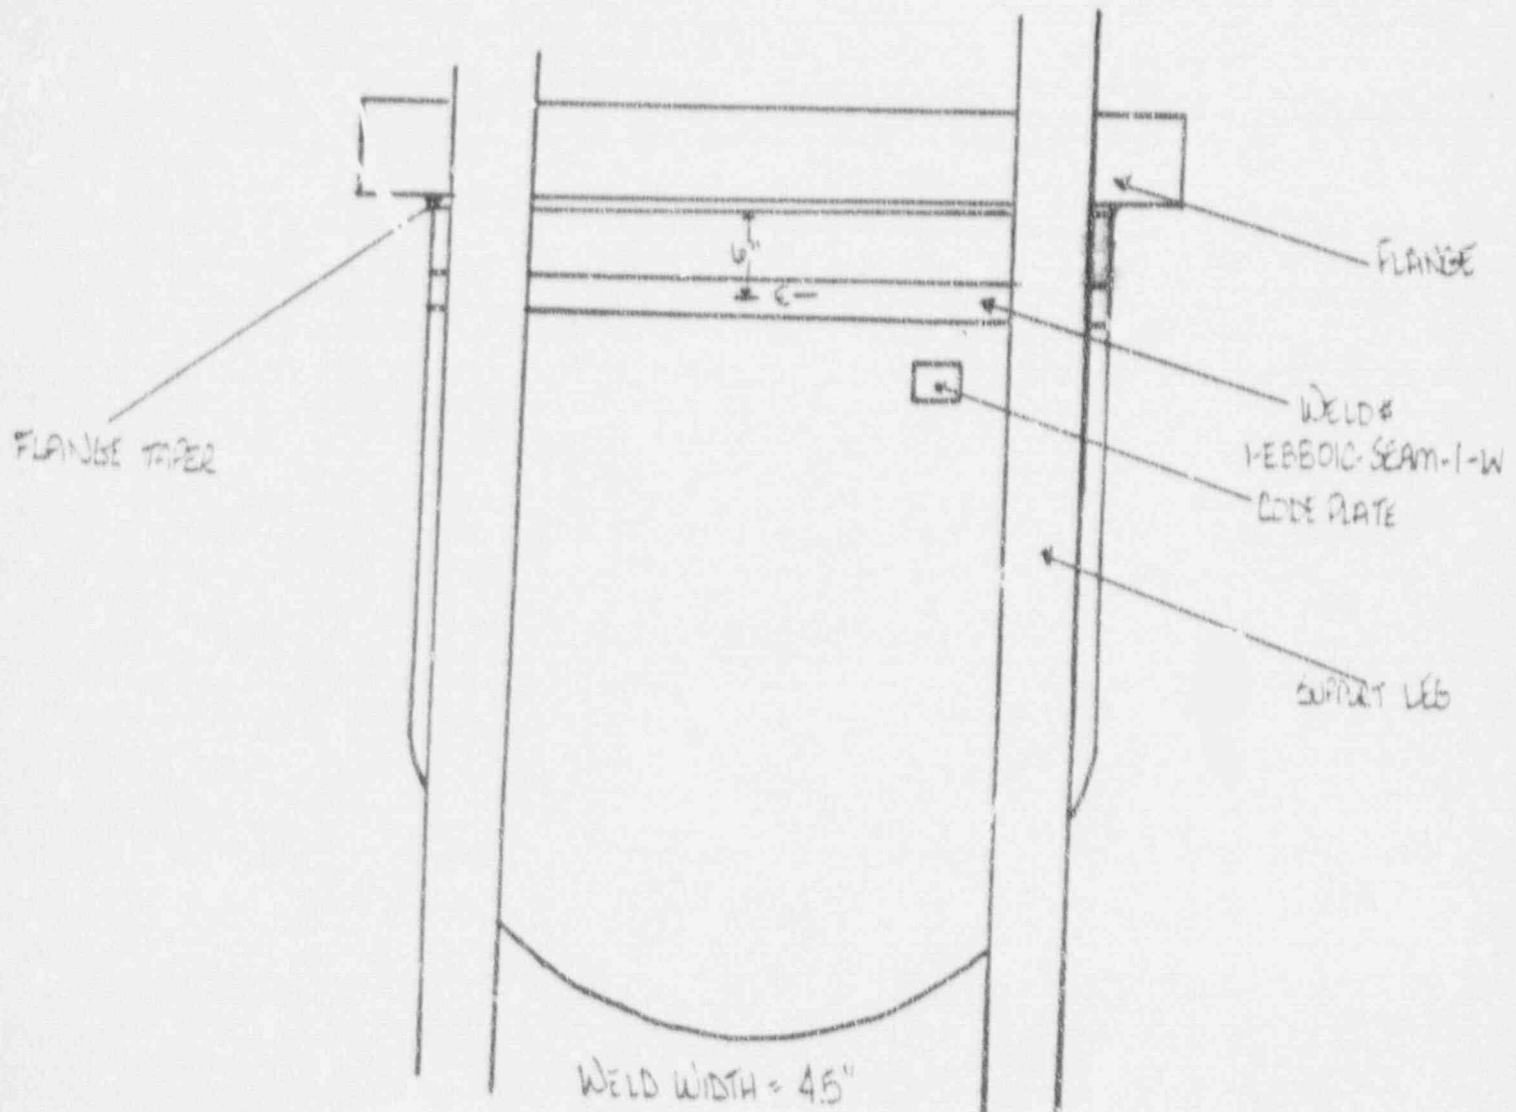
Basis for Relief: The volumetric examination of the subject weld is 22.4% obstructed by four (4) supports. The 60° axial scan on the tubesheet side is 30% obstructed by the support flange. The obstruction results from insufficient base metal between the weld and flange to complete this angle beam examination. There is approximately 1% obstruction due to weld taper and the code data plate. Reference Figure 5 for weld layout.

### SUPPORT LEG LOCATIONS

6" CW to 6 1/2" CW of Datum NO  
6" CW to 6 5/8" CW of Datum NO  
6 1/2" CW to 6 5/8" CW of Datum NO  
6 1/2" CW to 6 3/4" CW of Datum NO

### CODE PLATE LOCATION

from 7" to 10 3/4" below E of weld  
ON Bottom Head side  
22 1/2" to 29 1/2" CW from Datum NO

TAPER ON FLANGE LOCATED 6" BACK FROM E OF WELD

Alternate Examination: None; the Code required volumetric examination will be completed to the maximum extent practical.

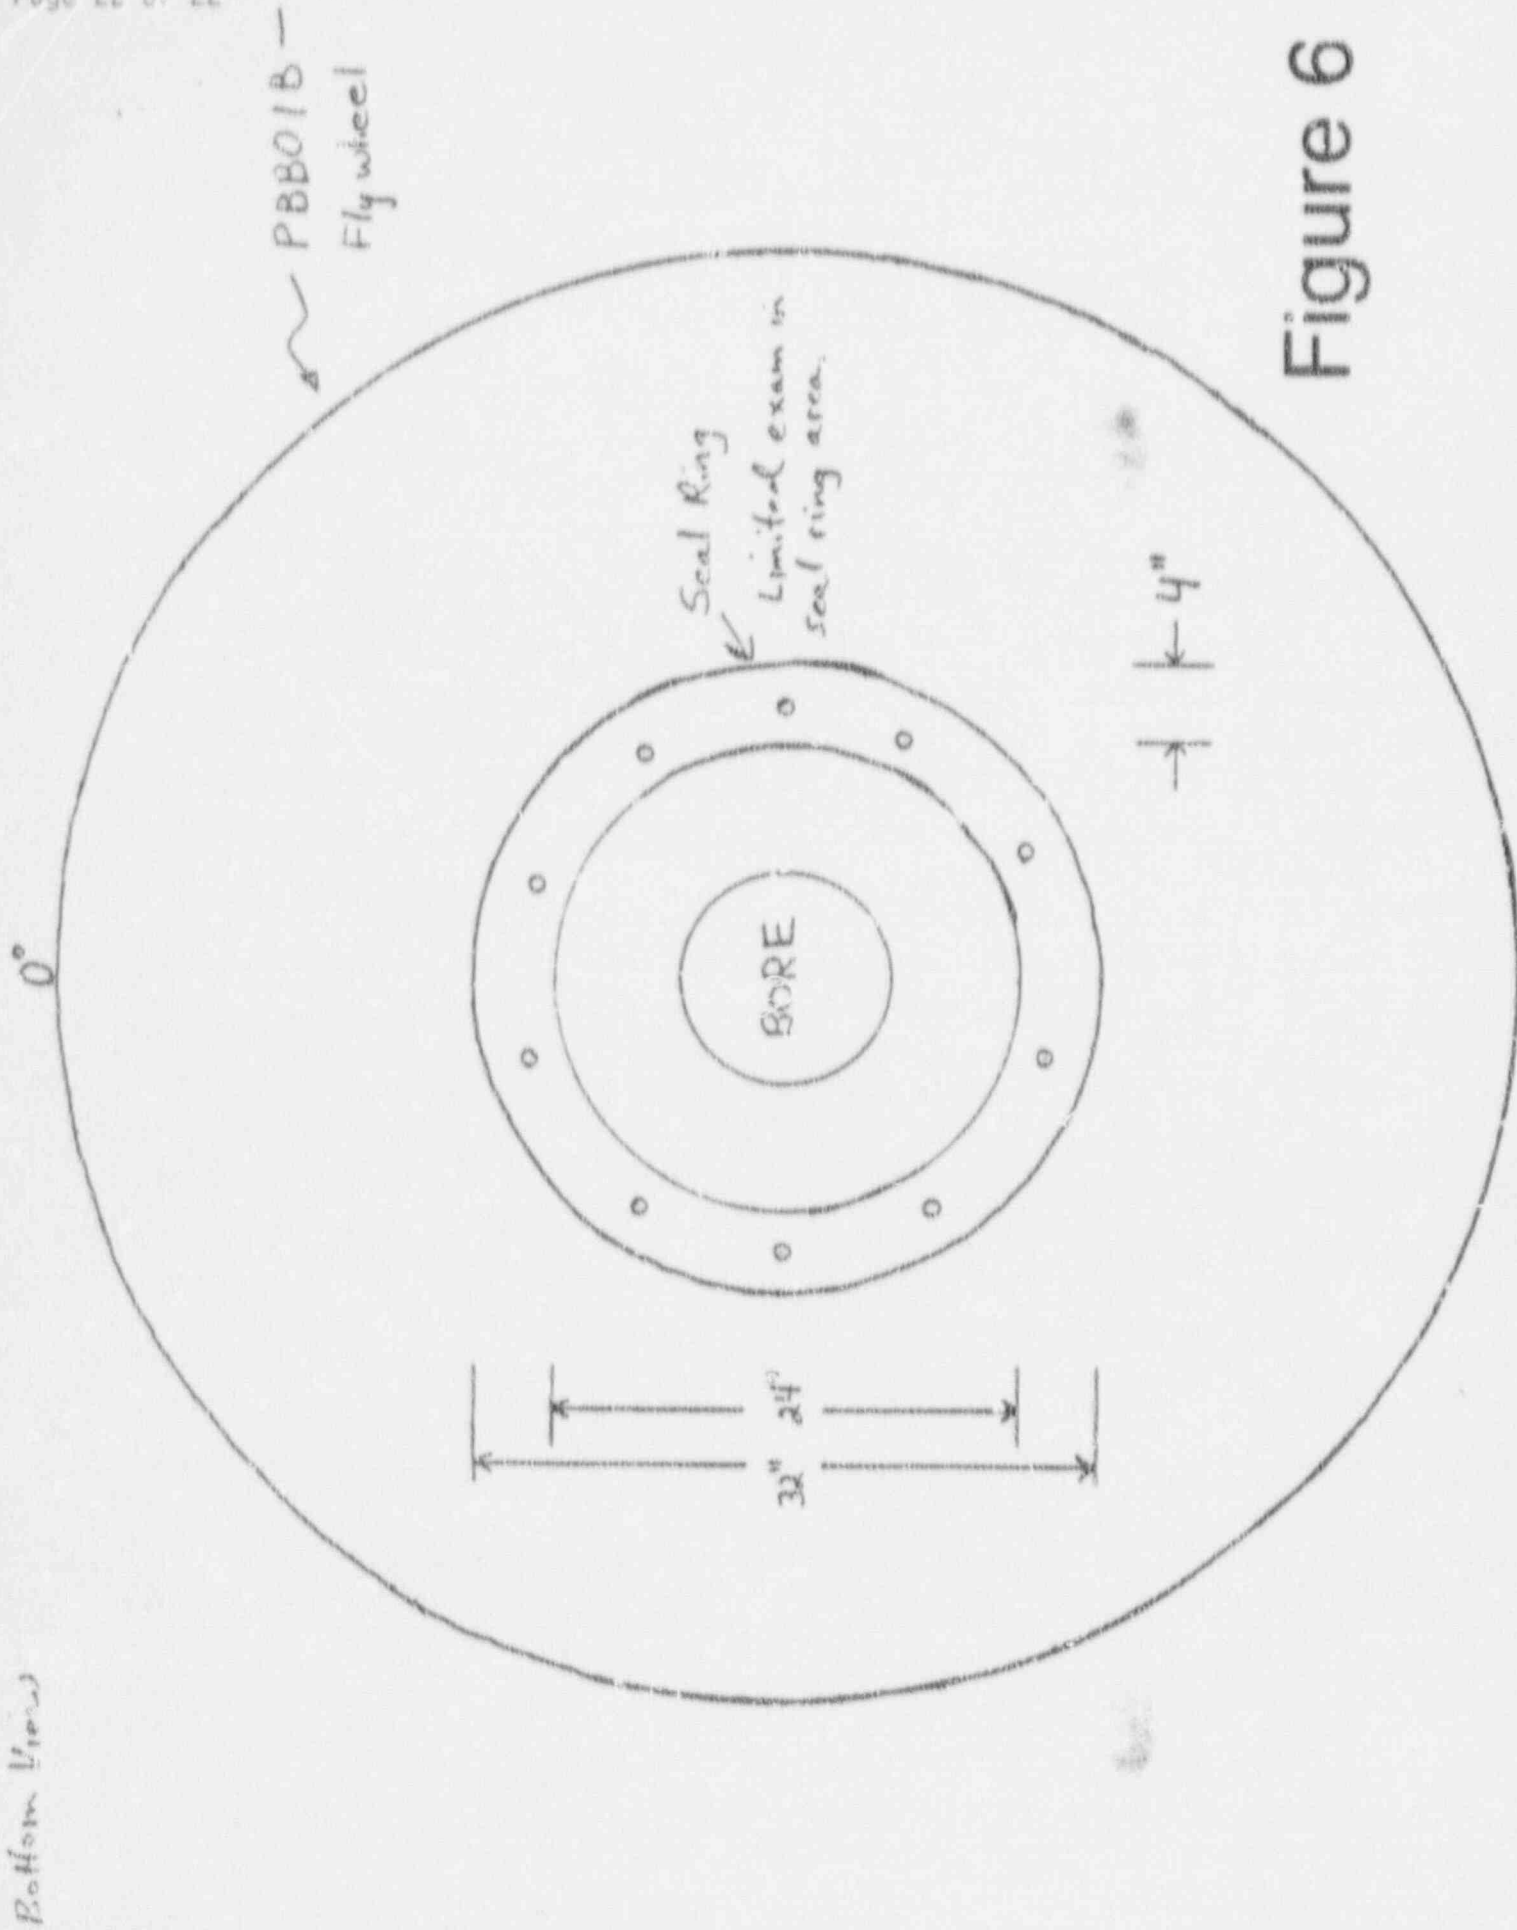
Figure 6

Basis for Relief: The surface examination of the subject Flywheel is 3% obstructed by a seal ring that is located on the bottom side of the Flywheel (reference Figure 6).

Tight clearances are required for seal ring location. This ring reduces the vacuum effect produced by the rotating flywheel in order to prevent oil from being sucked out of the oil reservoir stand pipe. After the ring is set, it should not be moved unless absolutely necessary.

Alternate Examination: None; the Code required surface examination will be completed to the maximum extent practical.
