Commonwealth Edison Company  
Byron Generating Station  
4450 North German Church Road  
Byron, IL 61010-9794  
Tel 815 234-5441

LER Number  
454:95-005

Title of Event: Fire Protection Report Discrepancies Due To Inadequate Evaluations During Preparation of Original Analysis

## FIRE PROTECTION REPORT DISCREPANCIES DUE TO INADEQUATE EVALUATIONS DURING PREPARATION OF ORIGINAL ANALYSIS

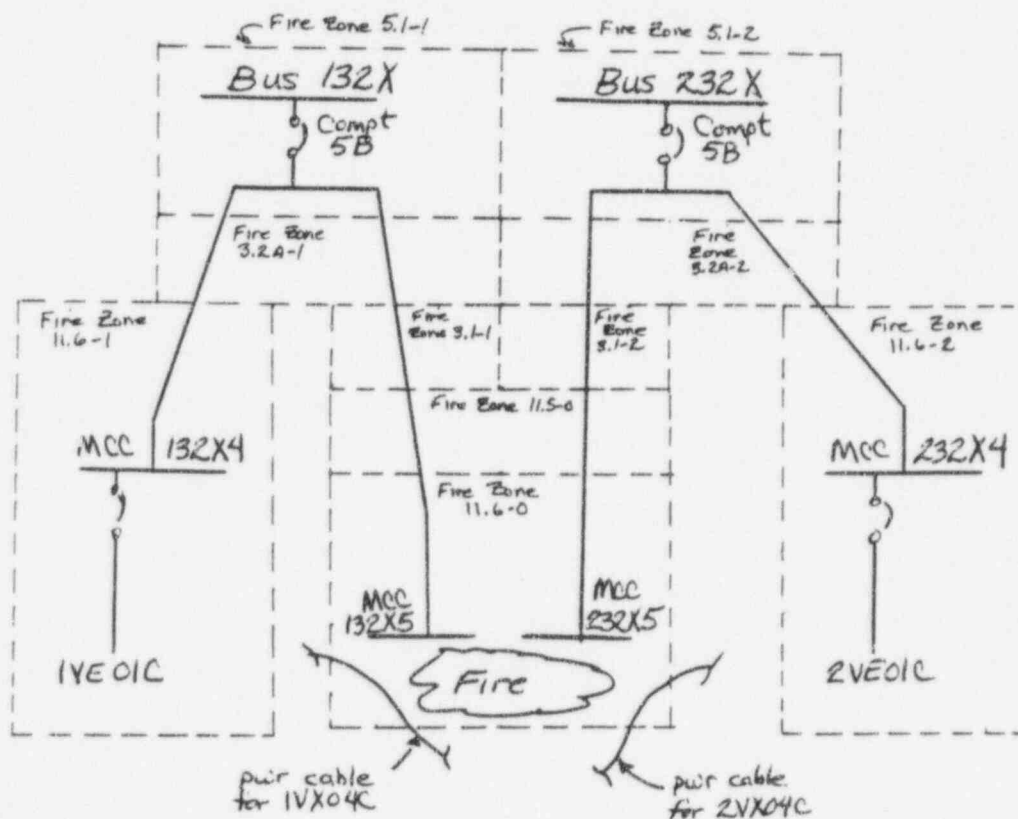
Figure 1: Configuration of Fire Zone 11.6-0

The FPR Safe Shutdown Analysis for Fire Zone 11.6-0 failed to recognize the loss of electric power to the Division 12 and 22 MEER Supply Fans. Although the power cables for these fans are not routed through Fire Zone 11.6-0, they are powered from Motor Control Centers (MCCs) which are affected by a fire in zone 11.6-0. The MCCs supplying power to the Division 12 and 22 MEER Supply Fans are powered from two 480 volt breakers that also power MCCs located in zone 11.6-0. The MCCs located in fire zone 11.6-0 can be damaged by a fire in this zone. A fire induced fault on these MCCs will cause the 480 volt breakers to open which will also de-energize the MEER Supply Fans. See Figure 1 in Attachment A for a diagram of the above configuration.

The cause of the events reported on 10/12/95 and 10/13/95 was a failure of the team of analysts preparing the original Byron Safe Shutdown Analysis to recognize the interconnection between MCCs powered from a single 480 volt Bus breaker. Consequently, the Safe Shutdown Analysis for Fire Zones 11.4-0 and 11.6-0 did not consider the potential loss of some MCCs located outside of the fire zone. The team of analysts considered the equipment and cables located in the fire zone that could be directly affected by a fire. An assumption was implicitly made and the analyses was performed as if the power and control for each component formed an independent circuit and that a failure of cables for one component would not have any impact on any other safe shutdown components. This assumption is based on breaker coordination studies that demonstrate that fire induced faults on a cable will not cause an upstream supply breaker to open before the specific load fuse or breaker for the circuit in question opens. This assumption would not apply if two MCCs are fed from a single bus breaker.

Problem: Appendix R Fire in Zone 11.6-0 (Elev. 426', AB) may cause failure of:

- 1). Power cable for 1VX04C (U-1 Div 11 MEER Supply Fan)
- 2). Power cable for 2VX04C (U-2 Div 21 MEER Supply Fan)
- 3). Fault MCC 132X5 which causes Bus 132 Compt 5B breaker to open when sensing fault current.

Therefore MCC 132X4 de-energized resulting in:

- (a) Loss of 1VE01C (U-1 Div 12 MEER Supply Fan)
- 4). Fault MCC 232X5 which causes Bus 232 Compt 5B Breaker to open when sensing fault current.

Therefore MCC 232X4 de-energized resulting in:

- (a) Loss of 2VE01C (U-2 Div 22 MEER Supply Fan)

Which means for a fire in Zone 11.6-0;

Both redundant MEER Supply Fans are lost on both units.

1. Plant modifications have been initiated to permanently correct each deficiency described in this LER. The Unit 1 modifications are expected to be installed by May, 1996, and the Unit 2 modifications are expected to be installed by December, 1996. (NTS # 454180950005-01,02)
2. An action plan to assess the FPR Safe Shutdown Analysis (Section 2.4 of the FPR) is being developed. The plan will review all previously identified problems, determine root cause, and recommend corrective actions in order to confirm the technical integrity of the FPR analysis. Comprehensive reviews of the Byron FPR Safe Shutdown Analysis are being considered to search for and identify any other unknown discrepancies which may exist. (NTS # 454180950005-03)

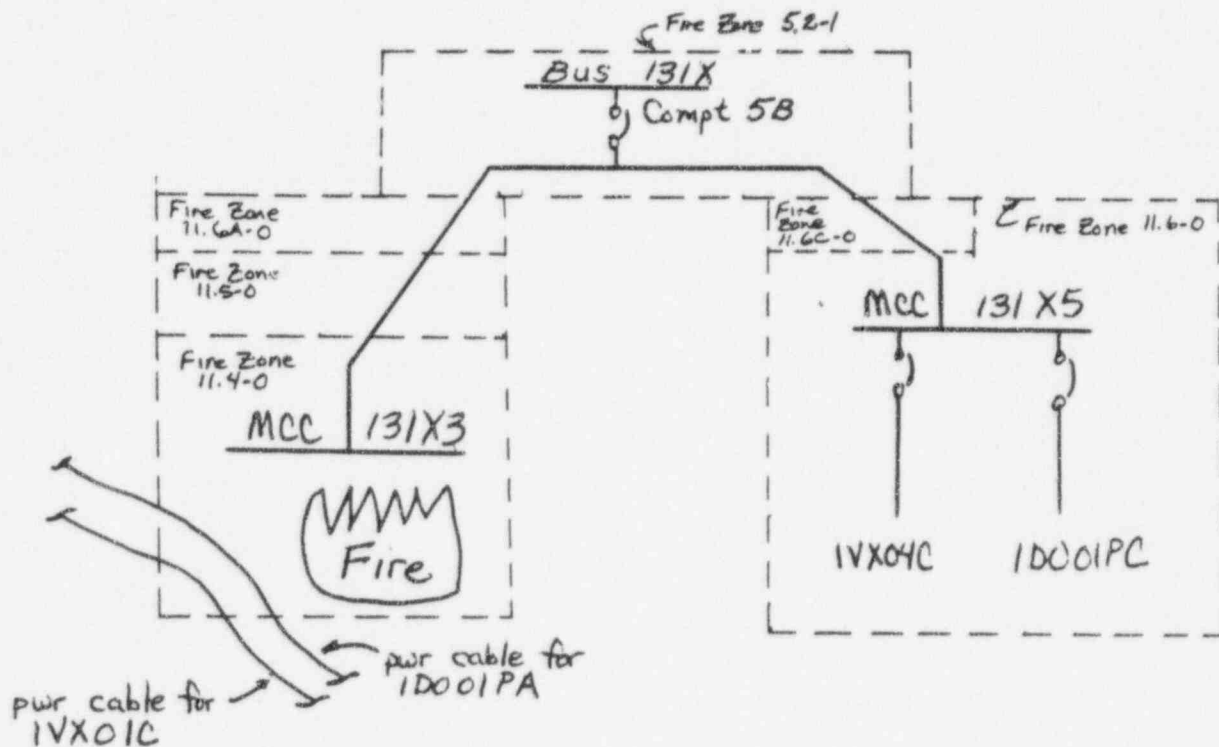
Figure 2: Configuration of Fire Zone 11.4-0

Unit 1 FPR Sections 2.4.2.43 and A5.8.17 state that Division 11 equipment is relied upon for a fire in Fire Zone 11.4-0. The power cable for Diesel Oil Transfer Pump (1DO01PA, Division 11) is routed in this zone and can be damaged by a fire. Redundant pump (1DO01PC, Division 11), its power cable, and MCC power source are located outside of zone 11.4-0. The MCC power source receives power from a common 480 volt bus breaker which also powers an MCC located in Fire Zone 11.4-0. The MCC located in zone 11.4-0 can be damaged by a fire in this zone. Therefore, a fire-induced failure on this MCC will cause the common supply breaker to open and de-energize the MCC supplying power to pump 1DO01PC. With both Diesel Oil Transfer pumps not available, the 1A Emergency Diesel Generator is not available. Additionally, the Division 11 ESF Switchgear Room Supply Fan (1VX04C) is powered by the MCC for pump 1DO01PC. Similarly, fan 1VX04C may not be available for a fire in zone 11.4-0. See Figure 2 in Attachment A for a diagram of the above configuration.

Problem: Appendix R Fire in Zone 11.4-0 (Elev. 383', AB) may cause failure of:

- 1). Pwr cable for 1VX01C (Div 12 ESF Swgr Supply Fan)
- 2). Pwr cable for 1DO01PA (A Diesel Oil pp for 1A D/G)
- 3). Fault MCC 131X3 which causes Bus 131 Compt 5B breaker to open when sensing fault current.

Therefore MCC 131X5 de-energized resulting in:

- (a) Loss of 1VX04C (Div 11 ESF Swgr Supply Fan)
- (b) Loss of 1DO01PC (A Diesel Oil pump for 1A D/G)

Which means for a fire in Zone 11.4-0, which the FPR Safe Shutdown Analysis states that Division 11 will be protected from fire:

- 1). Both DO pumps for the 1A D/G are lost
- 2). Div 11 ESF Swgr Room Supply Fan 1VX04C is lost
