This report is number 95-013-00, Docket No. 50-456.

LICENSEE EVENT REPORT (LER)

Braidwood Units 1 and 2

Fire Protection Appendix R Design Discrepancies Due to Inadequate Evaluations During Preparation of Original Analysis

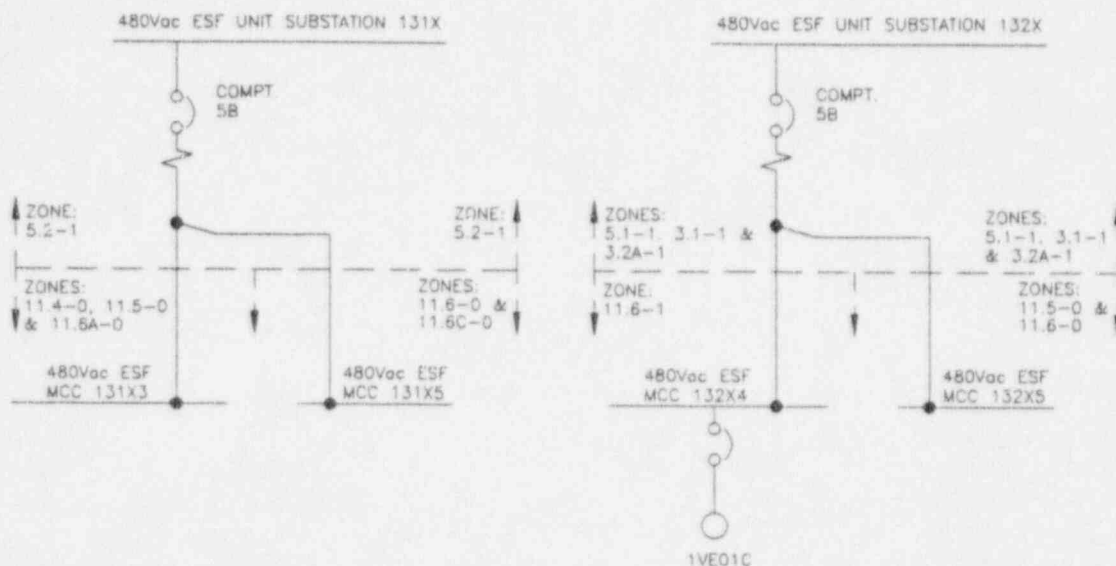
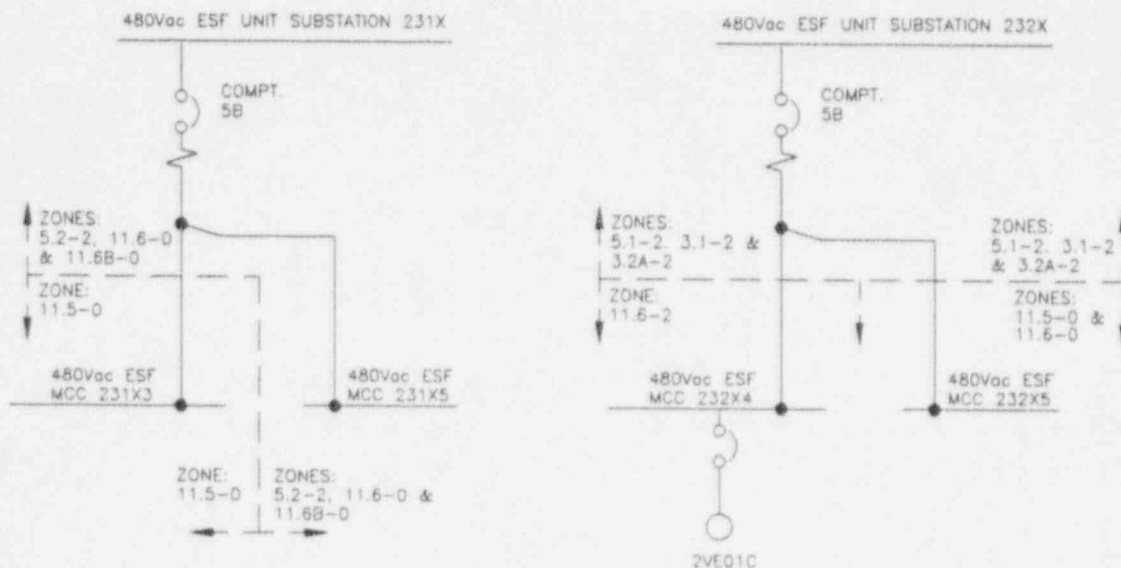
FIGURE 1 - MCCs WITH COMMON SOURCE BREAKERS

The FPR analysis failed to recognize that (2) 480 Vac ESF Motor Control Centers (MCCs) on each train of both Units are powered from a common source breaker at their respective Unit Substations, see Figure 1. As a result, fire induced failures on one MCC, including its feed cable could trip the common source breaker and render both MCCs unavailable. A review of the affected MCCs concluded that the Train A MCCs did not create any Appendix R separation discrepancies; however, the Train B MCCs did. The FPR analysis assumes that the power source for the Train B MEER Supply Fans (1VE01C & 2VE01C) would be available after a fire in zones 11.5-0 (Unit 2) & 11.6-0 (Units 1 & 2). Since the MCCs supplying electrical power to these fans share common Unit Substation breakers with another MCC which could be damaged due to a fire in zones 11.5-0 (Unit 2) & 11.6-0 (Units 1 & 2) the fans would be unavailable. The Engineering Department concluded that a deficiency existed in the FPR analysis and issued a Problem Identification Form (PIF) on October 9, 1995 to document the discrepancy.

The cause of the first identified discrepancy was a failure of the original Braidwood FPR Safe Shutdown Analysis to recognize the interconnection between MCCs powered from a single 480 volt Unit Substation breaker. Consequently, the FPR Analysis for Fire Zones 11.5-0 and 11.6-0 did not consider the potential loss of some MCCs located outside of the fire zone. The analysis addressed what equipment and cables are located in the fire zone and could be directly affected by a fire. An assumption was implicitly made and the analysis was performed as if the power and control cables for each component formed an independent circuit and that a failure of cables for one component would not have any impact on any other safe shutdown components. This assumption is based on breaker coordination studies that demonstrate that fire induced faults on a cable will not cause an upstream supply breaker to open before the specific load fuse or breaker for the circuit in question opens. This assumption is not valid for the identified configuration of two MCCs fed from a single Unit Substation breaker. The exception to the breaker coordination assumption is an isolated case in the existing Byron and Braidwood Safe Shutdown Analysis.

1. Hourly fire watches will remain in effect for all fire zones until all Safe Shutdown discrepancies are permanently rectified.
2. The Station has initiated plant modifications to permanently resolve the deficiencies described herein. The affected MCCs will be re-powered from different source breakers at their respective Unit Substations. The affected DG and SX system cables will be re-routed out of the fire zones. The AF pump circuitry will be re-wired to eliminate the impact of fire induced failures on the affected AF system cables. Installation of the Unit 1 modifications were all completed during the recent re-fueling outage with the exception of one cable in the SX system. Installation of the Unit 2 modifications will begin during the upcoming re-fueling outage. The installation activities for these modifications will be completed by December 1996. This will be tracked to completion by commitment 456-180-95-01301 and -01302 for Units 1 and 2, respectively.
