NRC FORM 366 (5-92)						U.S. NUCLEAR REGULATORY COMMISSION						APPROVED BY OMB NO. 3150-0104 EXPIRES 5/31/95																																																																													
LICENSEE EVENT REPORT (LER)												ESTIMATED BURDEN PER RESPONSE TO COMPLY WITH THIS INFORMATION COLLECTION REQUEST: 50.0 HRS. FORWARD COMMENTS REGARDING BURDEN ESTIMATE TO THE INFORMATION AND RECORDS MANAGEMENT BRANCH (MN88 7714), U.S. NUCLEAR REGULATORY COMMISSION, WASHINGTON, DC 20555-0001, AND TO THE PAPERWORK REDUCTION PROJECT (3150-0104), OFFICE OF MANAGEMENT AND BUDGET, WASHINGTON, DC 20503.																																																																													
(See reverse for required number of digits/characters for each block)																																																																																									
FACILITY NAME (1) MONTICELLO NUCLEAR GENERATING PLANT												DOCKET NUMBER (2) 05000 - 263						PAGE (3) 1 OF 14

TITLE (4) Mis-Positioning of Division B Drywell Spray Block Valve																																																																																									
EVENT DATE (5)						LER NUMBER (6)						REPORT NUMBER (7)						OTHER FACILITIES INVOLVED (8)

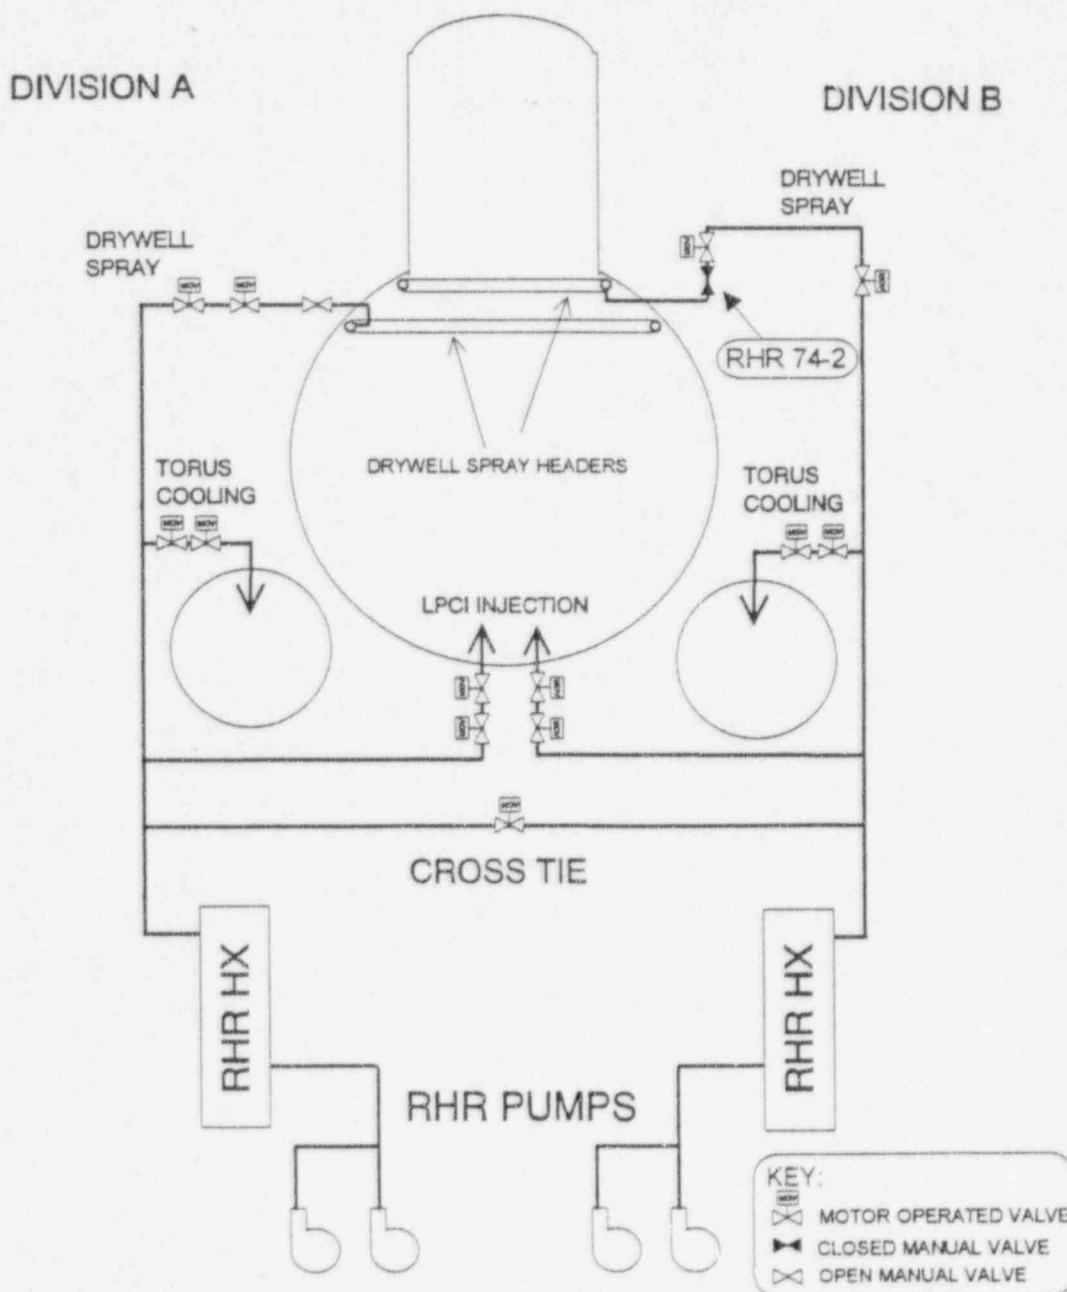
**FIGURE 1 - SIMPLIFIED RHR SYSTEM
SHOWING AS FOUND CONDITION**

While at 100% power on October 12, 1995, valve RHR 74-2 was found closed and unlocked with a Hold card from the 1994 outage attached to it. RHR 74-2 is the manual Division "B" drywell spray block valve in the Residual Heat Removal (RHR)(EHS System Code:BO) system. It is required to be locked open at power. This error was discovered during on-line maintenance activities on the RHR system.

RHR 74-2 is located outside the drywell between the RHR Drywell Spray motor operated valves and the spray header inside the drywell (See Figure 1). RHR 74-2 is in the reactor water cleanup pump area, near the reactor water cleanup line which makes the area a high radiation area. The valve is a 10" rising stem valve, with no remote indication. Its closure blocks one of two paths for drywell spray to be injected into the drywell atmosphere.

1. The hold card was removed from RHR 74-2 on October 12, 1995, and the valve was opened and locked in the open position.
2. All locked valves outside the inerted drywell have been verified to be locked in their proper position.

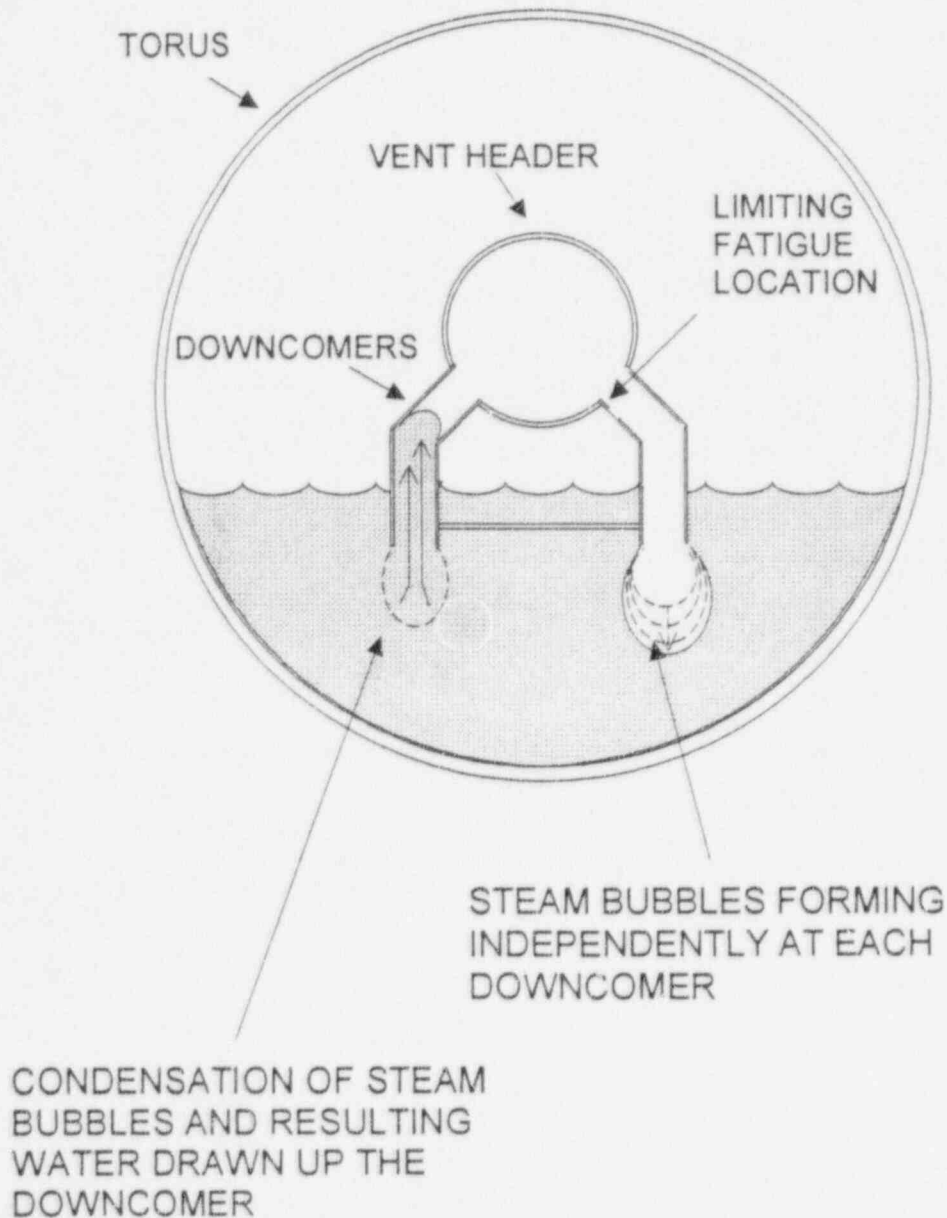
FIGURE 2 - CHUGGING IN THE TORUS

Chugging loads are the cyclic stresses caused by condensation of steam at the downcomer openings of the drywell vents. When a steam bubble collapses at the exit of the downcomers, the rush of water drawn into the downcomers to fill the void induces stress at the junction of the downcomers and the vent header (See Figure 2). Repeated application of such stresses could cause fatigue failure of the joints, thereby creating a direct path between the drywell and the torus airspace. Use of the drywell sprays in accordance with the Emergency Operating Procedures limits the fatigue stress cycles to ensure that no vent header failures occur.

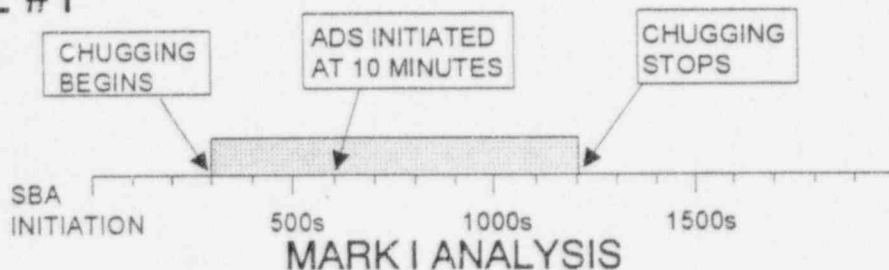
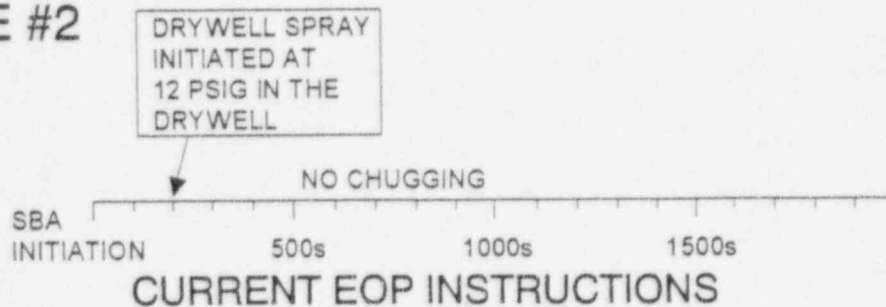
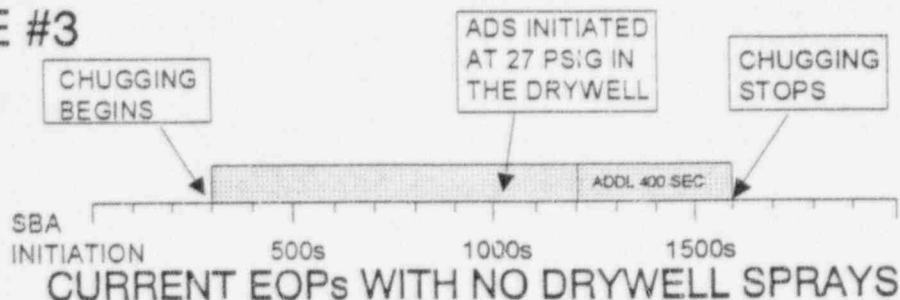
FIGURE 3 - VENT SYSTEM CHUGGING

No failures of suppression pool (torus) structures would have occurred during the limited time when both divisions of drywell spray were isolated, even if the drywell sprays were not restored. For a small break accident, the Mark I analysis predicts that chugging loads start 300 seconds following the initiation of the event (See Figure 3, Case #1). At 600 seconds (10 minutes) following the initiation of the event, reactor depressurization is assumed to be manually initiated. Chugging loads are assumed to be terminated at 1200 seconds. Since the completion of the Mark I evaluations, the Emergency Procedure Guidelines were changed such that chugging loads are terminated by the initiation of drywell sprays. Monticello's Emergency Operating Procedures would have drywell sprays initiated at 12 psig, which would occur approximately 220 seconds following the initiation of the small break accident (See Figure 3, Case #2). With the drywell sprays initiated at 220 seconds, chugging loads would be eliminated and the Mark I analysis is conservative. If a small break accident would have occurred when both subsystems of the drywell sprays were inoperable, the Emergency Operating Procedures would have directed the operators to depressurize the reactor at 27 psig in the drywell (See Figure 3, Case #3). This is identical to the action assumed in the Mark I analysis, but it would occur at a later time than assumed in the Mark I analysis. The primary containment response to a small break accident indicates that 27 psig would be reached at approximately 1000 seconds following the initiation of the event. Reactor depressurization would have been initiated 400 seconds later ($1000 - 600 = 400$ sec). The additional 400 seconds of chugging loads have been analyzed and the limiting fatigue usage factor has been determined to meet code requirements. Thus, without drywell sprays no fatigue failure would occur.
