Northeast
Nuclear Energy

Docket No. 50-423

MP-95-335

Millstone Nuclear Power Station, Unit No. 3
Steam Generator Tube Inservice Inspection Report

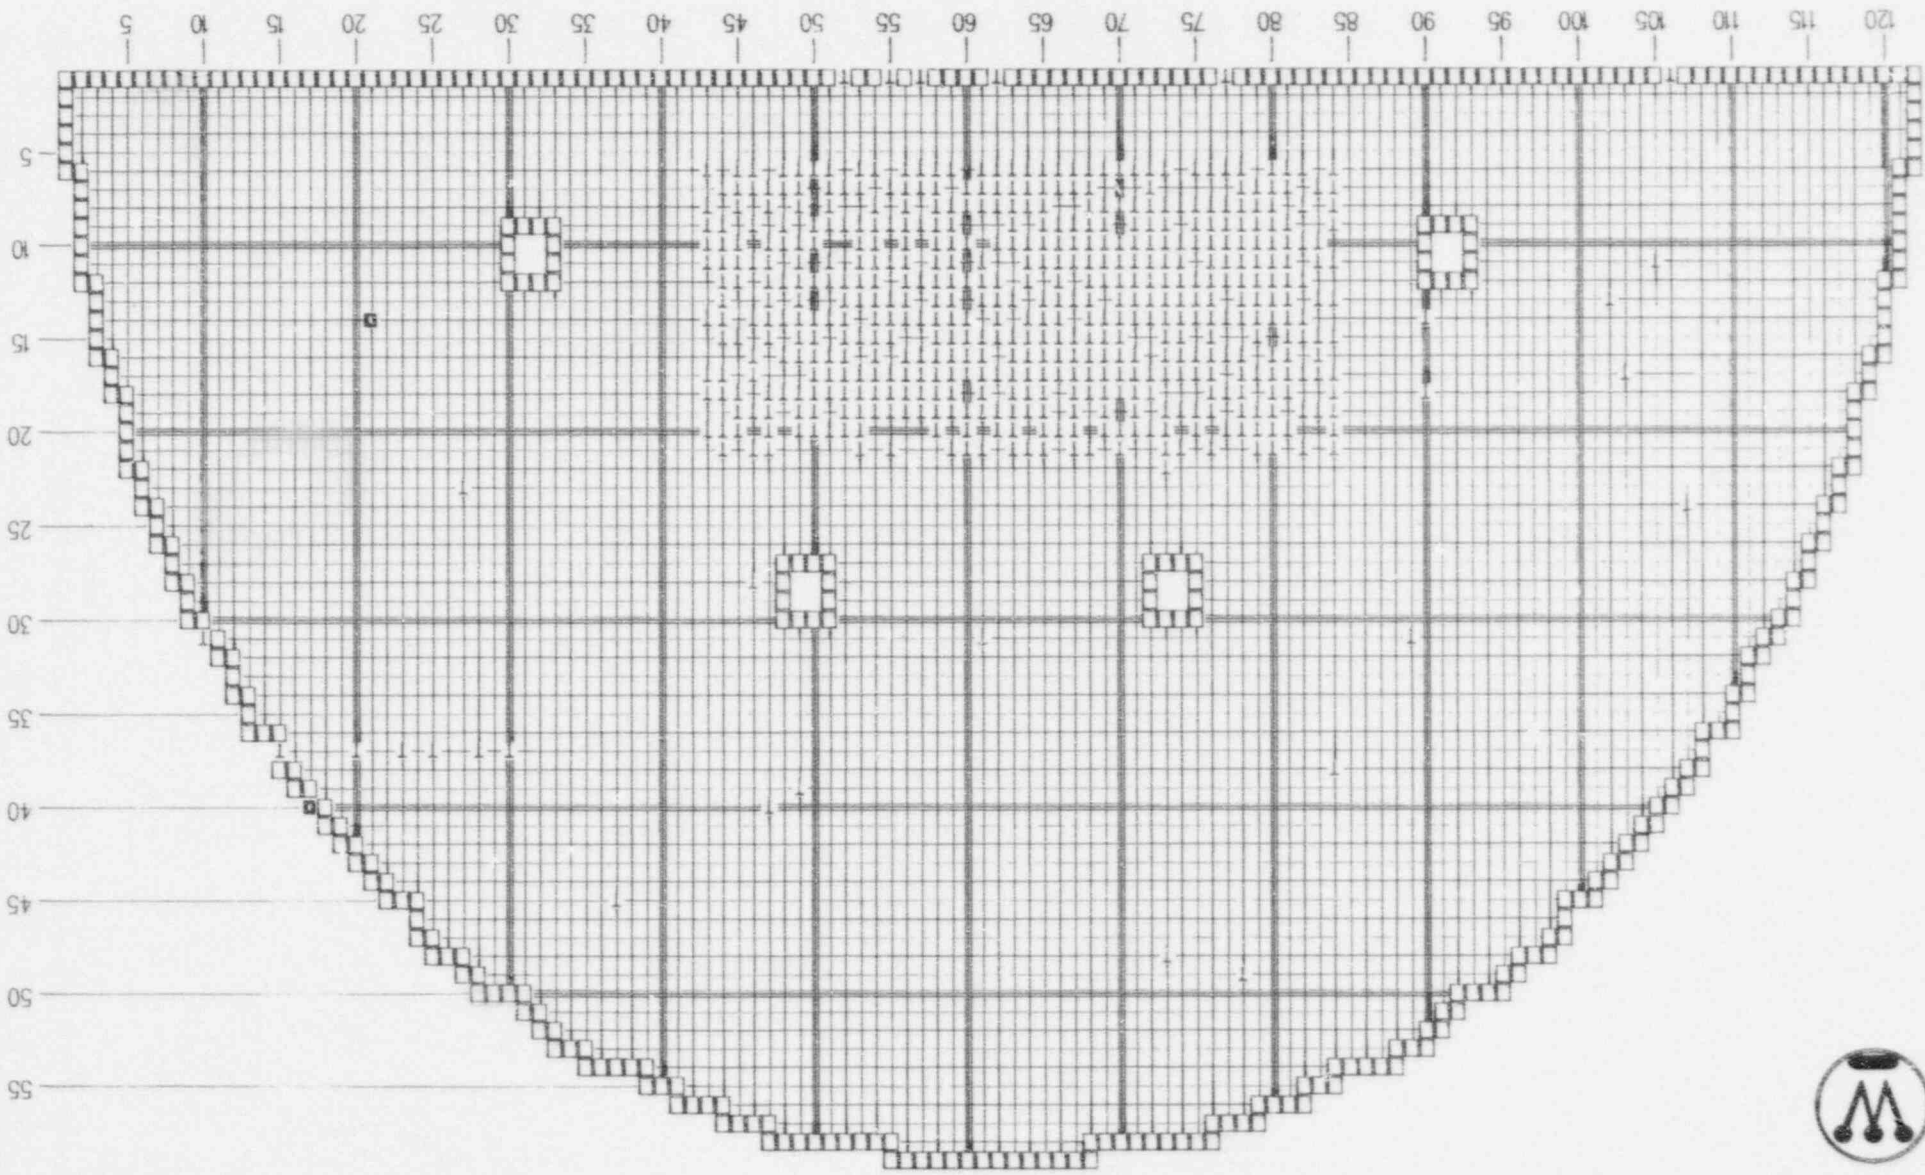
Figure 3 - S/G 'B' - RPC Inspection Map

Prior to the inspection, 50 tube locations were selected for examination with a Rotating Pancake Coil (RPC) probe. The tubes were selected based on previous inspection results which showed excessive tube geometry variations caused by the hydraulic tubesheet expansion process. Since these geometry changes result in increasing tube stress, they are considered more susceptible than other locations for developing Primary Water Stress Corrosion Cracking (PWSCC). Since the Cecco-5 probe was qualified to detect PWSCC and it was being employed for detection of Callaway cracking, the original sample of 50 tubes scheduled for RPC exams was done with the Cecco-5 probe. A total of 7 RPC exams were performed at locations selected based on possible tube flaws identified by the Cecco probe. Figures 3 and 9 show the RPC inspection maps for S/G 'B' and S/G 'D' respectively.

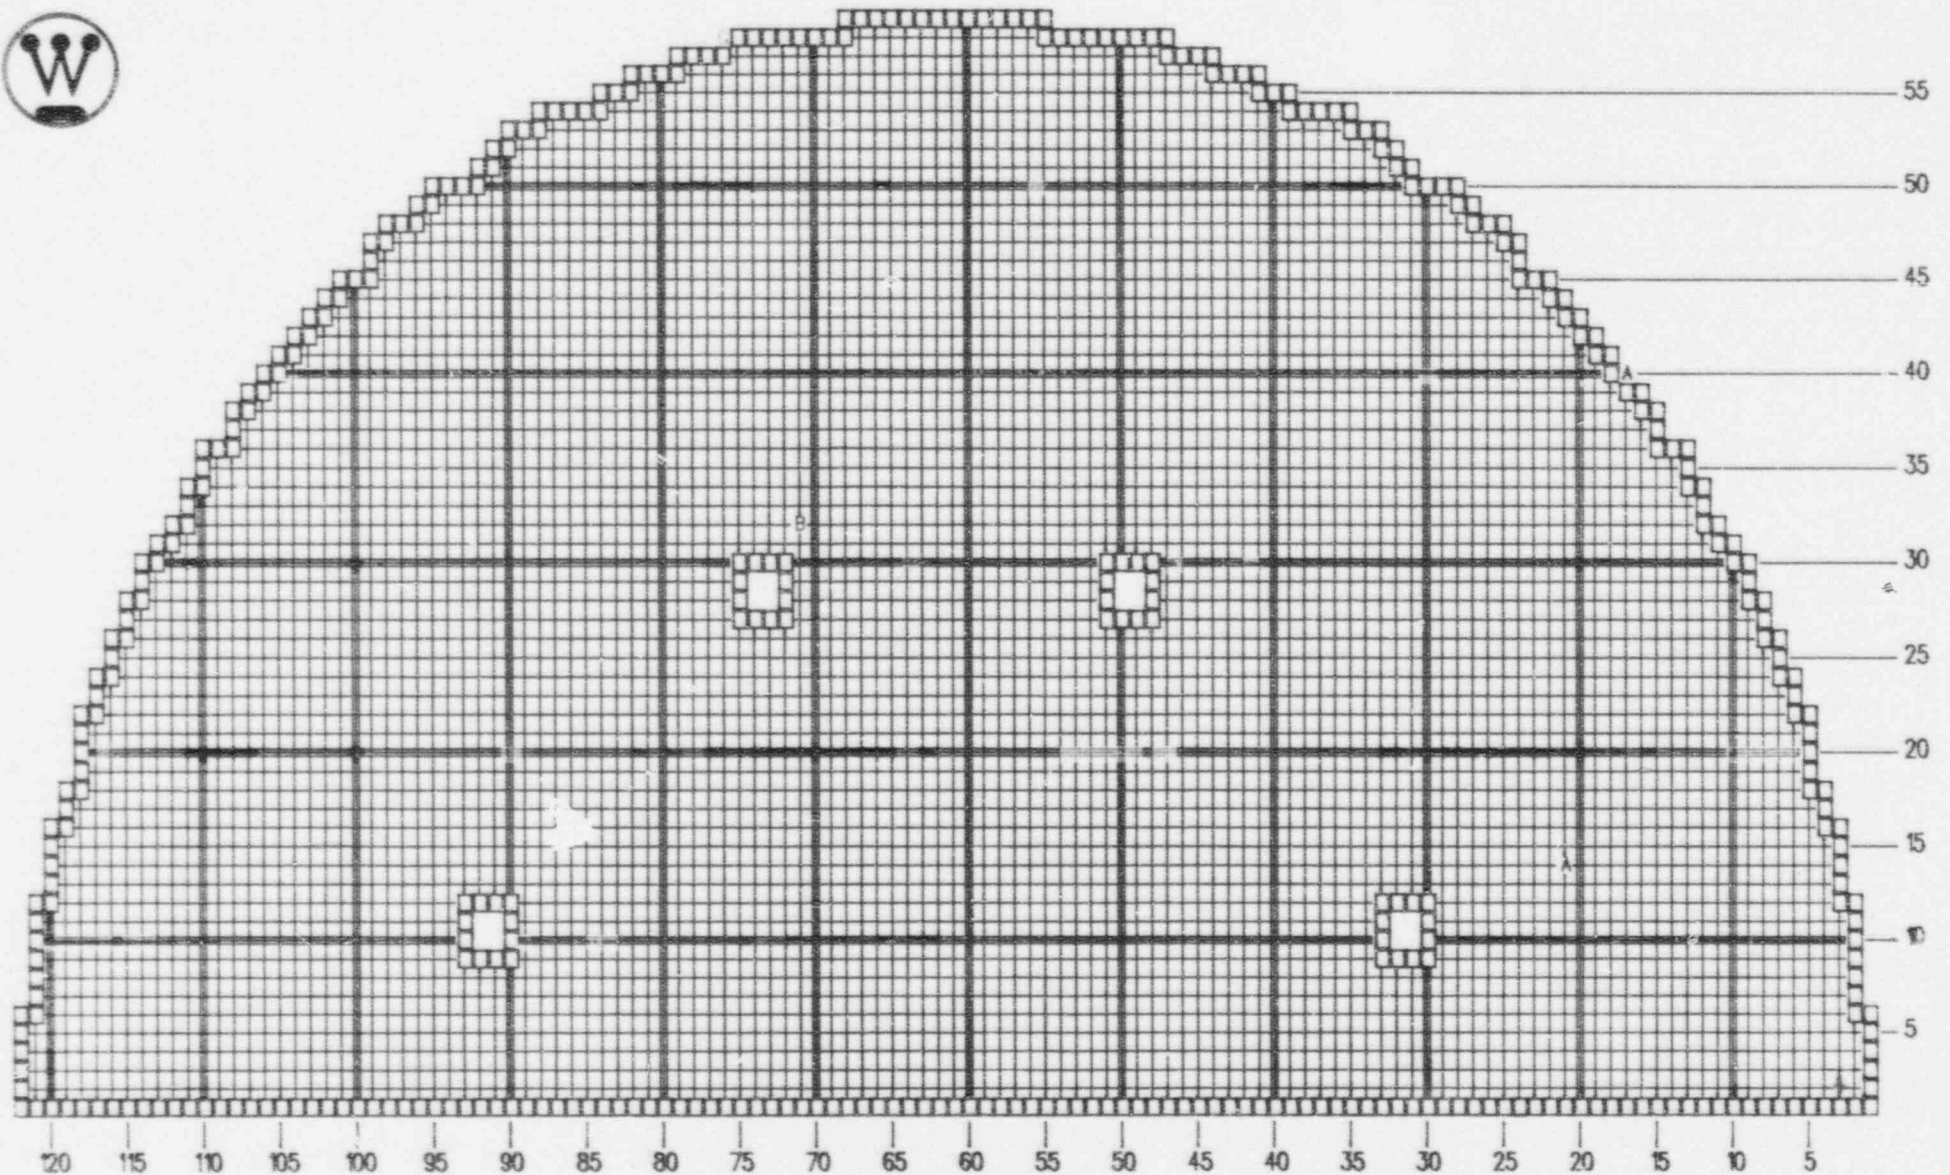
Figure 5 - S/G 'B' - Tubes With % Through Wall $\geq 11\%$ Growth

D : 5 DEGRADED TUBE

& : 1 DEGRADED/DEFECTIVE TUBE

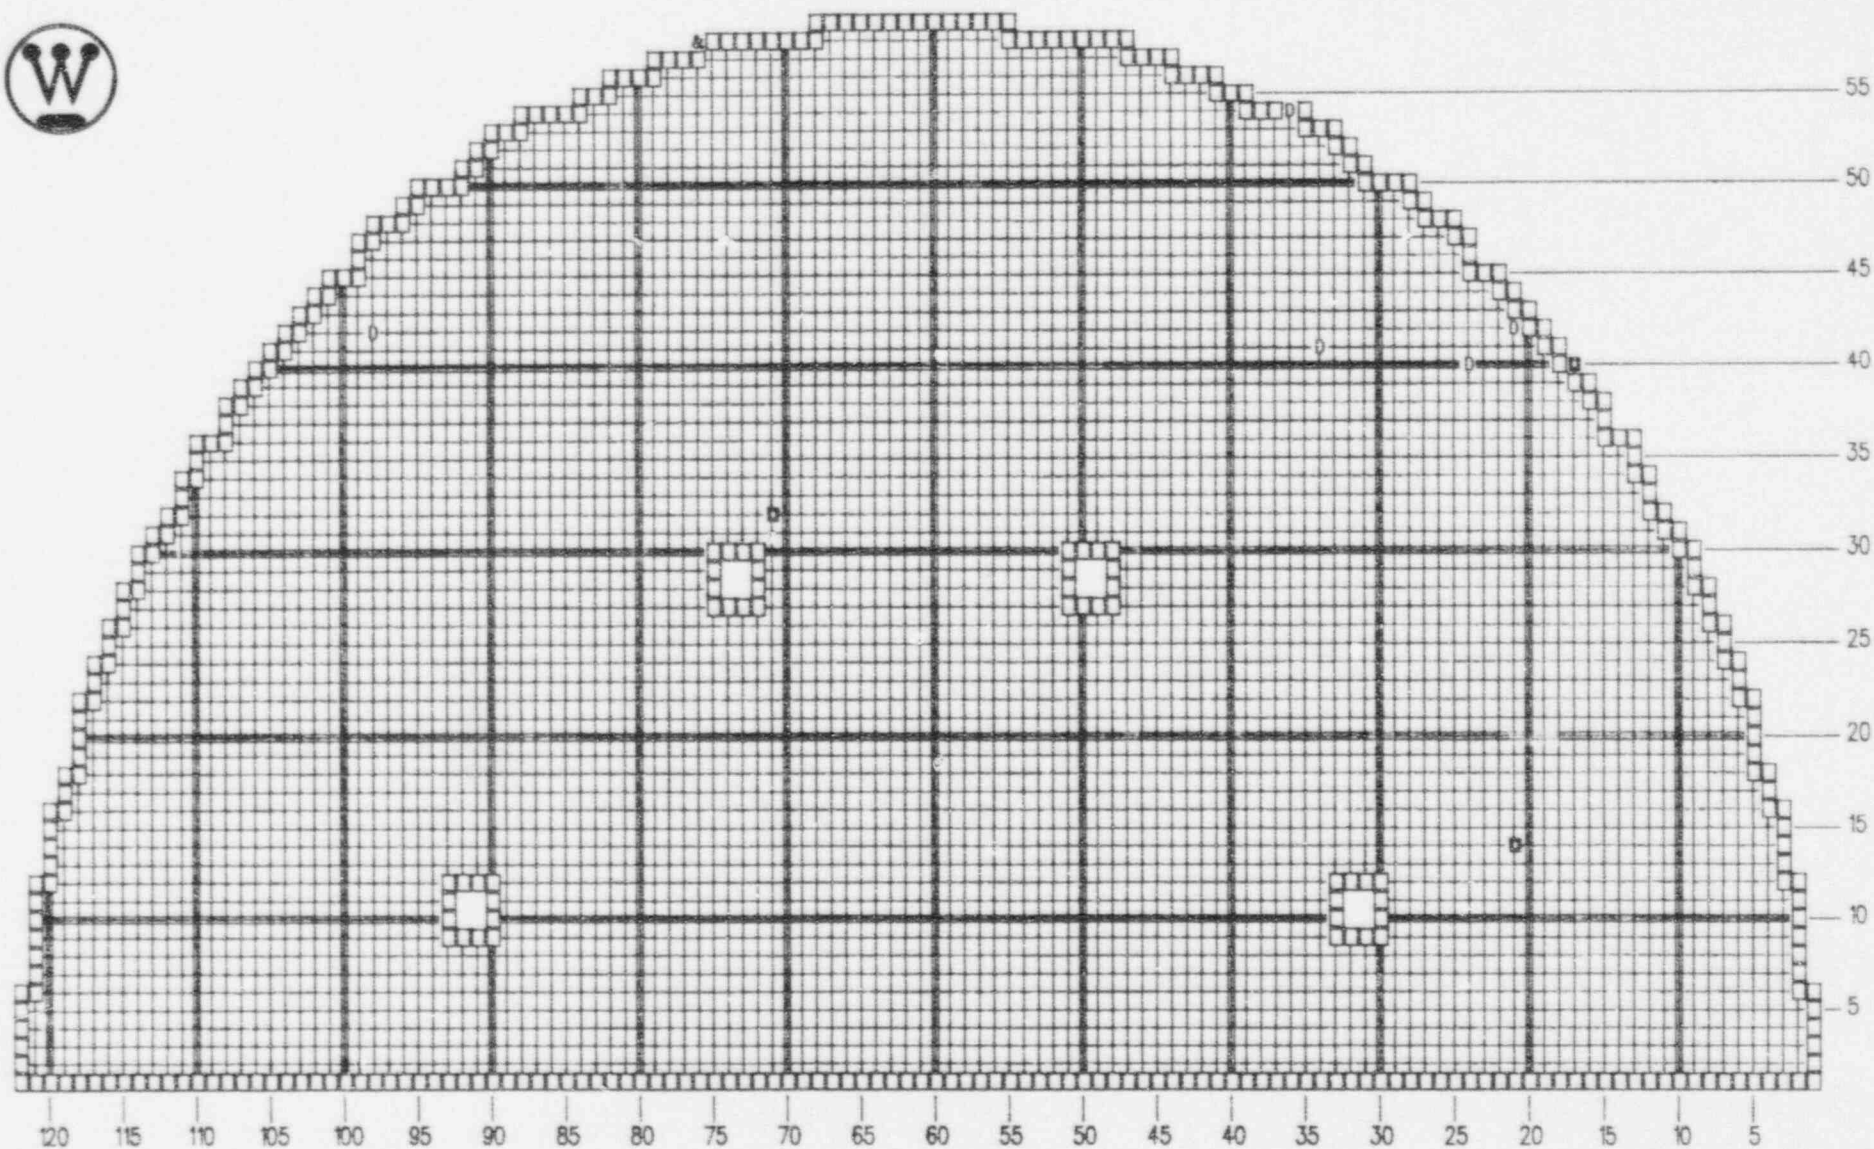
Figure 6 - S/G 'B' - Through Wall Indication Distribution Map (Hot and Cold Legs)

2 : 10 20-29% INDICATION

3 : 1 30-39% INDICATION

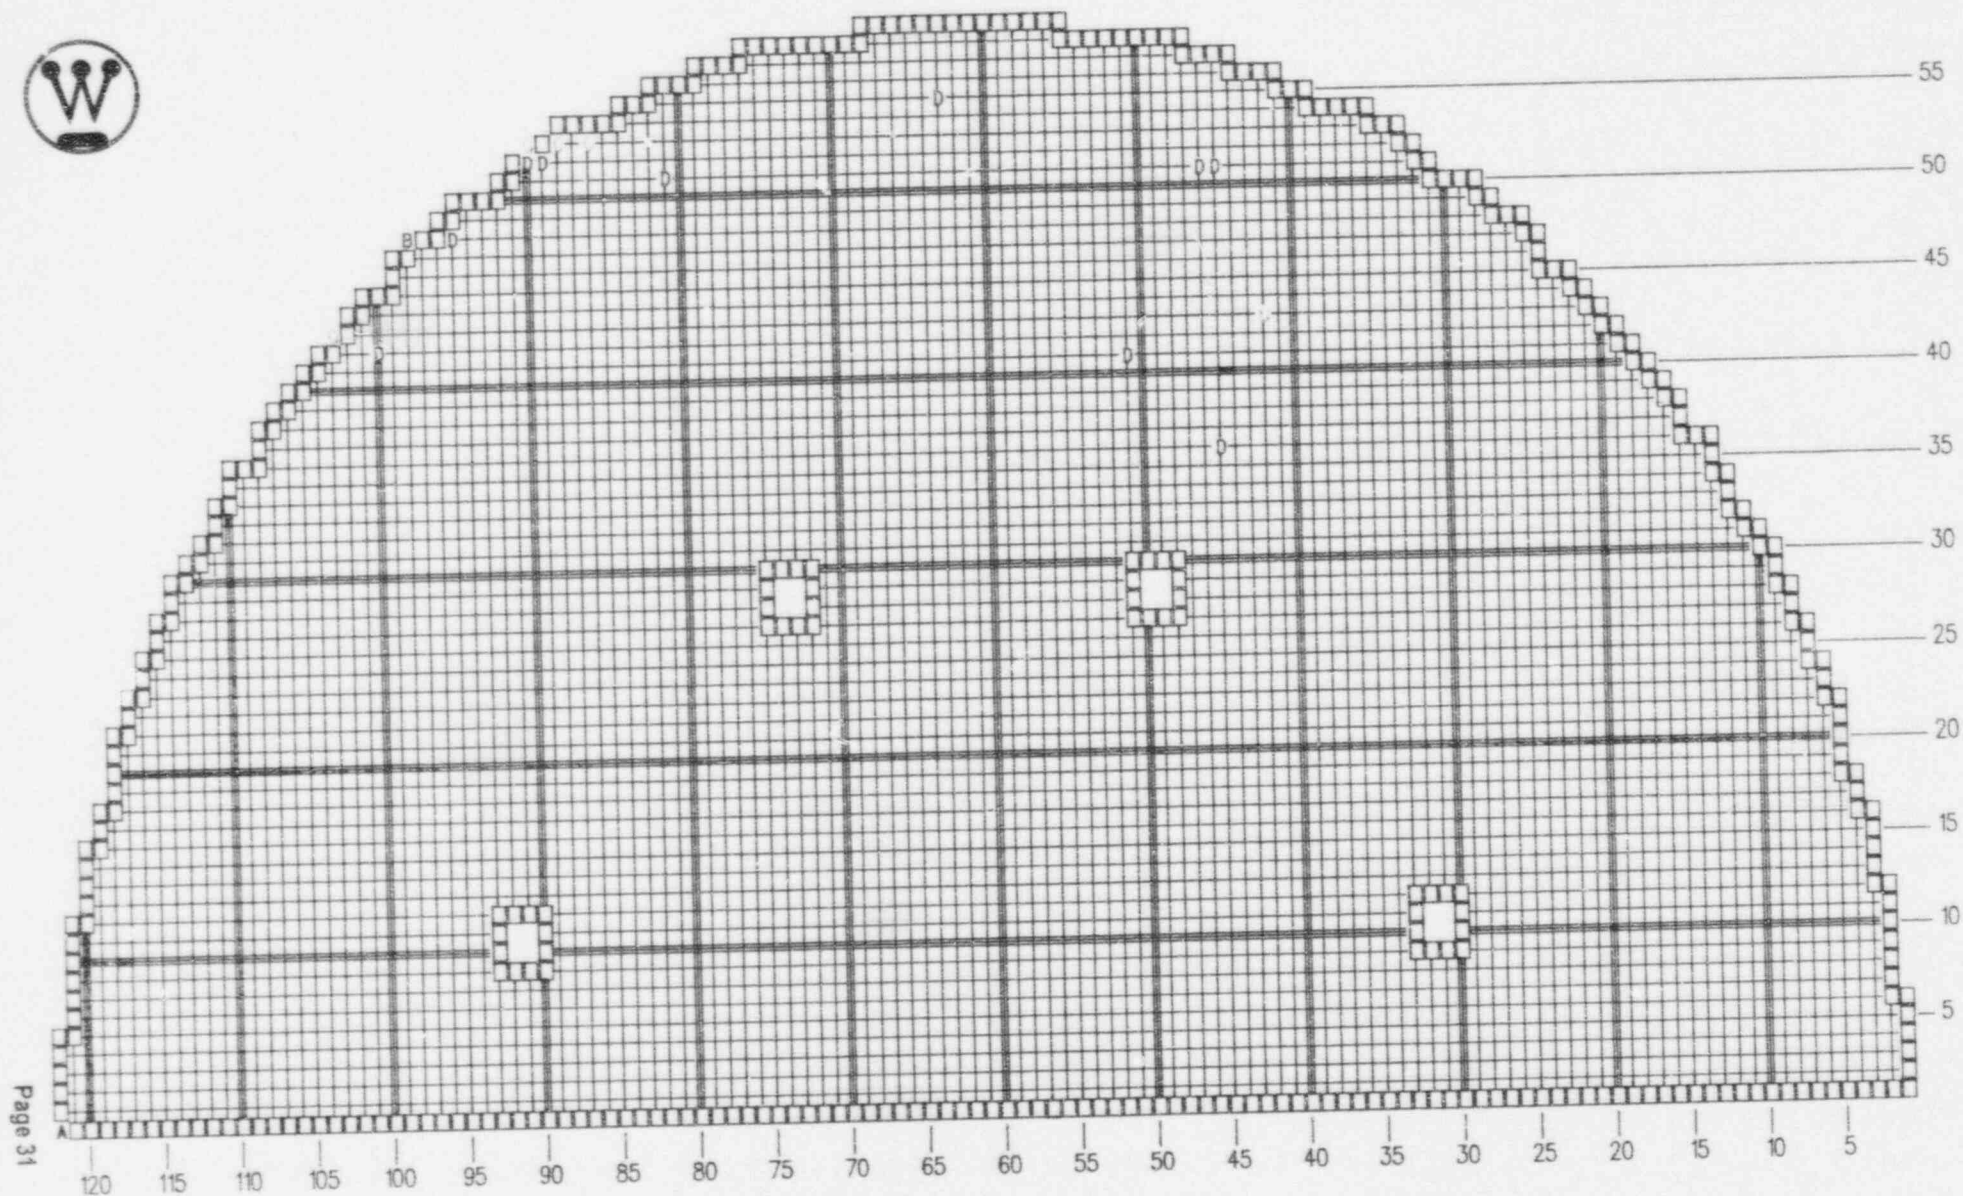
Figure 11 - S/G 'D' - Tubes With % Through Wall $\geq 11\%$ Growth

D : 11 DEGRADED TUBE

& : 9 DEGRADED/DEFECTIVE TUBE
