Investigation and Analysis
of
Suspect Fasteners

Event 29257

Final Report

Prepared by
Cardinal Industrial Products
Division of B&G Manufacturing Co., Inc.

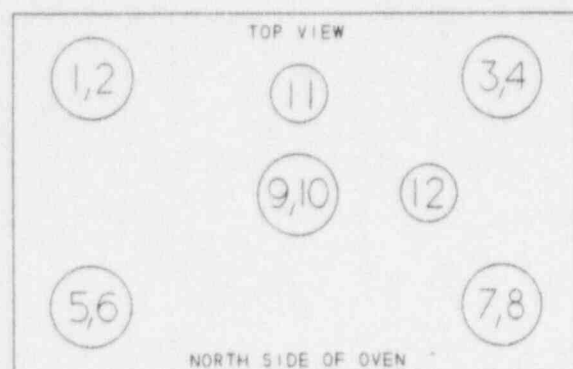
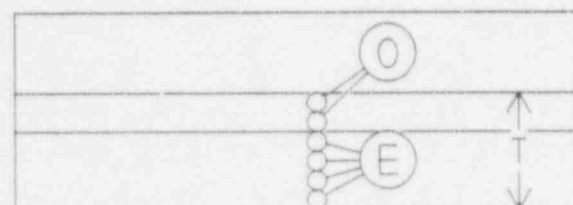
Test ZBG-TEST-03	Product 5/8-0 X 2½, 3 AISI 4140	Weight (pounds) 550
Date 9/8/95	Time @ Temperature (°F) 1 HOUR @1575	Quench POLY

1	52	53	49	
2	41	40	4.4	49
3	52	54	50	
4	35	52	50	3.9
5	51	55	50	
6	53	42	45	54
7	53	52	48	
8	45	44	36	23
9	54	51	50	
10	48	8.2	25	5.0
11	51	17	4	3
12	50	45	25	11
13

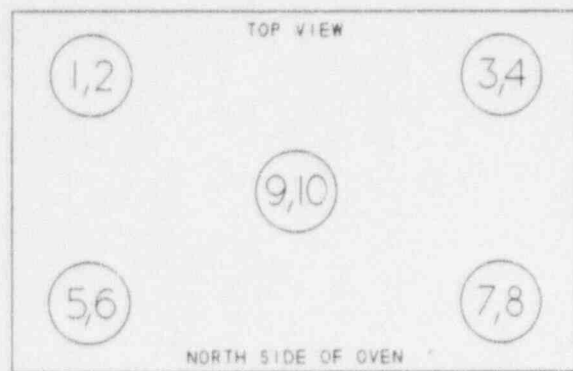
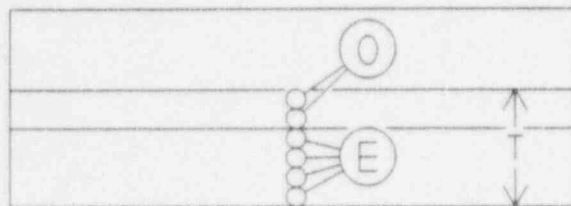
Test ZBG-TEST-04	Product 5/8-0 X 2½, 3 AISI 4140	Weight (pounds) 550
Date 9/10/95	Time @ Temperature (°F) 1 1/2 HOUR @1575	Quench POLY

1	55	51		
2	52	47	46	
3	57	48		
4	54	55	40	
5	52	56		
6	54	46	48	
7	52	52		
8	43	55	31	
9	49	52		
10	18	17	57	
11				
12				
13

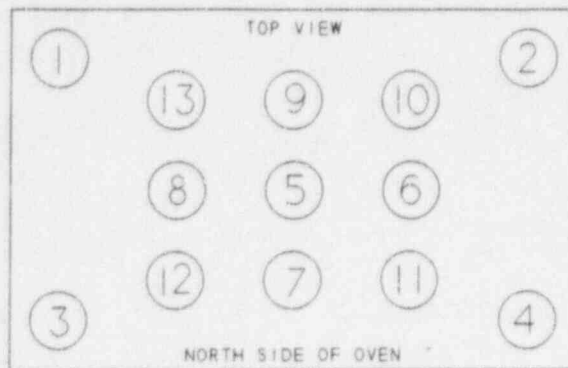
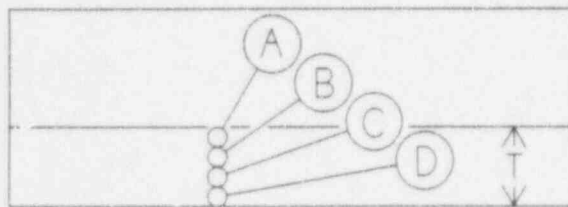
Test ZBG-TEST-21	Product 3/8-0 x 1 AISI 4140	Weight (pounds) 331
Date 9/20/95	Time @ Temperature (°F) 1 HOUR @1575	Quench POLY

One of the test charges that failed (#21) was 331 pounds of $\frac{3}{8}$ " x 1" long capscrews. This charge contained nearly 8,000 pieces and was only 2½ inches deep in the basket (the basket is 37 inches long and 25 inches wide). Another charge of the equivalent weight (#5) passed but contained $\frac{3}{8}$ " x 2½" and $\frac{3}{8}$ " x 3" long capscrews. This charge contained just over 1,100 fasteners and was 4½ inches deep. How densely fasteners were packed in the charge affected the amount of heat received through radiation as compared to conduction. In general, the smaller the diameter of the fasteners, the more the charge acts as a solid mass. In both of the above listed examples the charge was held at temperature for one hour, but the charge that failed had $\frac{3}{8}$ " diameter fasteners that packed more densely than the charge that passed with the larger, $\frac{3}{8}$ " diameter fasteners.

A	B	C	D
1	55	54	55	54
2	53	56	54	53
3	49	54	54	53
4	58	56	56	56
5	50	53	23	1.3
6	54	50	47	8
7	55	54	53	34
8	56	54	45	16
9	55	54	48	29
10				40
11				38
12				26
13				46

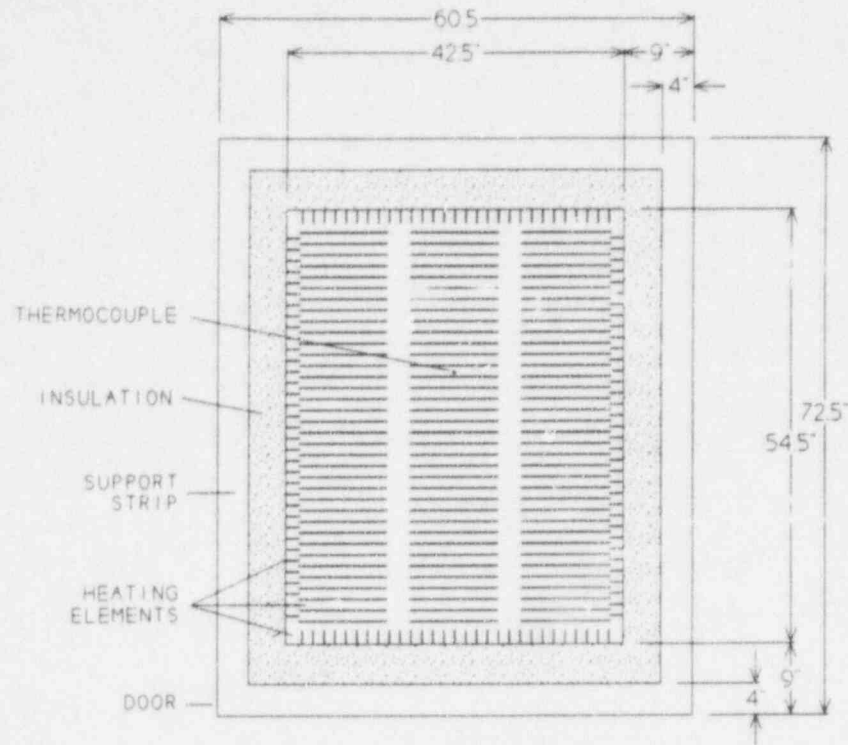
Figure 6 - Top View of Door

register its temperature is positioned in the upper region of the furnace (See Addendum 3). The results of the test charges demonstrated that not all the contents of a charge reach the indicated temperature at the same time. The time required for the bottom layer of fasteners to reach temperature was affected by the weight of the charge and the charge density.

The heat treatment equipment located at Cardinal facility does have limitations. In general, the furnace has heating elements on four sides and on the ceiling (See Addendum 3). This would not be a problem except that the single thermocouple is located in the ceiling of the furnace. The temperature indicated on the display panel and recorded on the strip chart

may not reflect the temperature throughout the furnace and the charge. This limitation, however, could have been compensated for procedurally by allowing charges to remain at temperature for longer periods of time.

Figure 6 is a top view of the door as viewed from the base looking up. The right side of the drawing faced the quench tank. This view shows the upper three rows of heating elements and the location of the thermocouple.
