JOB NO. 7597-20	ACCESSION NO.
UNIT <u>2</u>	U- <u>406385</u>
TITLE ENVIRONMENTAL QUALIFICATION TEST REPORT OF RAYCHEM NUCLEAR CABLE BREAKOUT AND END SEALING KITS	
JOB: JOSEPH M. FARLEY NUCLEAR PLANT ALABAMA POWER CO.	
Supplier: RAYCHEM CORPORATION  (071508)	F.O. APCO Req. APCO PCN No. (If Applic.) <u>R-87-0-4475</u>

REPORT NO. 58442-2  
OUR JOB NO. NDQ 58442  
CONTRACT ---  
YOUR P. O. NO. A01183

ENVIRONMENTAL QUALIFICATION TEST REPORT  
OF  
RAYCHEM NUCLEAR CABLE BREAKOUT AND END SEALING KITS  
FOR  
RAYCHEM CORPORATION  
MENLO PARK, CALIFORNIA

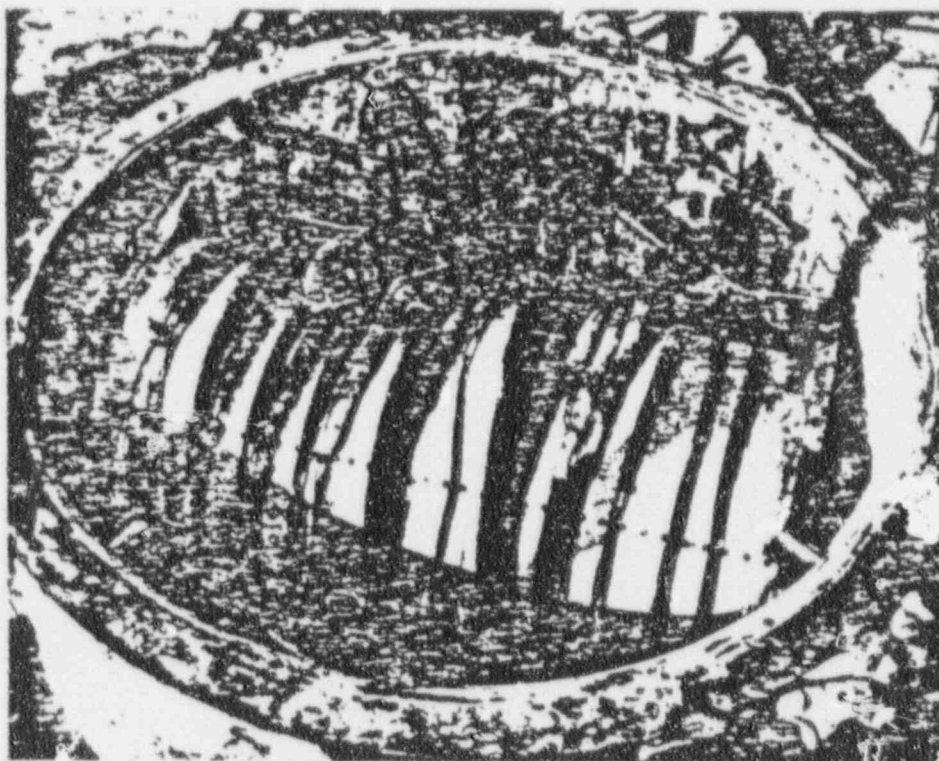
FIGURE 8. Test Chamber and Samples

At the conclusion of the test profile (Figure 5), the test vessel was flooded with tap water. The specimens were then given a voltage withstand test, and the insulation resistances measured. The results of the insulation resistance tests are given in Table 1. The vessel was then opened and the cause for some of the specimens being unable to hold rated voltage investigated. The test vessel with the specimens in place is shown in Figure 8. Figure 9 shows the test specimens after removal from the test vessel.

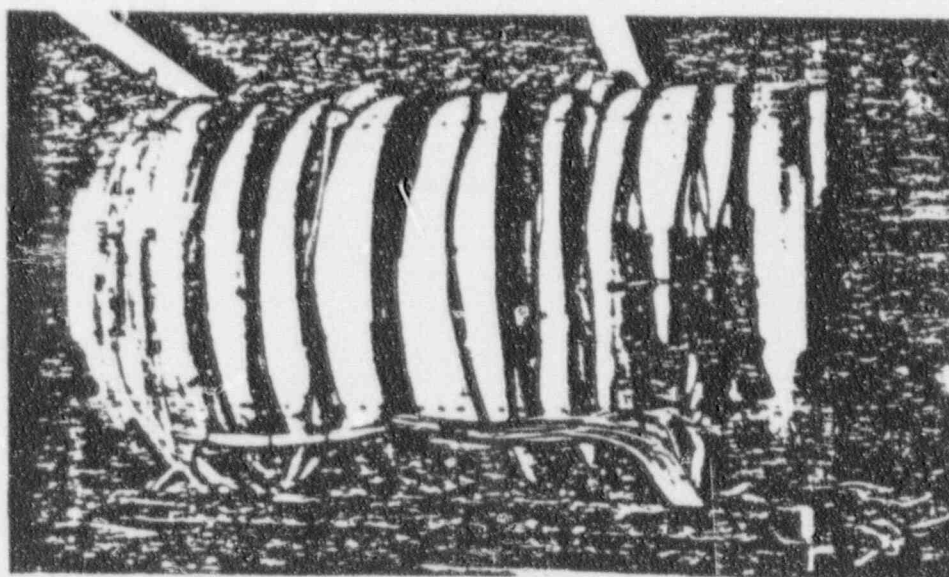
FIGURE 9. Mandrel After Removal from Vessel

Visual examination of the sleeves used over the cable breakouts and end caps showed surface degradation and some superficial crazing. This was most apparent on specimens 2-4 and 2-5.
