Tennessee Valley Authority, Post Office Box 20000, Knoxville, Tennessee 37979

March 27, 1992

SEQUOYAH NUCLEAR PLANT (SQN) - ICE CONDENSER LOWER PLENUM FLOOR MOVEMENT  
AND DEGRADATION

ICE CONDENSER LOWER PLENUM FLOOR  
MOVEMENT AND DEGRADATION

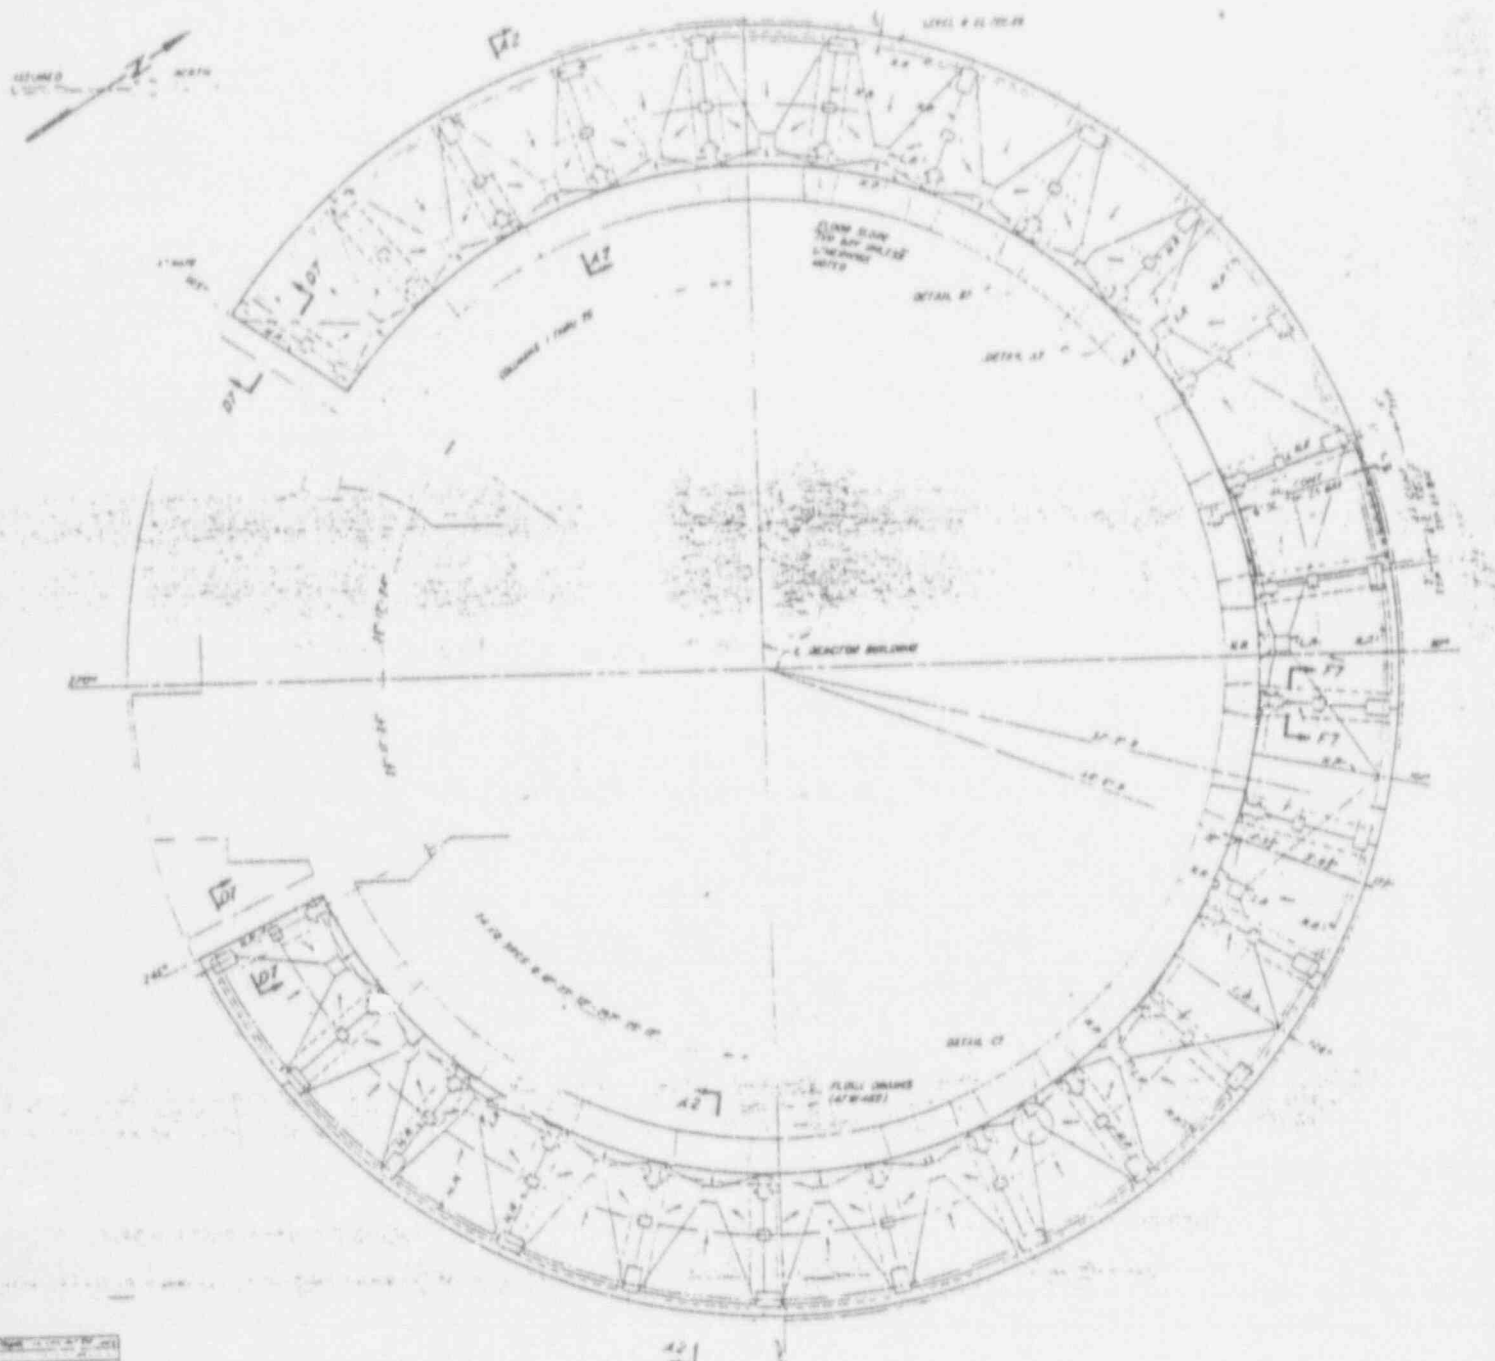
## Attachment 3

The ice condenser is divided into 24 bays, with each bay having a pair of inlet doors in the lower plenum (see Attachments 3 and 4 for the lower elevation door and plan views). These door panels are provided with tension spring mechanisms that produce a small closing torque on the door panels as they open. The magnitude of the closing torque is equivalent to providing approximately 1-psf pressure drop through the inlet ports with the doors open to a position equivalent to the full port flow area. The zero load position of the spring mechanisms is such that, with zero differential pressure across the door panels, the gasket holds the door slightly open. The setting provides assurance that all doors

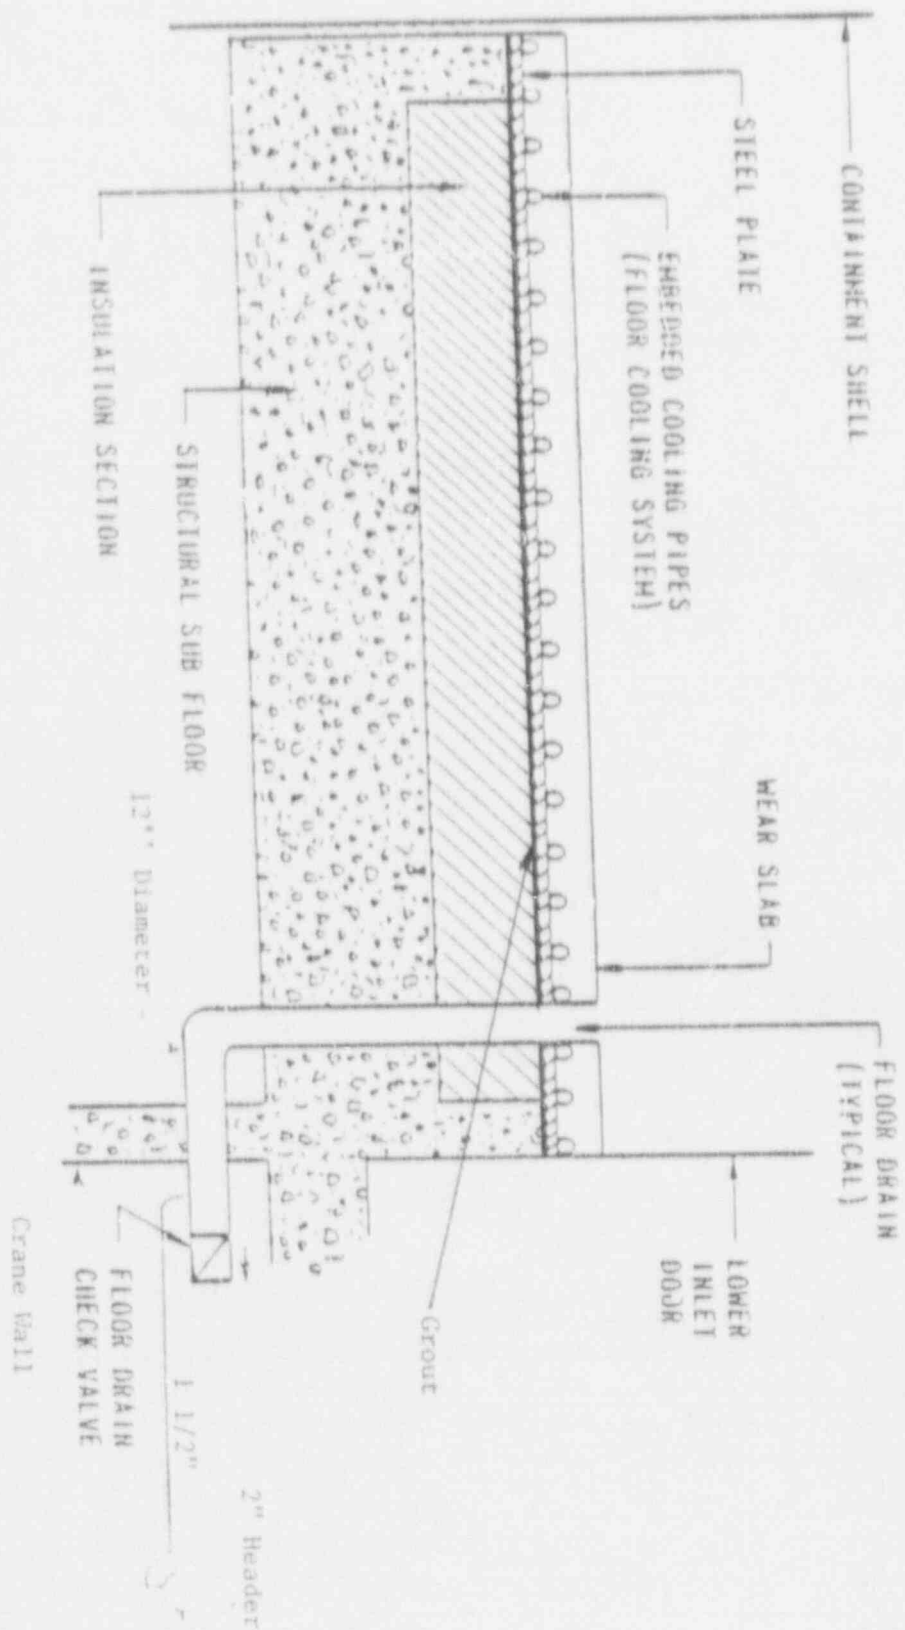
Figure 6.5.1-2 Floor Structure

The ice condenser floor assembly consists of an 18-inch-thick structural slab, spanning between the crane wall and concrete columns at the steel containment vessel (SCV) (see Attachment 5 for the floor assembly details). A vapor barrier (copper armored sisalkraft) is installed on top of the structural slab, with a 15-inch-thick foam concrete layer poured as an insulator. The foam concrete is a very light-weight concrete consisting of portland cement, water, and a foaming agent. On top of the foam concrete, a 1-inch-thick layer of grout was placed to provide a level surface for the placement of a 1/4-inch steel plate that has the glycol piping attached to it. Within each bay, the steel plate consists of two pieces that were "butted" together and spliced with a plate on the top. The splice plate was tack welded to the two bottom plates. The 4-inch concrete wear slab is poured on the top of the steel plate. Reinforcing steel at 6 inches on center in both the radial and circumferential direction was placed with 1/2 inch cover from the top of the slab. Each bay of the wear slab is independent of the next bay and separated with expansion joints. The wear slab is also independent of the crane wall with an expansion joint occurring at the juncture of the crane wall and wear slab. The design required that the expansion joints be sealed with a sealer 1/2 inch deep.

Upward movement and cracking of the wear slabs were identified in both SQN Units 1 and 2. The cracking is located principally near points of rigid restraint. This upward movement also resulted in mechanical interference with the bottom frames of a number of lower inlet doors, thereby increasing the required opening force beyond the technical specification (TS) limit of 675 inch-pounds. The condition was discovered of the lower inlet doors during the Unit 2 Cycle 5 refueling outage inspections on March 16, 1992, and verified on March 17, 1992, following further engineering inspection and review. The movement of 27 of 48 doors was found to be inhibited, along with localized wear slab cracking and upward displacements of up to several inches. The immediate apparent cause of the wear slab degradation was water intrusion, freezing, and expansion within the floor assembly. A confirmatory inspection of Unit 1 on March 18, 1992, which was operating near 100 percent power three months into Cycle 6 operation, identified similar indications, although to a lesser extent, affecting 11 of 48 doors. TVA conducted an orderly shutdown of Unit 1 to effect resolution to the observed problems, and hot standby was reached at 0247 Eastern standard time on March 19, 1992. The condition resulted in potential operability impacts of the ice condenser from both performance and structural standpoints.

TVA has concluded that the wear slab movement and degradation resulted from water intrusion, freezing, and expansion within the floor assembly. Several paths for floor assembly water intrusion were created by initial construction and design deficiencies. A design change during construction and approved by Westinghouse allowed the removal of the requirement for a sealed metal flashing at the crane wall expansion joint and for elimination of the expansion joint and sealant over two short sides of the middle column support. Additionally, walkdowns have determined that the sealer in the expansion joints, which is required by the designer, is "missing" in several areas. It was also found that the steel plates were warped in some cases at the time of initial installation and were installed on cured hardened grout, leading to gaps within the floor assembly. Subsequent maintenance practices resulted in significant exposure to water during outage maintenance activities (e.g., defrosting and cleaning) and did not establish appropriate controls to prevent water from accumulating or standing on the floor and in the drains during those maintenance activities. Additionally, humid, lower-containment air present in the floor drains during operation would provide a mechanism for condensation and freezing with n available gaps and passages.

An additional modification will be implemented before start-up to seal exposed wear slab interfaces and joints at water intrusion paths, and to seal wear slab cracks as appropriate. Possible methods to drain water and/or ice accumulation from the floor assembly are being evaluated. Voids and separation in the floor drains will also be repaired as appropriate.
