November 28, 1995
MP-95-342

LICENSEE EVENT REPORT (LER)

FACILITY NAME (1)	DOCKET NUMBER (2)	PAGE (3)
Millstone Nuclear Power Station Unit 2	05000336	1 OF 4

TITLE (4)
Potential for EDG Overload With 2 HPSI Pumps Aligned to 1 Facility

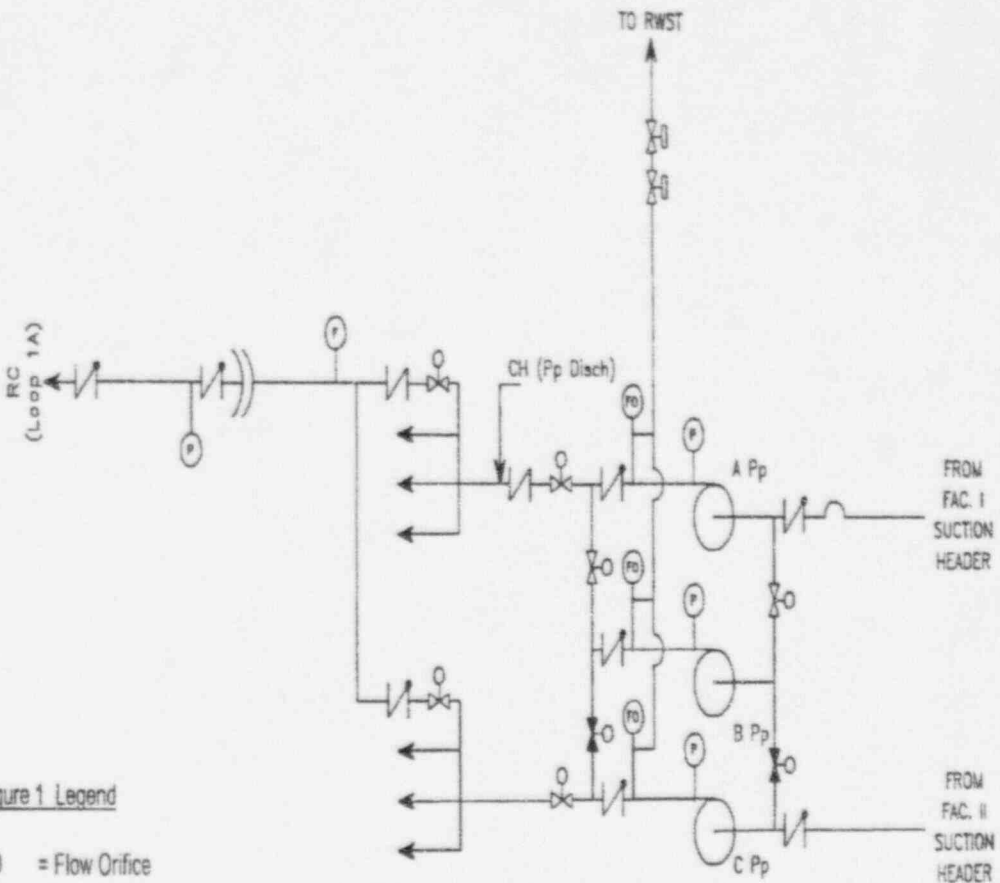
Figure 1
HPSI SYSTEM

Millstone Unit 2 is designed with 3 High Pressure Safety Injection Pumps (HPSI), see Figure 1. For power operations two HPSI Pumps are required. The third pump or "B Pump" is an installed spare that can be aligned (both electrically and mechanically) to either facility 1 or facility 2. This configuration is desirable because it allows the normally aligned pump to be removed from service for maintenance or testing.
