Edwin I. Hatch Nuclear Plant - Unit 2
Reactor Vessel Inventory Loss Results in
Unplanned Engineered Safety Feature System Actuations

Enclosure: LER 50-366/1995-008

Reactor Vessel Inventory Loss Results in Unplanned Engineered Safety Feature System Actuations

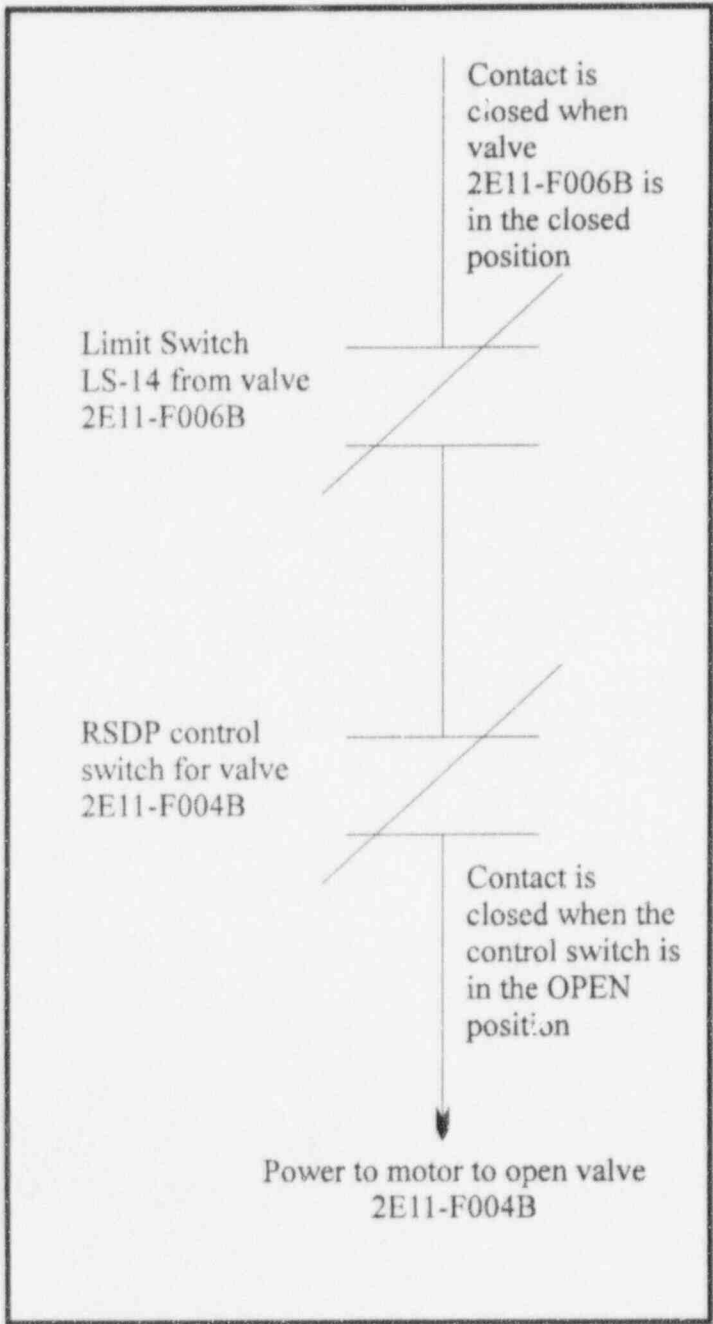
Figure 1: As-Designed RSDP Opening Circuit for Valve 2E11-F004B

When RSDP switch S-10 was placed in the "EMERG" position, valve 2E11-F004B should have started to open. This is because its RSDP control switch was in the "OPEN" position and the interlock between valves 2E11-F004B and 2E11-F006B, which prevents the opening of one valve when the other is not fully closed, should have been satisfied with valve 2E11-F006B fully closed (see Figure 1). However, valve 2E11-F004B did not open when the PEO placed switch S-10 in the "EMERG" position because Limitorque operator limit switch LS-14 for valve 2E11-F006B was set to operate opposite from design. This limit switch, which provides the interlock permissive to open valve 2E11-F004B from the RSDP only, was improperly set to provide a permissive signal to open valve 2E11-F004B when valve 2E11-F006B started to open (see Figures 2 and 4). This was a problem only when control was at the RSDP, however. The Main Control Room control and interlock logic functioned properly because a different Limitorque operator limit switch (LS-6) is used to provide the position of valve 2E11-F006B. This limit switch was, and is, set correctly.

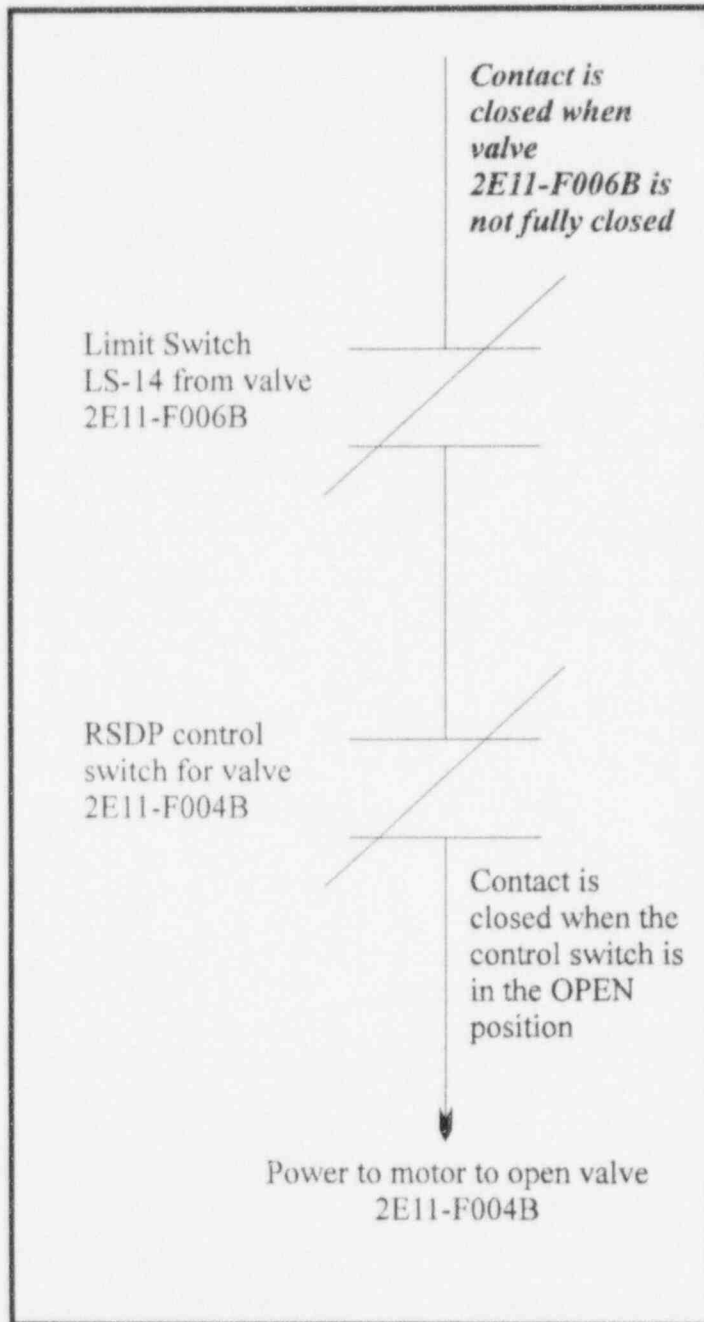
Figure 2: As-Found RSDP Opening Circuit For Valve 2E11-F004B

RHR System elementary drawings were not clear regarding the limit switch set-up for valve 2E11-F006B. The limit switch setting diagram which applies to this valve does not explicitly state this. Furthermore, below this diagram is a note which references another drawing whose limit switch setting diagram could be interpreted to apply to valve 2E11-F006B. This latter limit switch setting diagram is formatted in such a way as to be confusing regarding limit switch set-up and therefore could have led to LS-14 being set to operate in the manner found on 11/3/95 (see Figure 2).

Limit switch LS-14 was found labeled "LS-15." Additionally, limit switch LS-15 (an unused switch) was found set to operate as LS-14 should have been set, i.e., to close only when valve 2E11-F006B was fully closed. Consequently, it is possible the interlock logic wiring for LS-14, at some time, had been incorrectly connected to LS-15 as a result of the aforementioned labeling error. Had the interlock logic been wired to LS-15, the valves and interlock logic would have functioned correctly. However, had this wiring error been corrected at a later date, that is, the logic wiring for LS-14 connected correctly to LS-14, the RSDP valve interlock would have been defeated because LS-14 was not set to operate per design.

The applicable RHR System elementary drawings will be clarified to indicate clearly which limit switch setting diagram applies to RHR System valves 2E11-F004A-D and 2E11-F006A-D. Additionally, the note which does not apply to the limit switch setting diagram will be removed or relocated. Similar changes will be made to the applicable Unit 1 RHR System elementary drawings as appropriate.

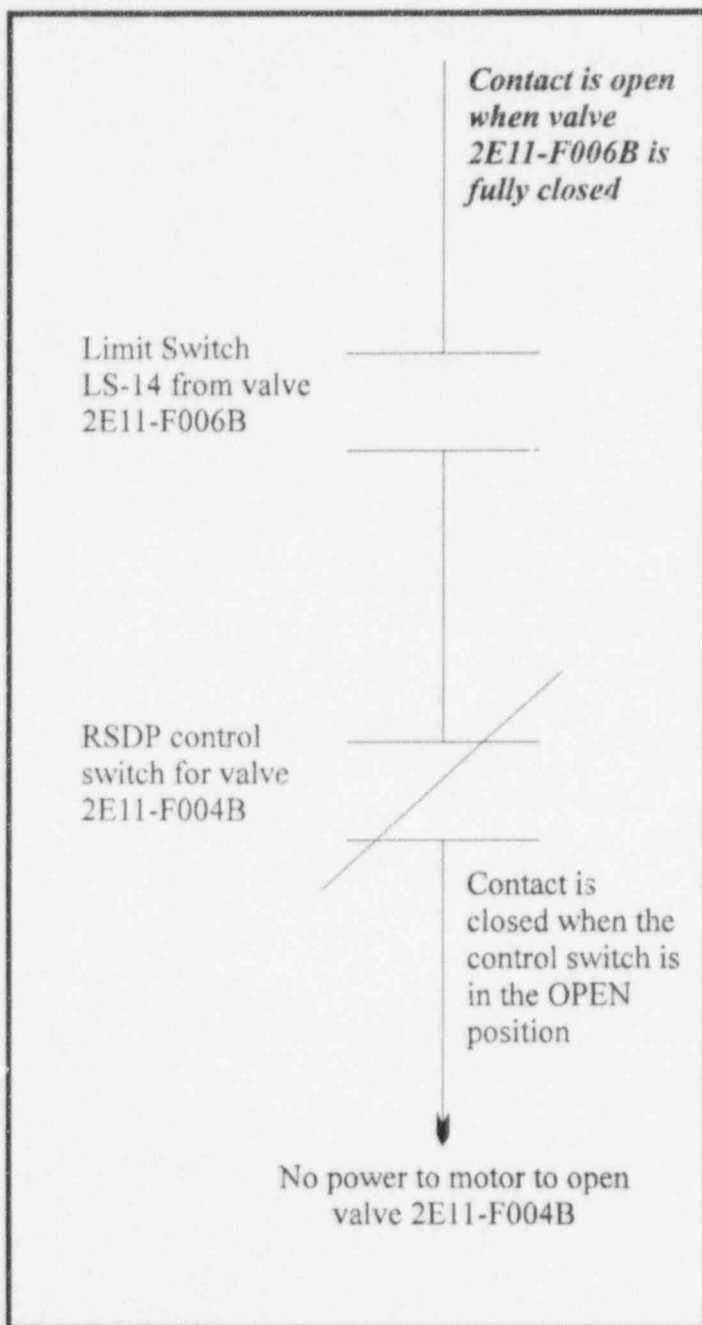
Figure 3: Status of RSDP Opening Circuit For Valve 2E11-F004B Prior to Opening Valve 2E11-F006B

to report to the operator that he had confirmed both valves were closed. This evolution took approximately 20 to 30 seconds to complete. The operator failed to ask specifically about valve control switch position and no one noted valve 2E11-F004B was not opening during this time, as it should have been if limit switch LS-14 for valve 2E11-F006B had been set properly (see Figure 3).

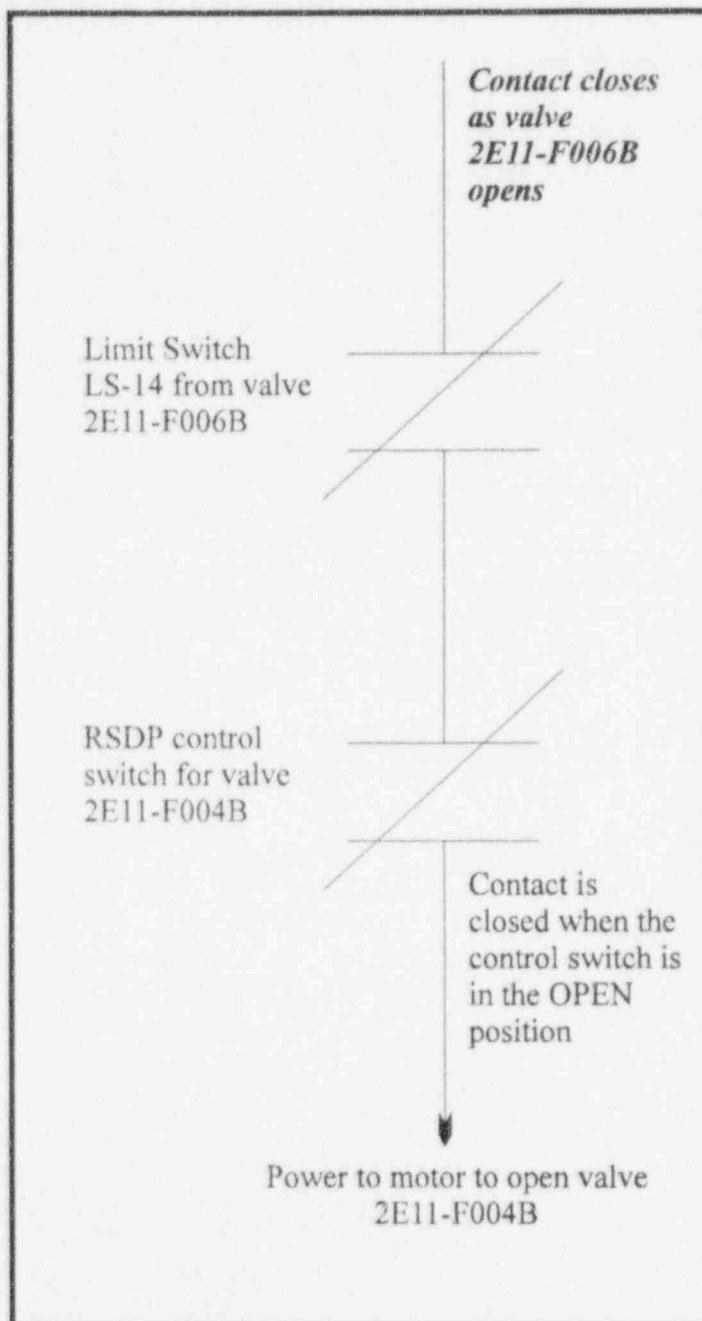
Figure 4: Status of RSDP Opening Circuit For Valve 2E11-F004B After Valve 2E11-F006B Began to Open

The operator then instructed the PEO at the RSDP, via the PEO on the telephone, to place the RSDP control switch for valve 2E11-F006B to the "OPEN" position. The PEOs did as instructed at which time both valves 2E11-F006B and 2E11-F004B began to open (see Figure 4). This created a flow path from the reactor vessel through SDC valves 2E11-F008 and 2E11-F009 and valves 2E11-F006B and 2E11-F004B to the Unit 2 suppression pool. Unit 2 reactor vessel water level began to decrease from its pre-event level of about 58 inches above instrument zero. The PEO at the RSDP noted that valve 2E11-F004B was opening unexpectedly and took the control switches for valves 2E11-F004B and 2E11-F006B to the "CLOSE" position as he had been told previously that both valves were not to be open at the same time. Both valves are designed to stroke fully open or fully closed once they start in the respective direction; therefore, placing the control switches in the "CLOSE" position did not stop the valves from continuing to open.

Valves 2E11-F004B and 2E11-F006B opened simultaneously because: 1) limit switch LS-14 on valve 2E11-F006B was set incorrectly and 2) the RSDP control switch for valve 2E11-F004B was in the "OPEN" position, its normal position. It could not be determined conclusively how or when LS-14 on valve 2E11-F006B was set incorrectly, but it may have been the result of unclear drawings and/or a mislabeled limit switch. The licensed operator directing the valve stroking activities at the RSDP failed to ask specifically about valve control switch position. Therefore, he did not realize the control switch for valve 2E11-F004B was in the "OPEN" position and did not instruct the PEOs to place it in the "CLOSE" position.
