Subject: McGuire Nuclear Station Unit 1
Docket No. 50-369
Licensee Event Report 369/92-01, Revision 1

McGuire Nuclear Station, Unit 1

TITLE(4) A Technical Specification Violation Occurred Because Of Failure To Remove A Steam Generator Tube From Service, As Necessary, During the Unit 1 End Of Cycle 7 Refueling Outage.

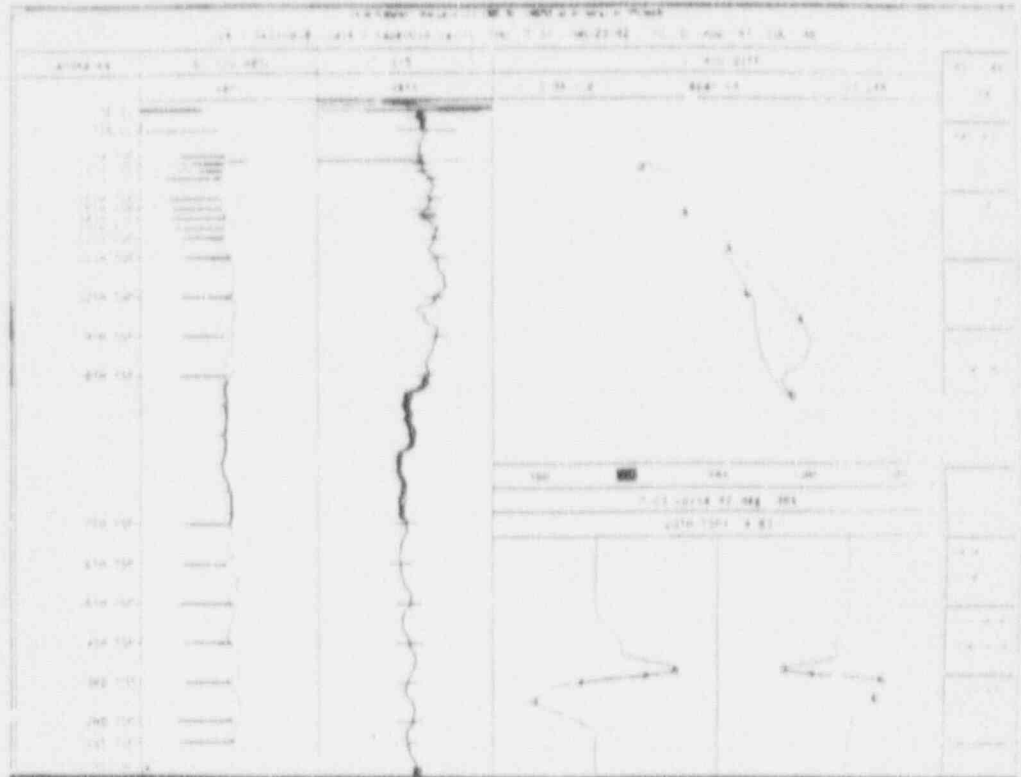
SC TUBE 47-46
BOBBIN COIL DATA
JANUARY, 1992

ECT of tube 47-46 revealed that the tube indication which caused the leak was a 1 inch long axial indication located approximately 5 inches above the 20th TSP. The SG Team initially identified 77 tubes in the 4 SGs which would need to be plugged. These tubes were identified as having indications in the free span area, the same as the indication on tube 47-46. MRPC testing was performed on 63 randomly selected tubes in the general vicinity of the leaking tube, 47-46. The MRPC testing was performed up to the 19th TSP. A review of the bobbin coil data gathered during this outage, revealed additional tube indications on tube 47-46, between the 14th and 15th TSPs. MRPC testing was performed on the tube indications, and the results revealed the indications to be similar to the leak defect. MRPC testing of the largest indication sized it to be 60 percent through wall (TW). A review of the 1991 EOC 7 ECT data for SG 1D revealed some evidence of the tube indication was present at that time, however, the amplitude was small, and was characterized as NDD (no detectable defect). Another 25 tubes located on the Cold Leg side were selected for full length MRPC testing. Thirteen tubes were from the same heat (same manufacturing group) as tube 47-46. Twelve tubes were from the same heat as tube 18-25 (from the tube leakage outage in March, 1989). During the

The leak on tube 36-30 was a sleeve to tube joint, while the leak on tube 47-46 was a 1 inch long axial crack. Leakage of this character is bounded by the analysis of "Steam Generator Tube Failure" as described in section 15.6.3 of the Final Safety Analysis Report (FSAR) accident analysis. A SG tube leak is classified as a Condition IV, Limiting Faults event. These events are not expected to occur, but are postulated because their consequences would include the potential for the release of significant amounts of radioactive material. They are the most drastic which must be designed against and represent limiting design cases. The accident analysis assumes a complete severance of a single SG tube. The leaks occurring on tubes 36-30 and 47-46 were of a smaller magnitude with less break flow from primary to secondary. Consequently, there was a slow rise in SG 1D water level and an increased time interval for actuation of EMFs-33 and -34. Hence, more time was available for OPS personnel to take control of the situation.

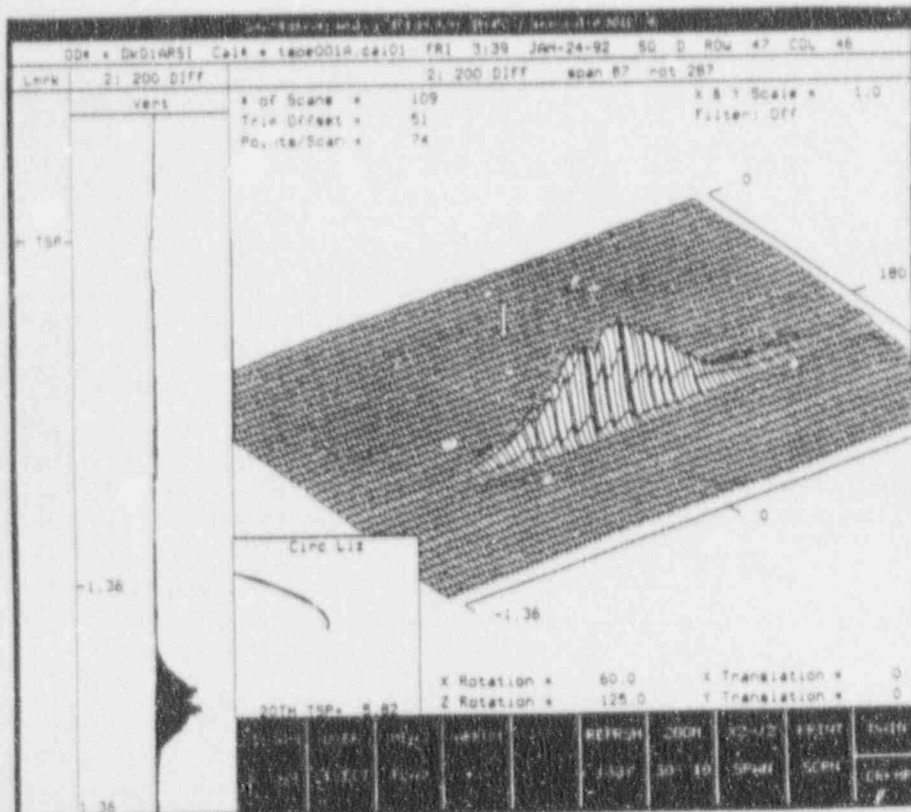
SC TUBE 47-46
MRPC DATA
JANUARY, 1992

MRPC testing, however, the results of the MRPC testing were not fully evaluated and the tube remained in service. ECT Management and Support Engineering personnel, after evaluating MRPC test data acquired on tube 47-46 during this outage, have determined that the indication from October, 1991, was incorrectly classified. As a result, the SG Team personnel developed the action plan listed below:

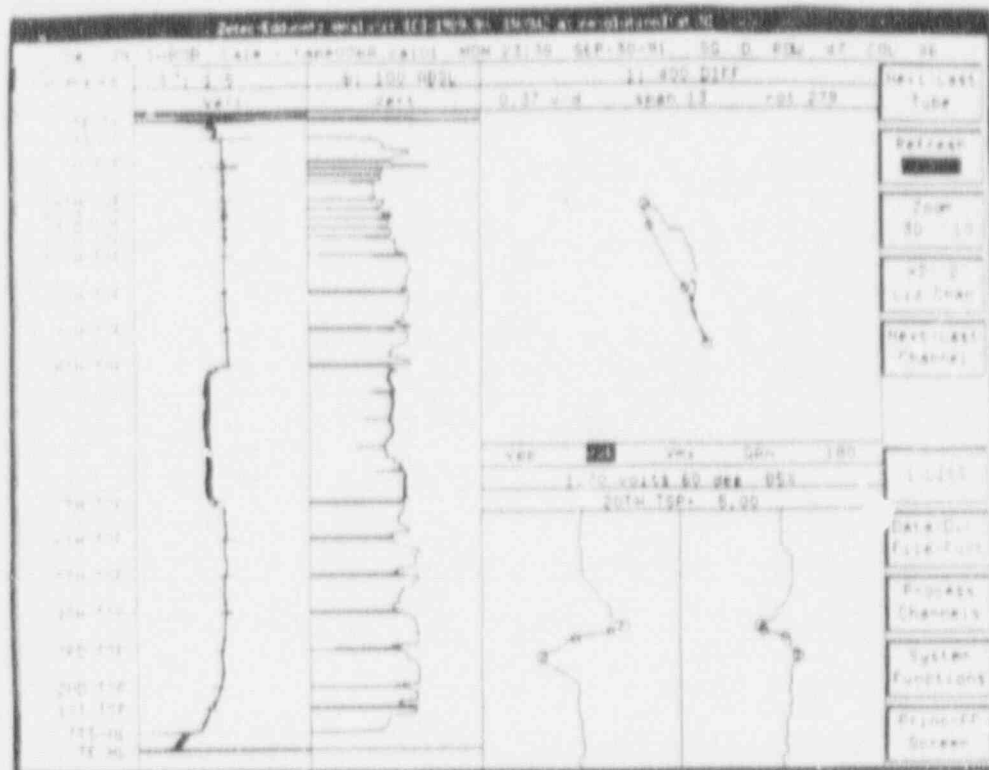
SC TUBE 47-46
BOBP™ COIL DATA
SEPTEMBER, 1991

Tube 47-46 Initial Action Plan: ECT of SG tube 47-46 using the bobbin coil test method was performed during the Unit 1 SG tube leak outage in March, 1989, and again during Unit 1 EOC 6, in 1990. At that time there were no indications noted. In October, 1991, during EOC 7, a 1.7 volt amplitude tube indication was observed from the bobbin coil test. The tube indication was classified as a Manufacturing Burnishing Mark (MBM). The tube then underwent

A cause of Inappropriate Action is assigned because the resolution of the tube indication was not the best alternative. During Unit 1 EOC 7, in 1991, the data analysts were reviewing the bobbin coil data on the SGs. An indication on SG 1D, tube 47-46 was flagged by a primary reviewer. The same indication was independently flagged by a secondary reviewer. The primary reviewer classified the indication as signal to noise (S/N), and additionally classified it as an MBM. A classification of S/N contends there is degradation, however, the S/N ratio is so small, the depth of the degradation cannot be quantified. Further classifying the indication as an MBM was based on the characteristics of the signal, and the primary analyst felt the phase angle was not a true representation of the depth of the indication. The secondary reviewer classified the indication as 85 percent TW. This was also based on the characteristics of the signal. As a result of the differing classifications, the indication was sent for resolution by a resolution team. The resolution team consists of a lead person from the primary and secondary data analysts. Ideally, these persons would be different from the original primary and secondary analysts. The resolution team evaluating the same data as the primary and secondary analysts, misclassified the indication as an MBM. The signal from the tube indication is very similar to the signal generated from an MBM. However, an MBM can be traced back to previous ECT data and normally

the voltage on an MBM is less than 1 volt. The voltage on this indication was 1.7 volts. During the investigation, a review of previous data did not indicate the presence of an MBM. It is reasonable to believe the indication would have been correctly classified if it had received closer scrutiny.

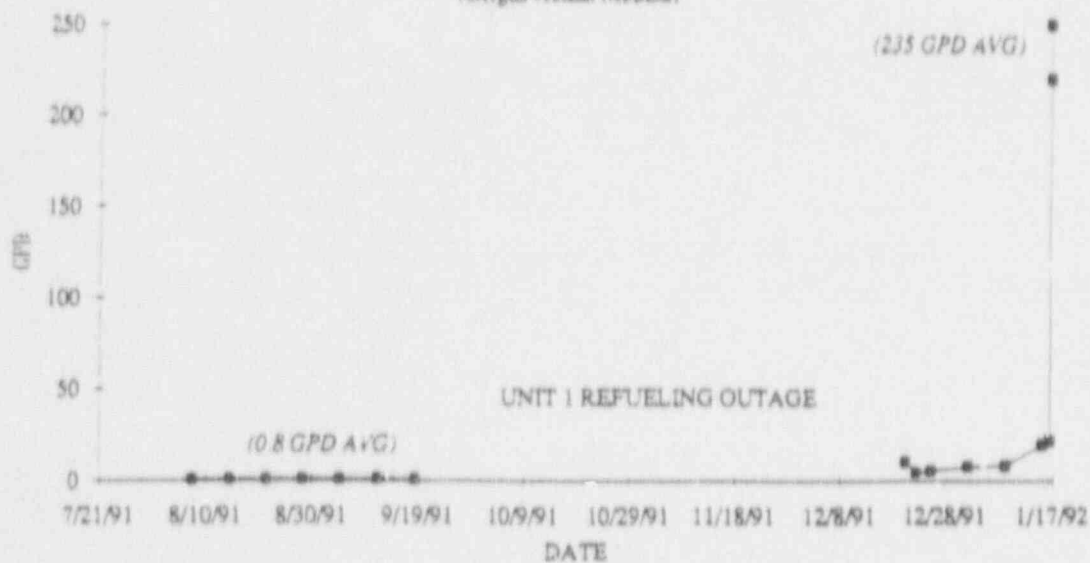
UNIT 1 PRIMARY TO SECONDARY LEAKRATE
(Offgas Xenon Method)

Prior to the Unit 1 shut down on January 16, 1992, Chemistry personnel performed several normal surveillance primary to secondary leak rate calculations as directed by procedure CP/O/B/8100/45, Chemistry Procedure for Calculation of Primary to Secondary Leak Rate (Enhanced Leak Rate Monitoring Program). The results of these calculations showed an increase in primary to secondary leakage from January 8, 1992, to January 15, 1992. The leakage on SG 1D had increased from 8.3 GPD to 20 GPD. Accelerated sampling and leak rate calculations revealed that the leak had increased to 22 GPD on the morning of January 16, 1992.

Through prompt investigation, it was learned that tubes 47-46 and 36-30 located in SG 1D, were responsible for the primary to secondary system leakage which shutdown Unit 1. Prior to the unit shutdown, the normal sampling and primary to secondary leak rate calculation program had been accelerated to closely monitor the leakage. As the leakage continued to increase, it was conservatively decided by Station Management to shutdown the unit. Even though the leakage increased to an averaged 235 GPD, it was well below the TS limit of 500 GPD through any one SG.
