RESOLUTION OF HIGH GROUND WATER LEVELS AT
GRAND GULF NUCLEAR STATION

Prepared for
Entergy Operations NPE
April 1992

Bechtel Corporation
Gaithersburg, Maryland

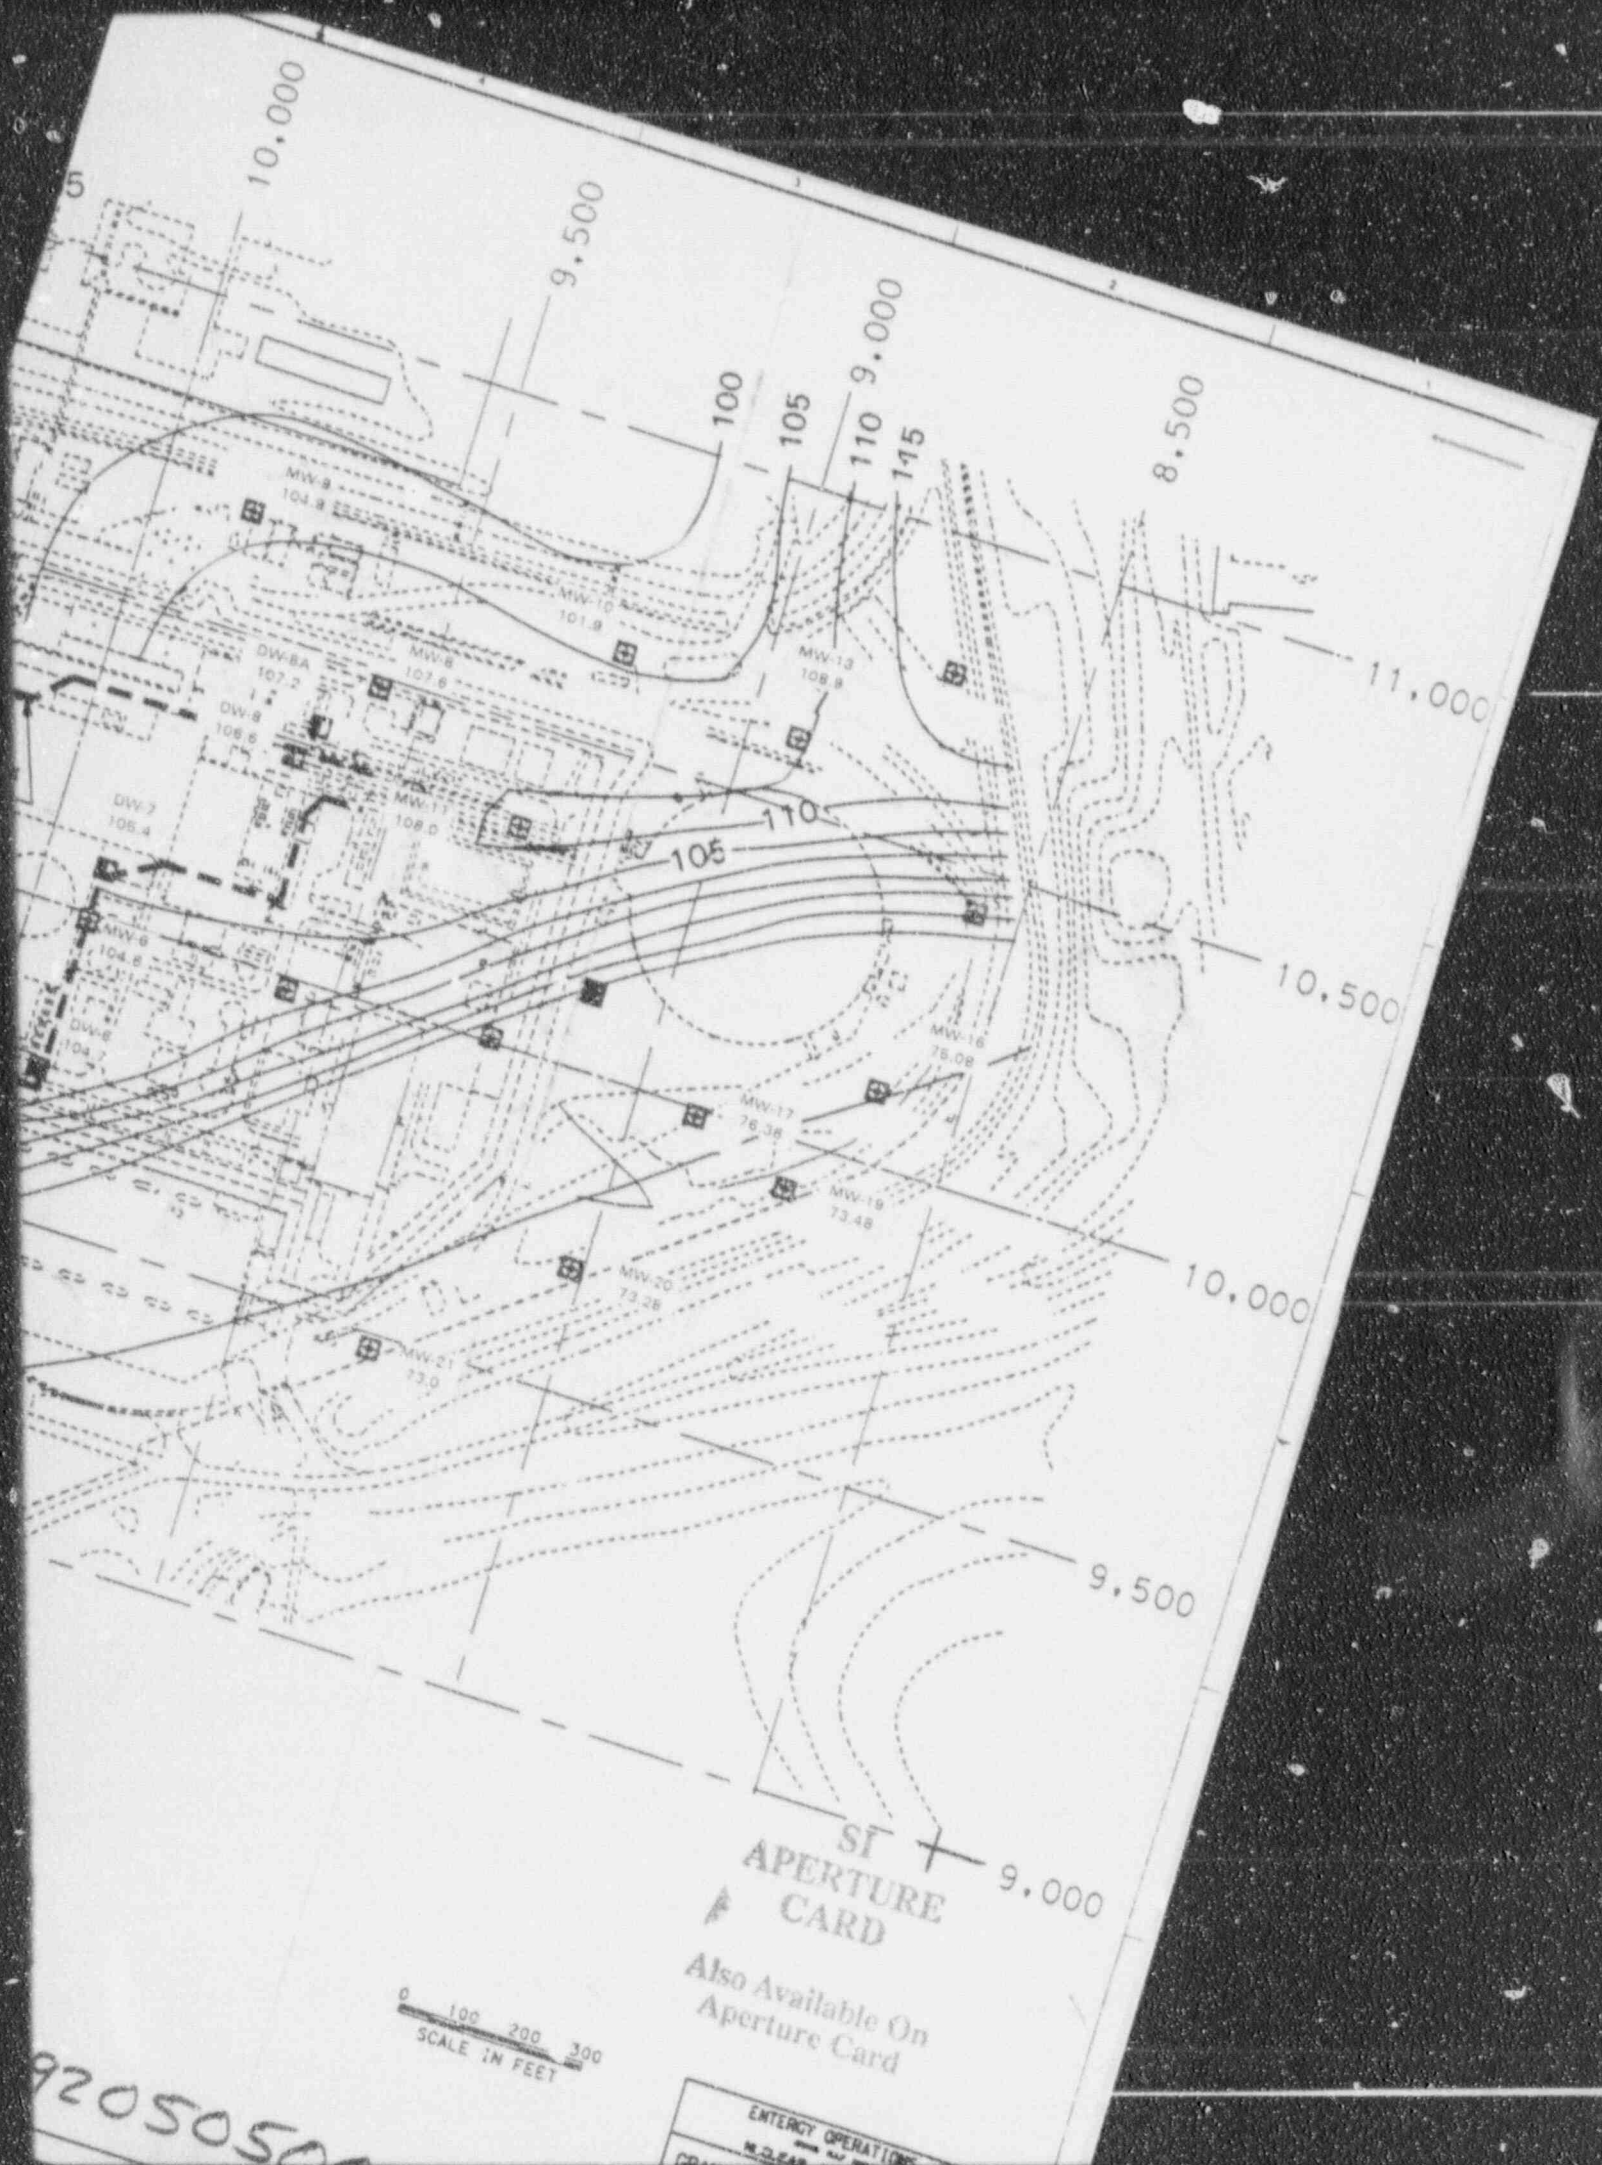
Figure 1 - Plant Site Well Plan

Seven monitoring wells (MW-1 through MW-7 on Figure 1) were installed in the backfill between the plant structures and the tieback wall.

Eight dewatering wells (DW-1 through DW-8 on Figure 1) were installed in the backfill in the power block area. These wells have also been used to monitor ground water levels.

Five monitoring wells (MW-8 through MW-12 on Figure 1) were installed to monitor water levels in the circulating water pipe trench (CWPT) backfill and in the Terrace deposits east of the power block. In addition, a supplemental dewatering well (DW-8A) was installed in the Terrace deposits in the vicinity of DW-8.

Fifteen monitoring wells (MW-13 through MW-26 on Figure 1) were installed in the Terrace deposits in the vicinity of the cooling tower and in the north site area to better define ground water flow patterns across the site and recharge sources. These wells were installed in accordance with the recommendations from the studies prepared for the GGNS Ground Water Monitoring Status Report (GNRO-90/00006) in 1990.

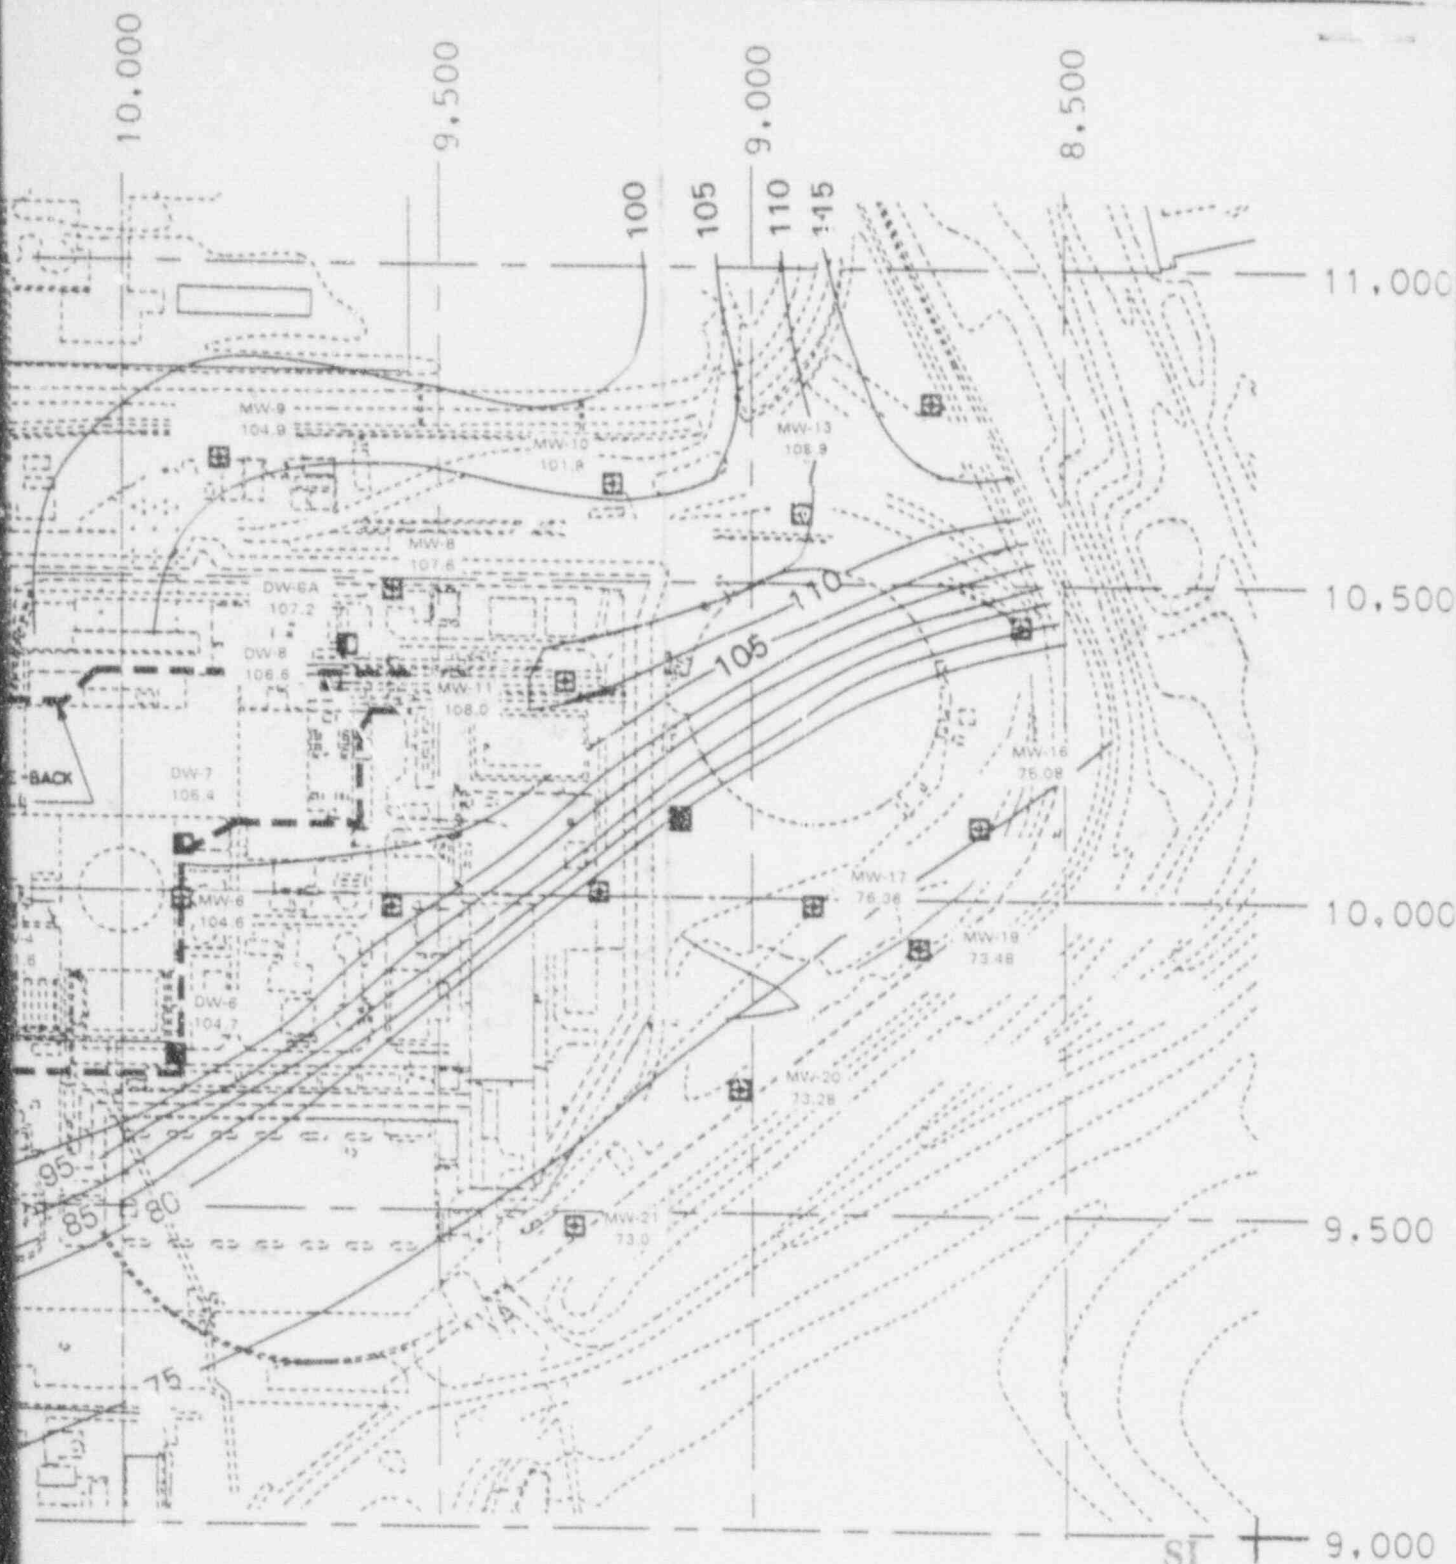
Figure 2 - Average Post-Construction Ground Water Elevations

A post-construction ground water level contour map (Figure 2) has been developed that reflects estimated average ground water levels which are considered likely to occur at GGNS during the life of the plant. The map is based on ground water levels that have occurred since the achievement of final site configuration, the absence of cooling tower leakage, and no further pumping from the dewatering wells.

The contour map shows that average water levels are between El. 105 and 110 ft. immediately south of the power block and between El. 100 and 105 ft. in the northern portion of the plant area. Water levels are higher east of the cooling tower due to the low permeability of the geologic materials in that area.

Monitoring wells, observation
 construction ground water
 taken on 11/09/90
 contour interval is 5 feet
