Subject: Conduit Support Walkdown Questions
Comanche Peak Steam Electric Station
Independent Assessment Program - Phase 4
Texas Utilities Generating Company
Job No. 84056

ATTACHMENT A

CONDUIT WALKDOWN QUESTIONS

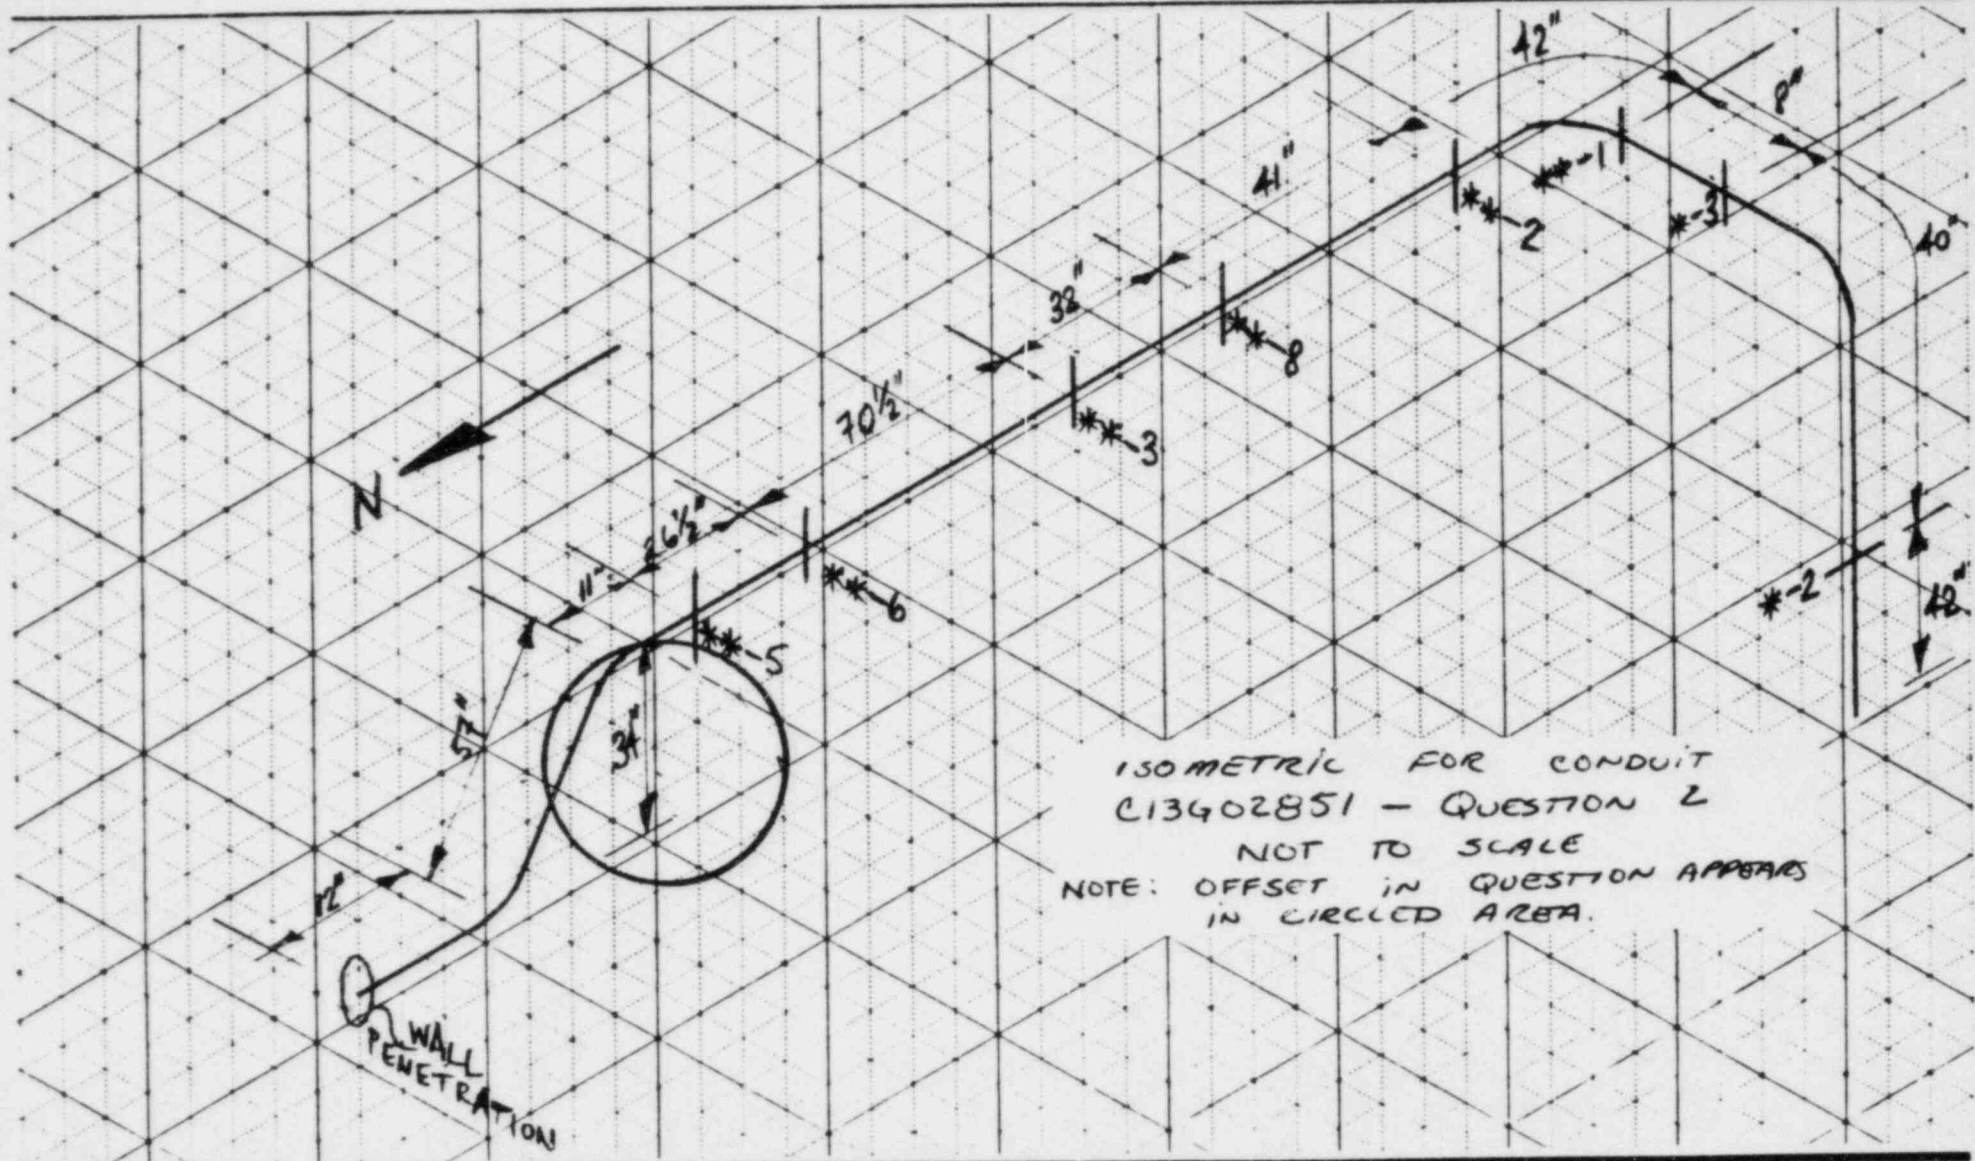
Conduit Support Walkdown Checklist

2. Conduit C12G02851 contains an S_3 offset of 2'-10". The allowable S_3 offset for a 1" diameter conduit per drawing 2323-S-0910, p. 6, sht 2, revision 8 is 2'-3". (See Cygna isometric sheet, attached).

Please provide Cygna with justification for allowing an offset dimension of $S_3 = 2'-10"$ for conduit C12G02851 which exceeds the allowable of $S_3 = 2'-3"$.

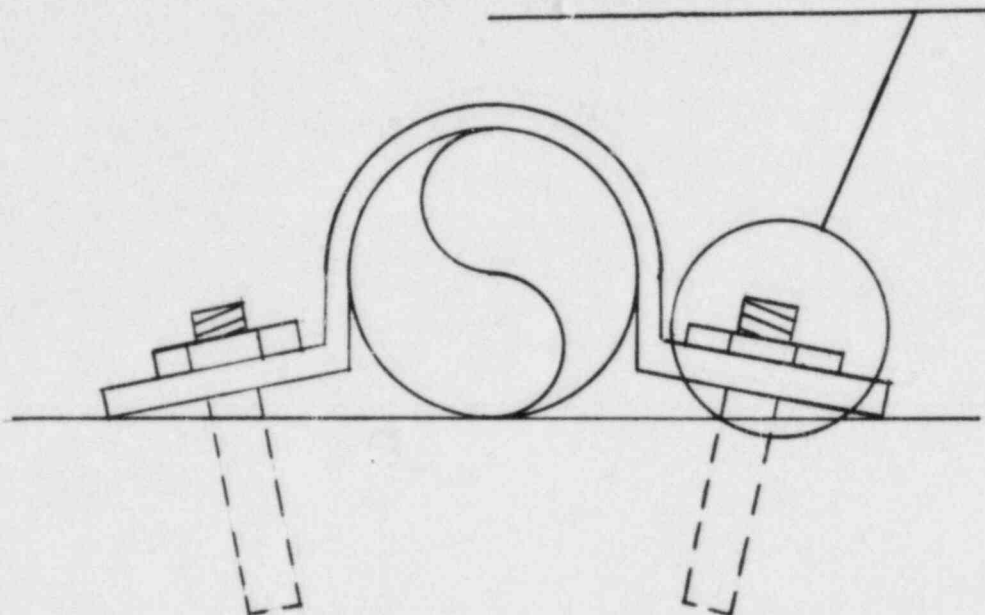
DEFORMED CONDUIT CLAMP
FOR CSD-5a TYPE
CONDUIT SUPPORT

3. Conduit supports C12G02851-6 and C12002935-3 are type CA-5a supports. Cygna's walkdown noted that the conduit clamps were severely deformed in their installed position. As indicated by the attached sketch, even with the clamp deformation, expansion anchor nuts and washers were in full bearing against the clamp, indicating that the anchors were installed at angles to the perpendicular to the concrete surface.

HILTI NUTS & WASHERS
IN FULL CONTACT W/ CLAMP

Please provide Cygna with documentation which addresses the acceptability of deformed clamps as described above.

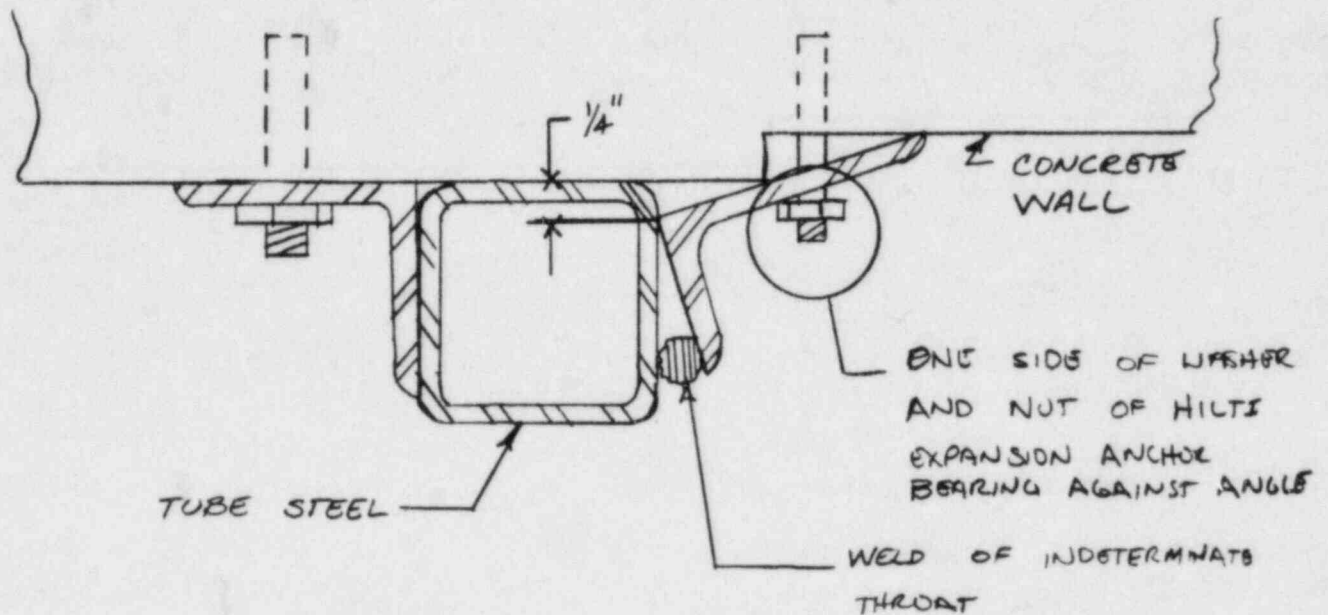
PLAN VIEW OF
SUPPORT CII Ø 04359-1
TYPE IN-CSM-154

4. For support C11004359-1, type IN-CSM-15a, Cygna's walkdown noted the installed configuration appears as shown in the attached sketch. Due to an irregular concrete surface, the leg of the right angle is not flush against the tube steel section but is rotated such that the tip of the other leg is in bearing against the concrete.

The installed configuration impacts the functional capacity of the support in the following fashion:

- a. The bearing area required for proper load transfer at the support concrete interface may not exist which would result in concrete stresses greater than allowables.

- b. With the angle rotated as shown, only one side of the Hilti expansion anchor is in bearing against the angle. Such a configuration results in the introduction of bending stresses within the bolt which have not been considered in the design.
- c. Due to the rotation of the angles, it would not be possible to place the groove welds between the tube and the angle as shown on the support drawing.

Please provide Cygna with justification for QC acceptance of the base angle installation for support C11004359-1.
